Service Bulletin

Bulletin No.: 19-NA-139

Subject: Creak Noise Heard from the Quarter Lower Rear Trim Panel Area

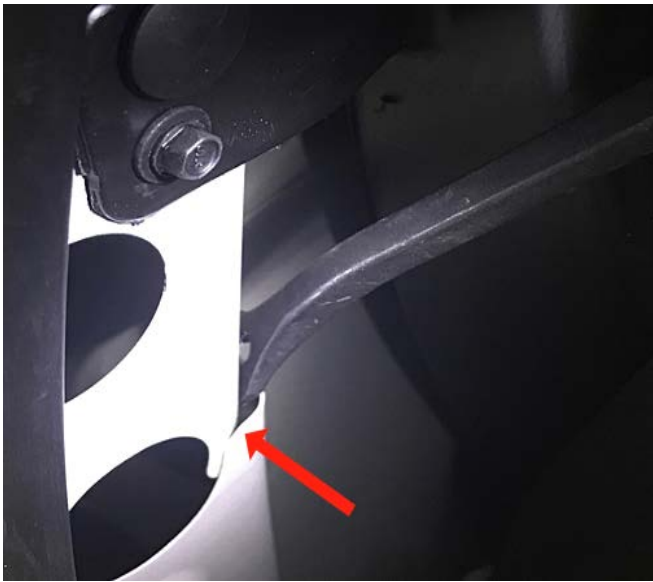
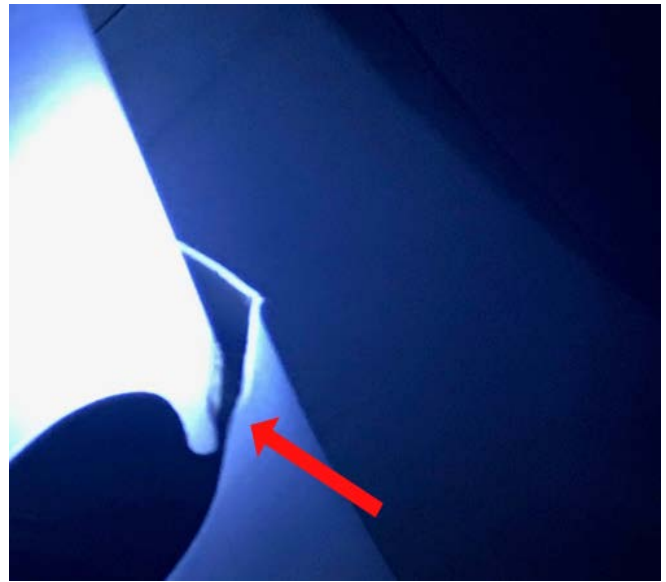
Involved Region or Country	North America, Europe, Russia, Middle East, South America, Japan, South Korea and Thailand.
Condition	Some customers may comment on a creak noise heard from the quarter lower rear trim panel area.
Cause	This condition may be caused when the quarter rear trim panel sheet metal, upper and lower, rubbing together.
Correction	Pry the upper and lower quarter rear trim panel sheet metal apart following the procedure below.

4. Pry the two pieces of sheet metal apart, as shown in the pictures above.
