Service Bulletin

Bulletin No.: 06-03-09-004M

Subject: Squeak Noise from Rear of Vehicle (Lubricate Rear Leaf Springs)

Models: 1999 - 2007 Chevrolet Silverado (Classic)
2007 - 2013 Chevrolet Silverado 1500
2007 - 2019 Chevrolet Silverado 2500/3500
2014 - 2019 Chevrolet Express
1999 - 2007 GMC Sierra (Classic)
2007 - 2013 GMC Sierra 1500
2007 - 2019 GMC Sierra 2500/3500
2014 - 2019 GMC Savana
2007 - 2010 HUMMER H3, H3T

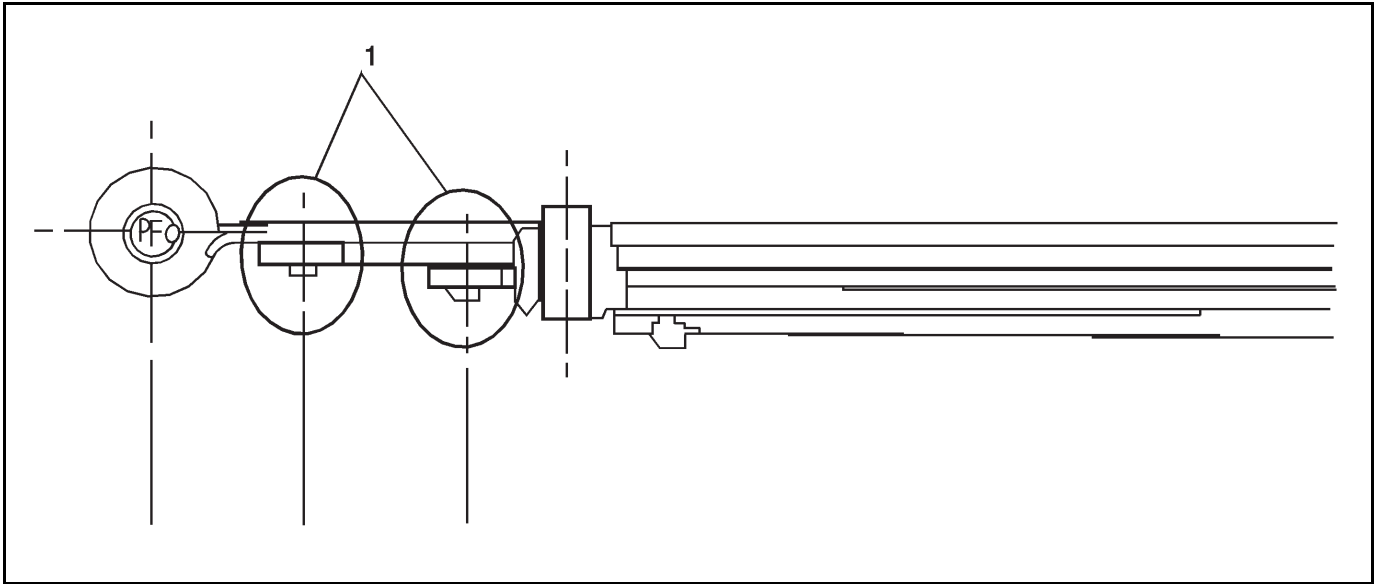
1826776

Some customers may comment about a squeak noise coming from the rear of the vehicle. During normal operation, certain vehicles may exhibit a squeaking noise that may be traced to the rear leaf springs. While this noise is an operating characteristic of leaf springs, the frequency and severity of this noise will be affected by the roads that the vehicle is driven on.

This condition may be due to debris getting between the leaf springs.

5. Apply a liberal amount of grease, P/N 19356408 (in Canada, use P/N 19356409), both underneath and on top of the front and rear tip inserts for the #2 and #3 leaves, as indicated above. A screwdriver can be used to gently pry up the leaf; however, a rag around the screwdriver must be used to prevent damage to the leaf. Use a flat-bladed tool, such as a gasket scraper or a brush to properly distribute the grease at least 6 inches from each end of the leaf.
6. Lower the vehicle to the ground and test drive to verify the repair.
