Service Bulletin

Bulletin No.: 13-08-116-001E

Subject: Aftermarket ALDL or DLC Interface Devices Causing Multiple Issues

Models: 2020 and Prior GM Passenger Cars and Trucks

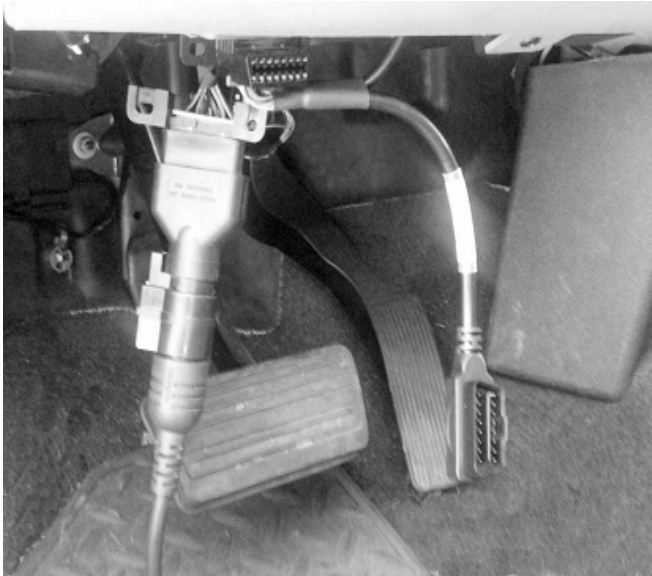
3346643

Device W/Secondary DLC Connector

This device has another DLC connector on it. The rest of the harness along with the device can be placed out of sight hidden from the technician, who may not notice the diagnostic connector is not in the factory location.

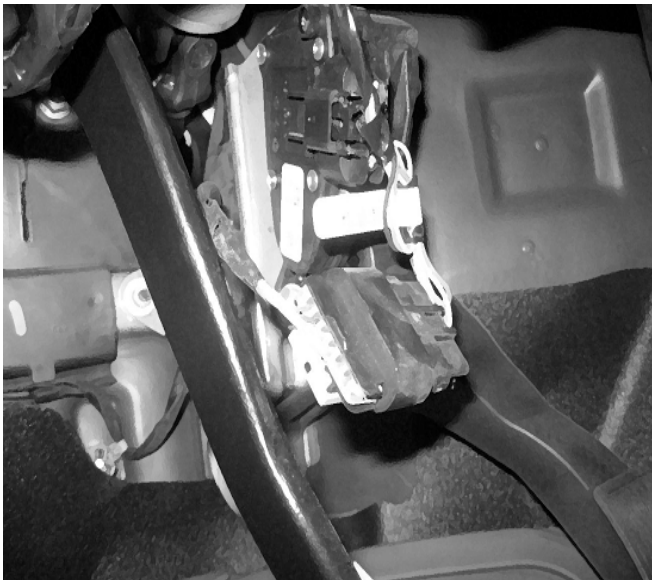
3346646

Pedal Mounted Aftermarket Device Interface

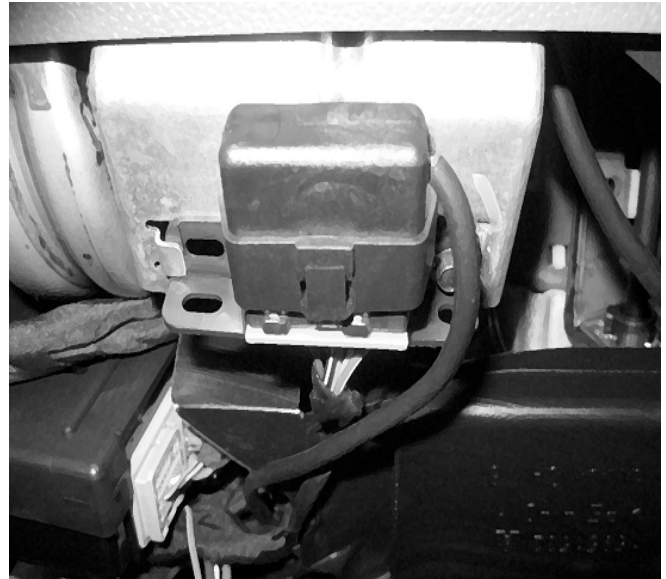
3346648

Aftermarket Device at ALDL

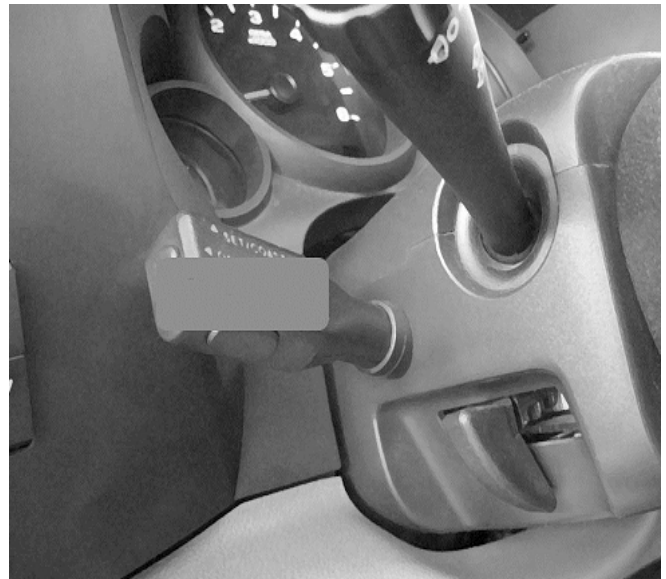
3346650

Aftermarket Device Switch

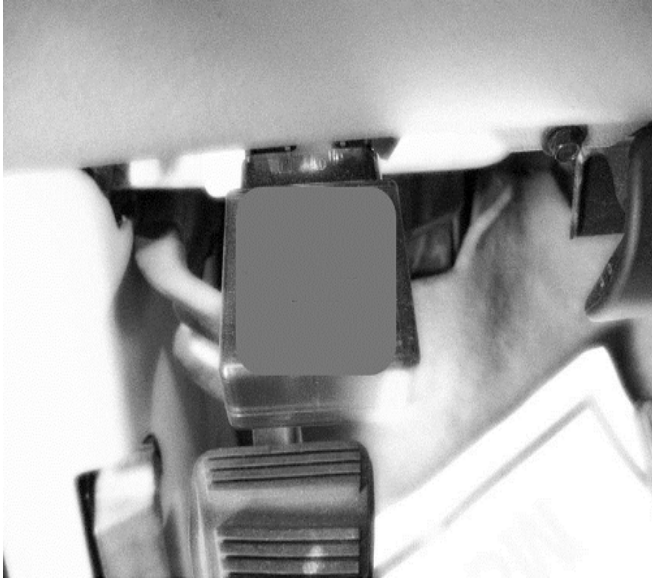
3346651

Monitoring Device Example

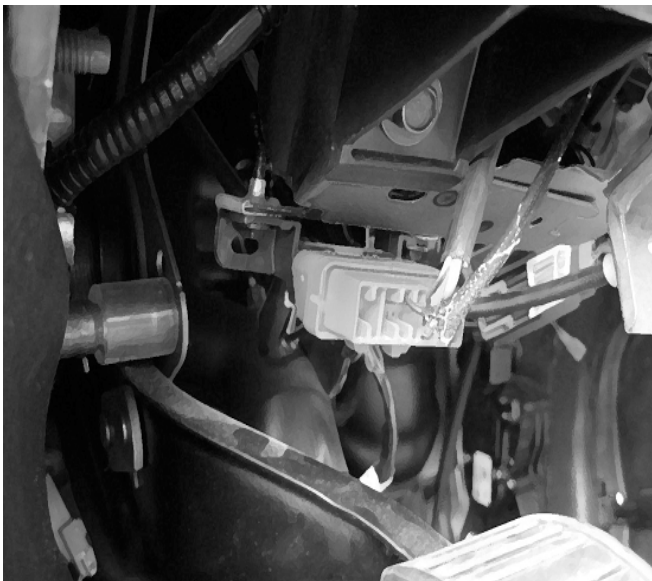
3346652

Fleet Tracking Device Interface (May Include Rental and Lease Vehicles)
