SERVICE BULLETIN

APPLICABILITY: 2015-2018MY Legacy and Outback

"Popping" or "Snapping" Sound When

NUMBER: 12-246-18R

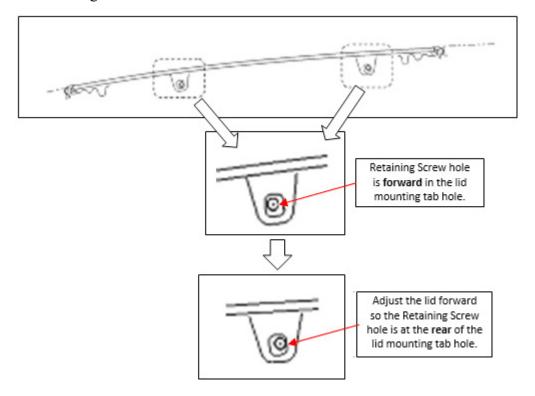
Step 1: Adjust the lid forward to reduce chances of the weatherstrip sticking or catching the edge of the sunroof opening in the roof panel or the sunroof frame. This can cause the snapping sound and / or damage to the weatherstrip / seal..

1a- Loosen the retaining screws and move the lid forward as shown below.

1b- Adjust the surface fitting of the lid to the roof panel, 1mm up from flush along the front edge and 1mm below flush along the rear edge.

1c- Tighten the screws and re-check sunroof operation.

NOTE: If completion of these **Step 1** adjustments has repaired the condition, replace the 4 lid retaining screws ONE AT A TIME (to retain the adjustment) with NEW screws and torque to 40 inch-pounds.

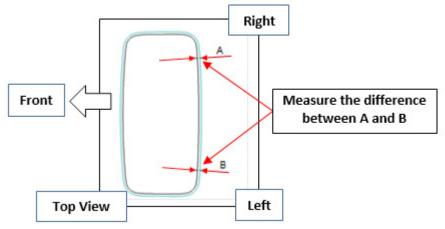
2a- Check and measure for a difference in the amount of deformation of the weather-strip.

If there is a difference between **A** and **B**, go to **2b** and **CAREFULLY** follow the adjustment procedure. If there is no difference, proceed to **Step 4**.
