SERVICE BULLETIN

APPLICABILITY: 2019MY Forester

NUMBER: 12-269-19

SUBJECT: Rattle Sound from EyeSight Camera Cover-
Design Change

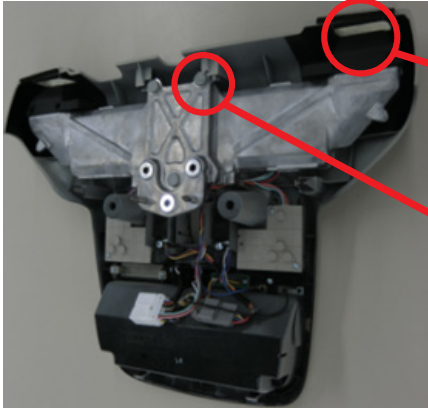
This bulletin announces 2 design changes to the EyeSight camera cover to prevent a rattling sound heard while driving. The changes involve the inside support ribbing near the front, center and a slight revision to the size of the bottom camera lens openings. Comparison images are provided below.

New Part	Old Part
Lens Opening

Rib Shape

The new covers were incorporated into production starting with VIN **KH551044**.
