Bulletin No.: PIP5571A

PIP5571A MIL / SES Lamp On After Engine Repairs, P0016 Set and Rough Idle

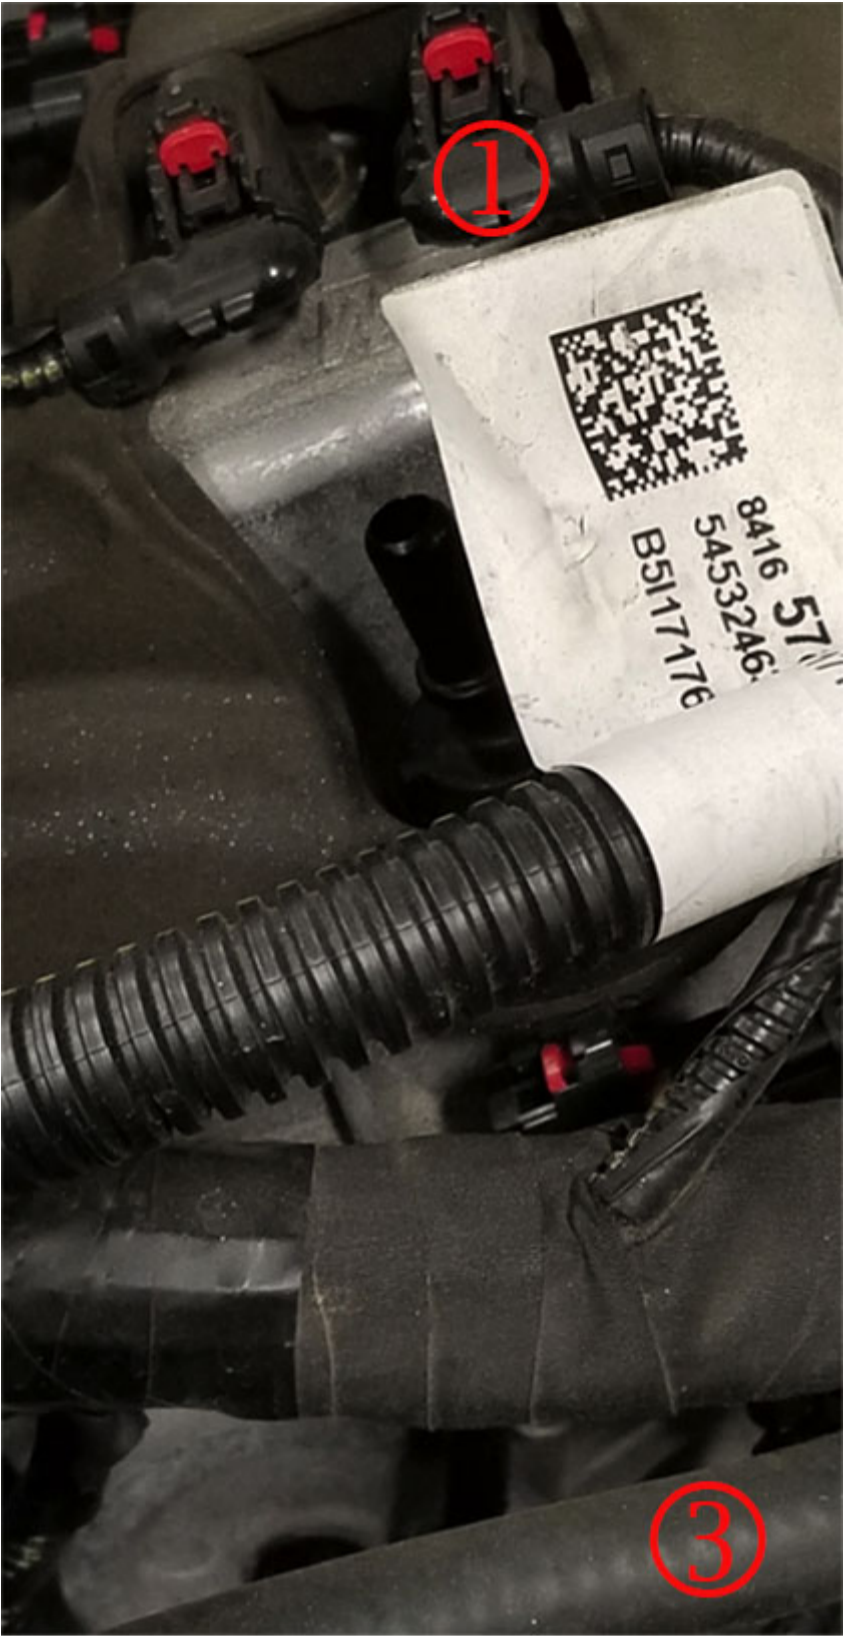
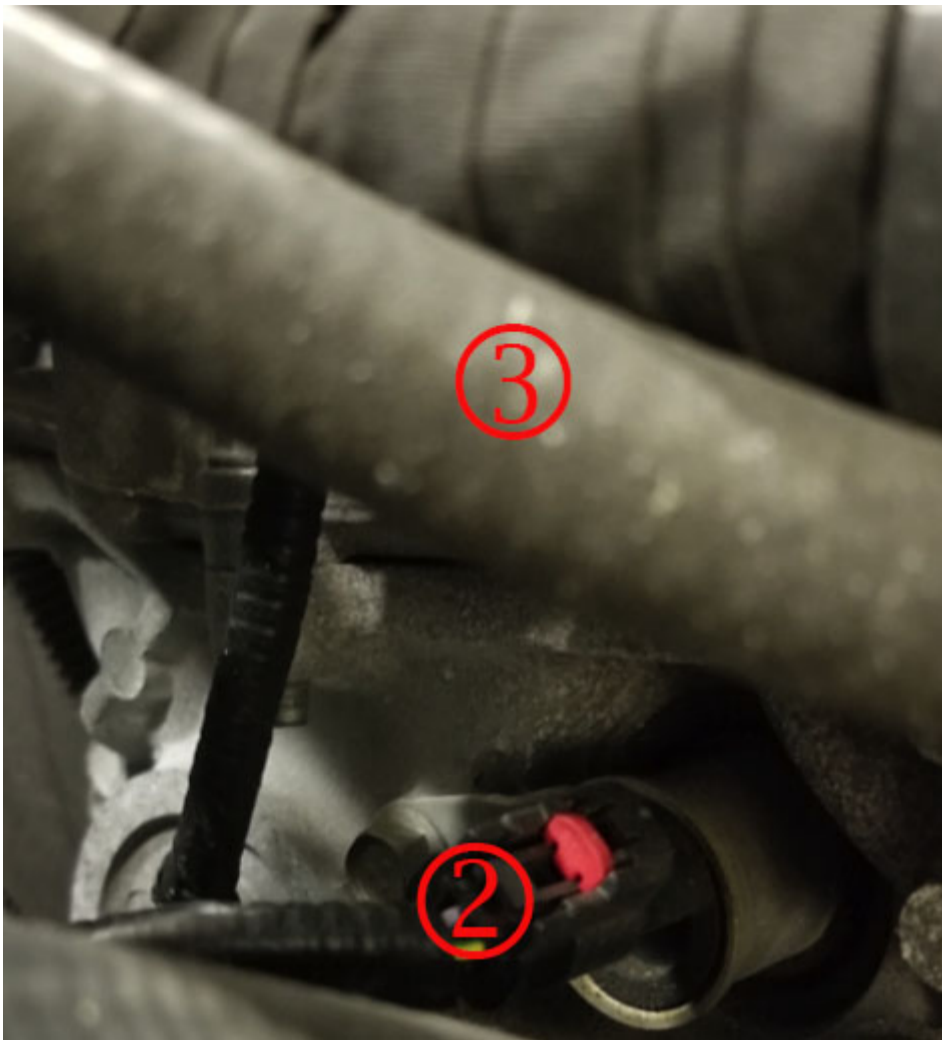
Involved Region or Country	North America
Condition	Some dealers will find a P0016 set after an engine repair that included moving the wiring harness on the right front side of the engine. This will be a hard code and will usually cause a rough idle concern.
Cause	What we are seeing is the wiring connectors for the intake camshaft actuator solenoid bank one on top of the engine and the connector for the intake actuator park lock solenoid in the front of the engine for bank one, have been swapped. These two connectors are identical and can only be identified by wire color in the connector.

- 1) Bank 1 intake actuator**
- 2) Bank 1 intake park lock solenoid
- 3) Same hose in both pictures for relativity.

Remove the connector and look at the schematic in eSI to compare and ensure the correct connector is plugged into the actuator and lock solenoid. (See pictures below)

If they are incorrect swap them back and clear the code to verify repair.
If they are already in the correct places then refer to the correct eSI diagnostics for this code.
