Service Bulletin

Bulletin No.: 16-NA-286

Subject: Hydraulic Brake Performance Issues on Hybrid Vehicles, DIC Messages Displayed and/or DTC C05AD, C0580 or P05FF Set

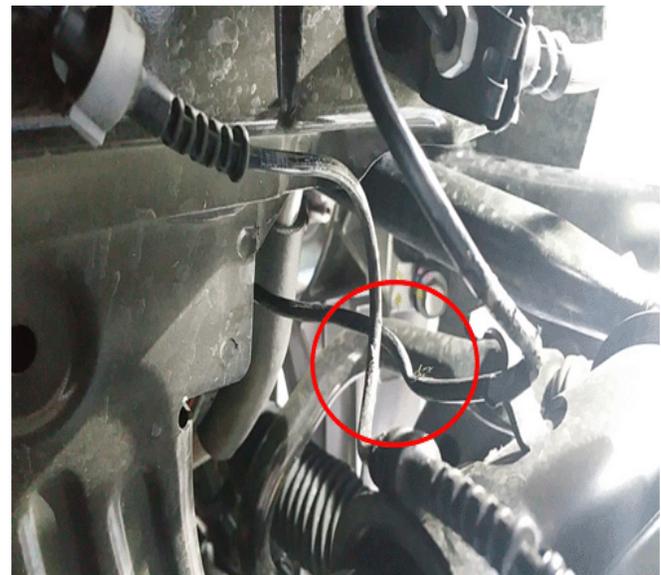
4565441

This example shows a misrouted front brake line, resulting in kinking from hitting the shock tower when the wheel is turned. This condition may cause reduced brake fluid apply pressure to the wheel resulting in brake performance issues. DTC C05AD Brake Blending System Performance may set.

Repair the kinked metal brake line. Refer to **Brakes > Hydraulic Brakes > Repair Instructions** in SI.

After the repair, if DTC C05AD is still set, refer to **DTC C05AD Brake Blending System Performance** in SI.

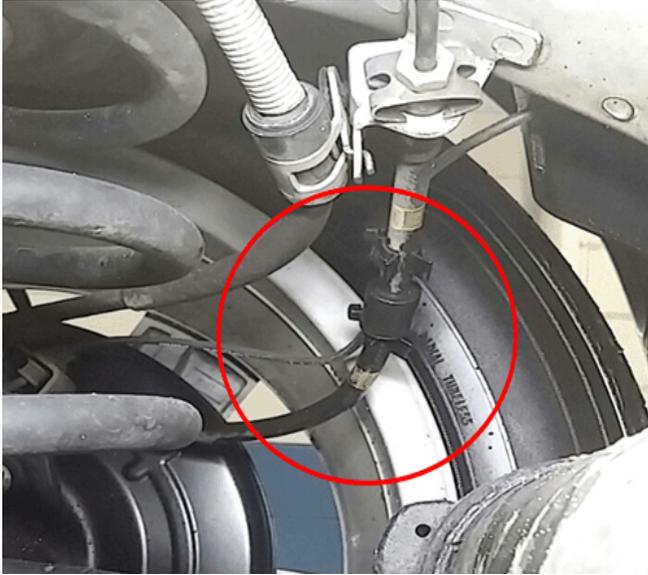
4565442

The brake hose is misrouted causing the hose to rub on the front tire, eventually resulting in a loss of brake fluid.

Replace and properly secure the brake hose. Refer to **Front Brake Hose Replacement** or **Rear Brake Hose Replacement** in SI.

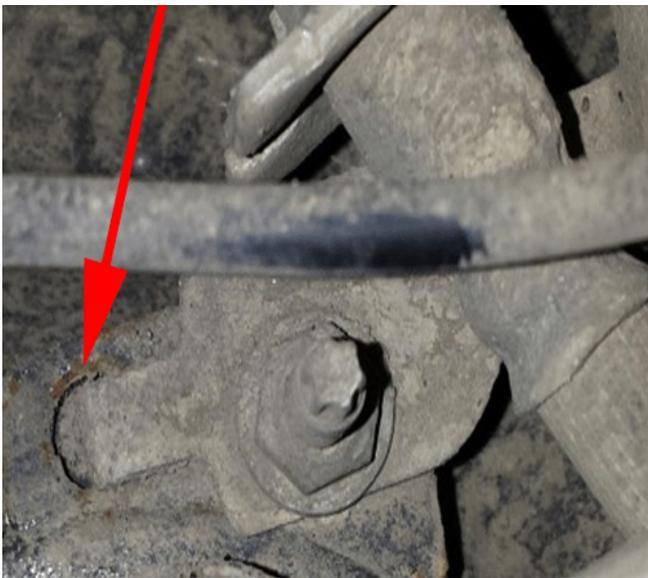
4565584

The misrouting may be caused by the anti-rotation bracket not properly seated into the retaining hole, or the hose is not otherwise properly secured resulting in it making contact with the rotating tire/wheel assembly.

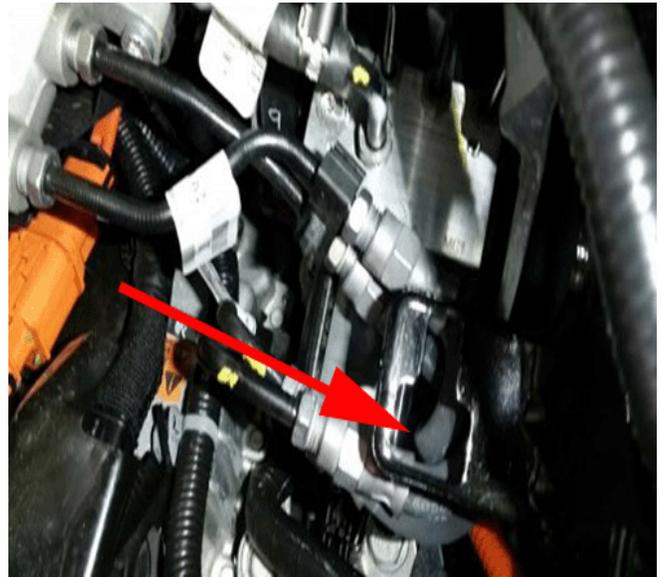
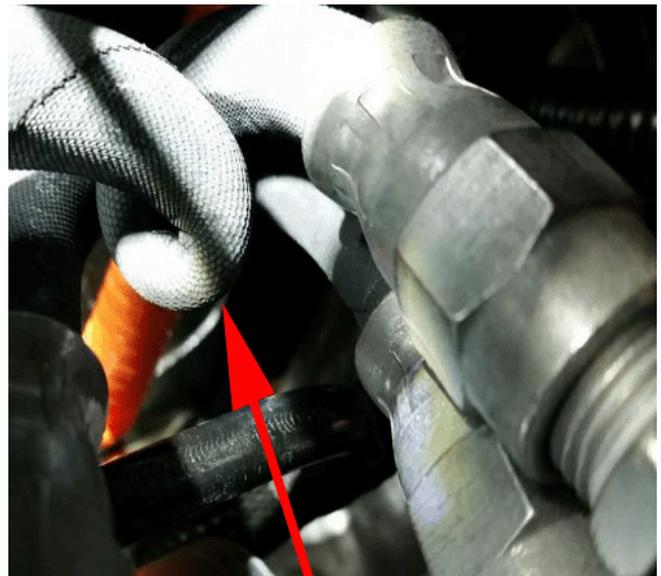
Perform a visual inspection of the flexible brake hose at the master cylinder for any kinks or twisting as shown. This condition may cause reduced brake fluid apply pressure to the wheels resulting in brake performance issues.

Replace the flexible brake hose at the master cylinder. Refer to **Brakes > Hydraulic Brakes > Repair Instructions** in SI.

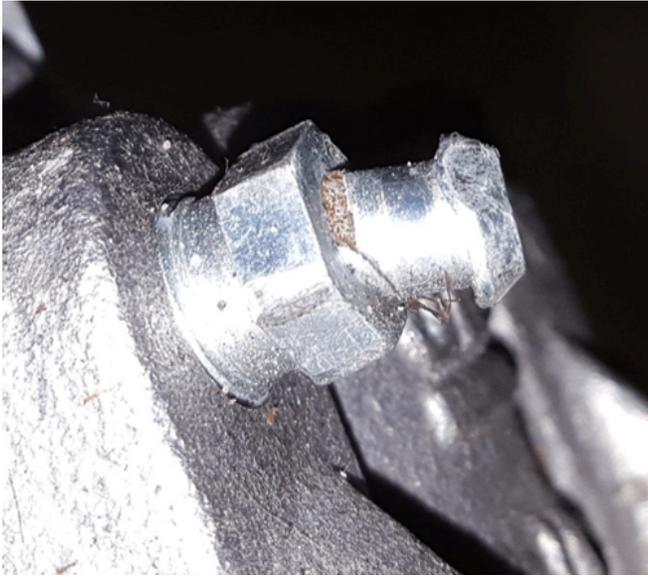
4565444

Each brake caliper has a brake fluid bleeder valve. A visual inspection may show that any of the front or rear brake fluid bleeder valves have been bent or cracked. A possible cause is road debris impact.

If this condition is encountered, replace the brake fluid bleeder valve.

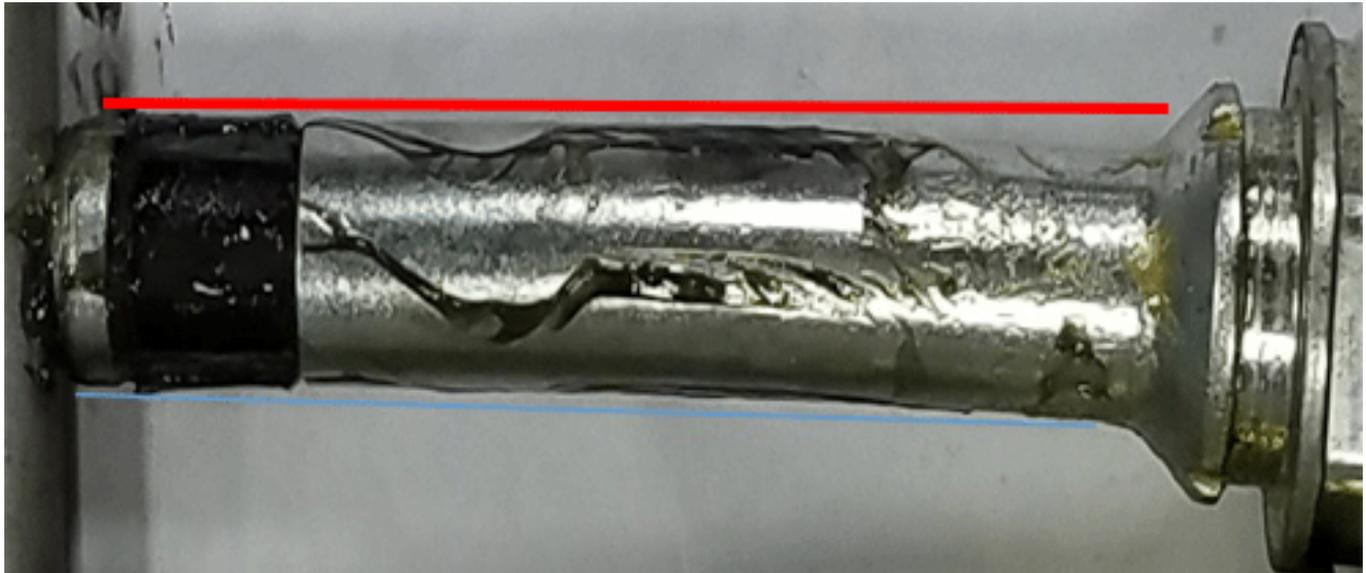
4565587

View of a damaged brake caliper guide pin.

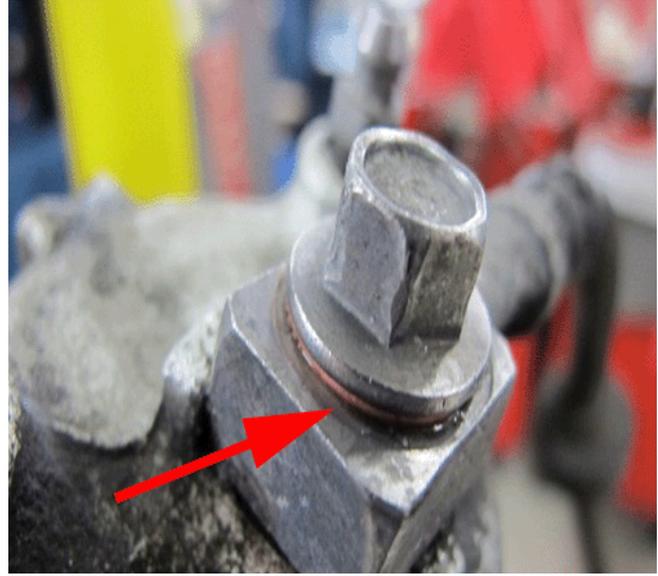
4565445

The brake hose caliper crush washer may exhibit a distorted oval shape and witness lines which indicate multiple use and may result in a brake fluid leak.

- ⇒ If either of these conditions are encountered, refer to **Front Brake Hose Replacement** or **Rear Brake Hose Replacement** in SI.
- ⇒ If the hydraulic brake system requires bleeding due to brake fluid loss, refer to **Hydraulic Brake System Bleeding** in SI.

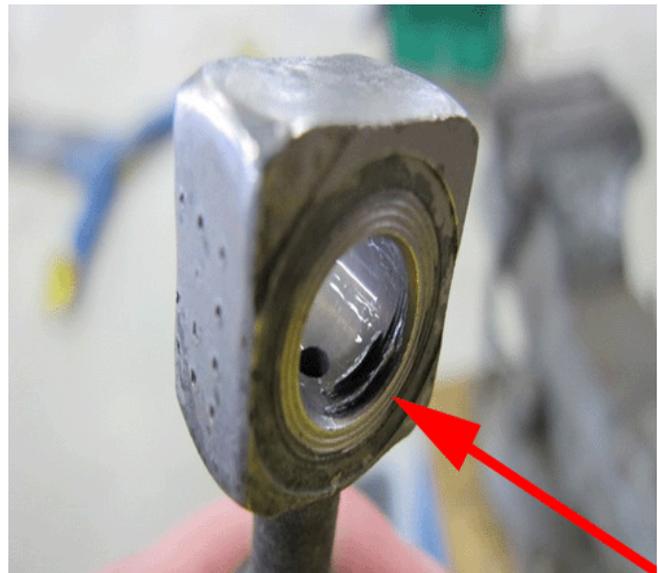
4565446

The brake fluid leak may also be caused by the brake hose caliper crush washer bolt being cross-threaded and retightened during installation.

Important: When tightening the brake hose caliper crush washer bolt, make sure to finger tighten the bolt first to avoid cross threading when reinstalling.
