# Service Bulletin

Bulletin No.: 17-NA-201

**Subject: Excessive Windshield Condensation, HVAC Defrost Door Flutter Type Noise Heard**

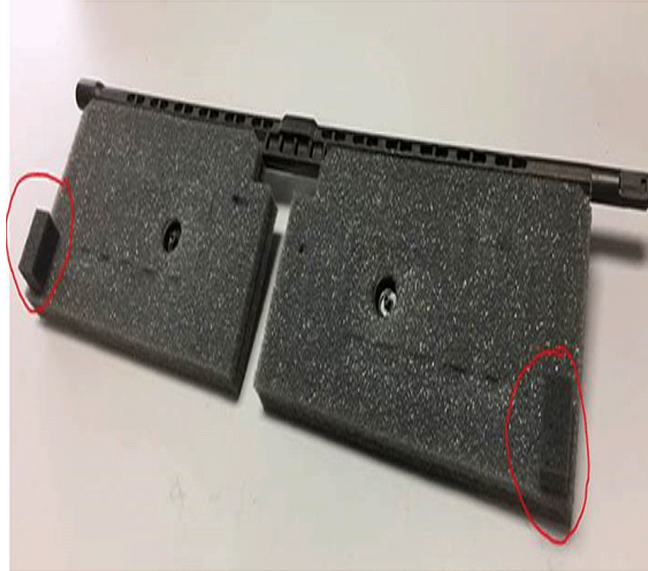
4779509

This condition may be caused by the foam pads on the defrost door allowing too much air to pass through, causing excessive condensation on the outside of the windshield.

<b>Correction</b>	<b>Condition 1</b> An updated software calibration has been released to address the flutter type noise condition. <b>Condition 2</b> For vehicles built prior to the Breakpoint listed in the table, remove both foam pads located on the defrost door to address the excessive windshield condensation then update the software to address the flutter issue that results when the foam is removed.
-------------------	---
