Service Bulletin

Bulletin No.: 17-NA-258

Subject: Excessive Wind Noise from Front Side Door Glass Area

Brand:	Model:	Model Year:		VIN:		Engine:	Transmission:
		from	to	from	to		
Chevrolet GMC	Silverado 1500 Sierra 1500	2014	2014			All	All
	Chevrolet GMC	Silverado Sierra	2015

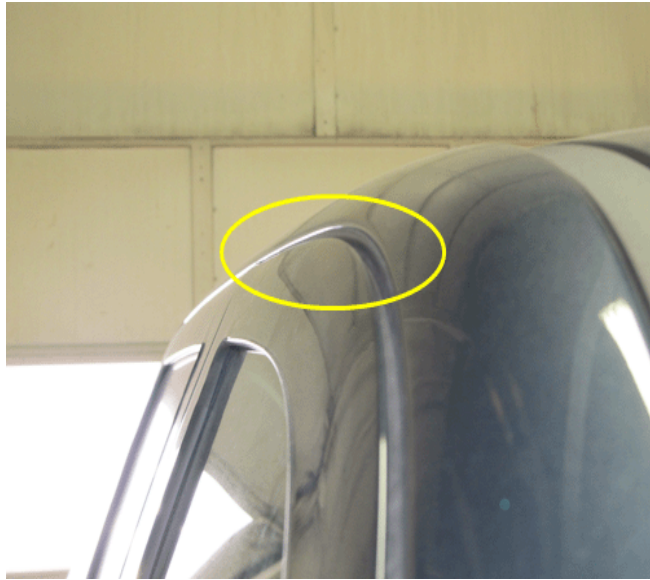
3806381

- Improper front side door fit to roof.

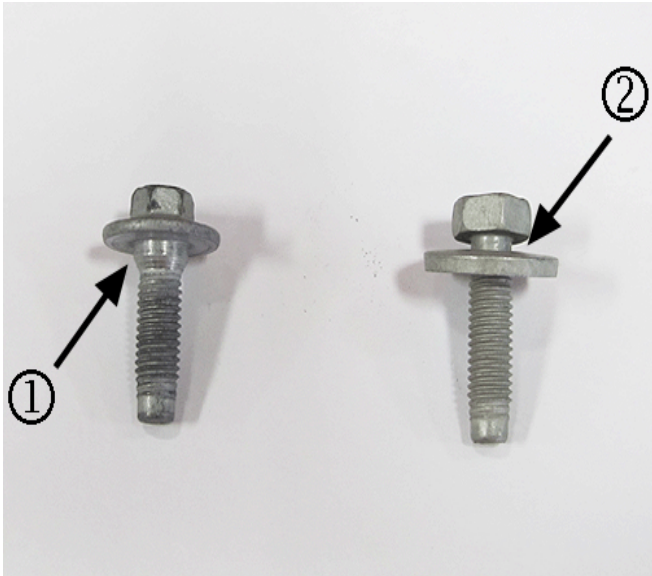
3806388

Note: The referenced hinge service bolt (2) is non-shouldered and will allow more adjustment than the original shouldered bolt (1).

3. If bending the door header does not resolve the condition, the door fit must be adjusted by adding two hinge service bolts, P/N 11561763.

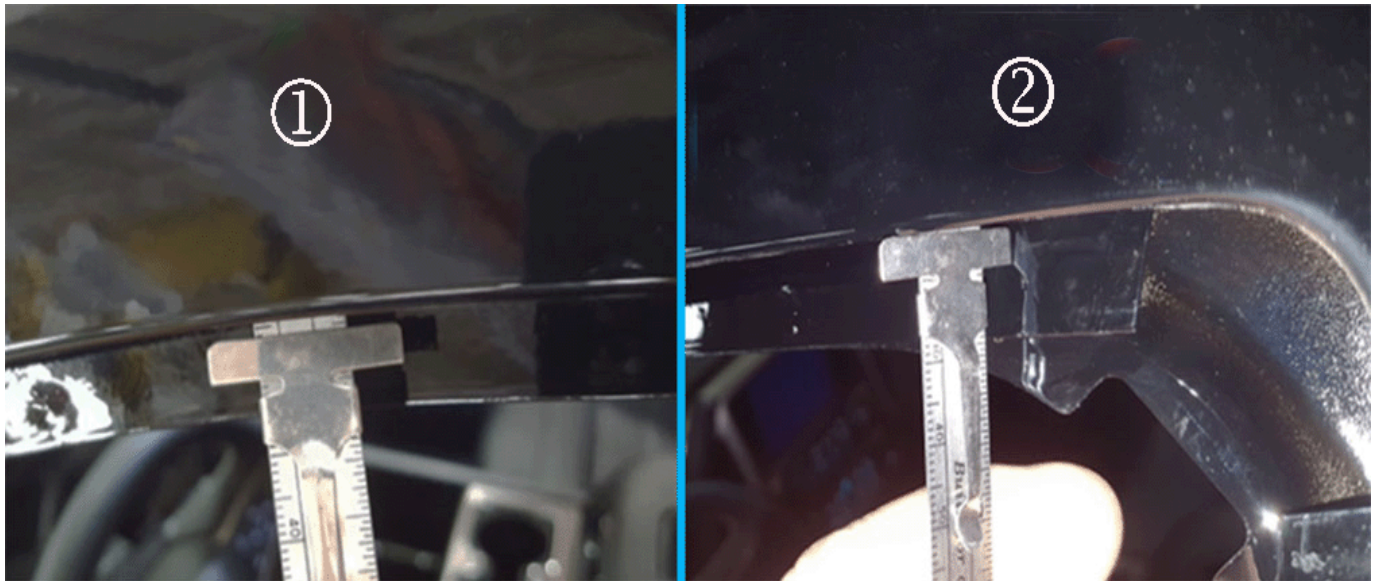
4846289

- 6.7. Inspect the upper door frame metal glass run channel, just forward of the B pillar, for possibly being out of design location.
- If the metal run channel is approximately the same depth across the top (1), no additional repair in this area is needed, and you can move ahead to step # 8.
 - If the metal run channel is approximately 1.5 mm higher (up/down) (2), continue to step # 7 to add foam tape.

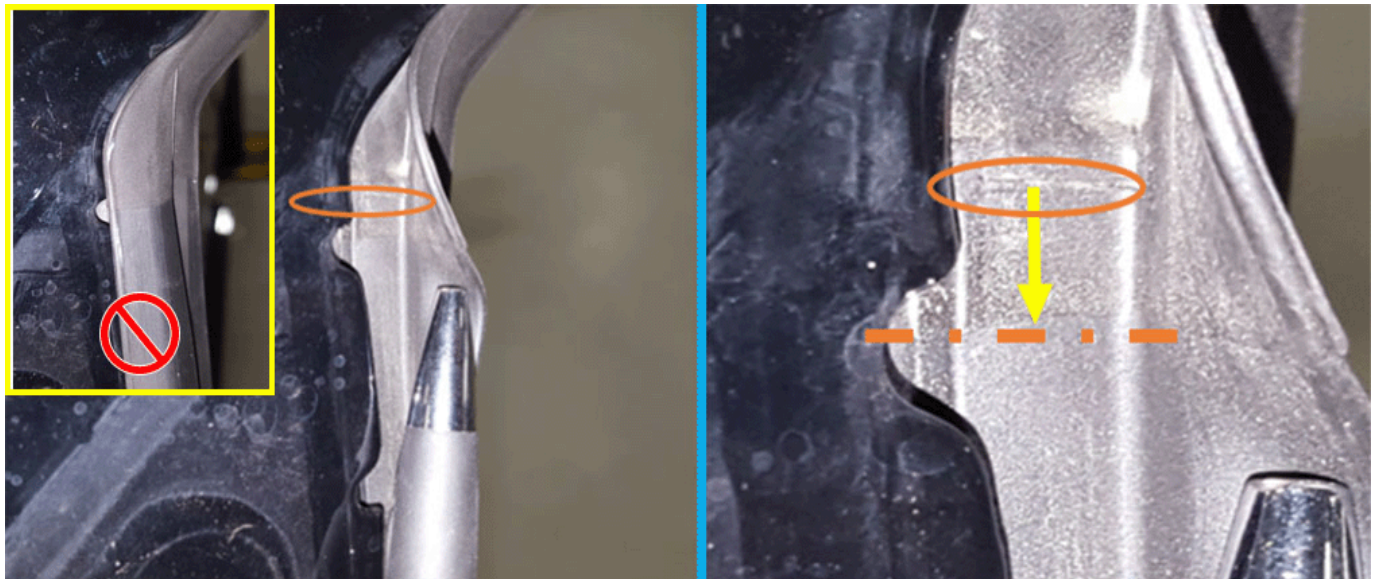
4846295

Important: The last example above shows the front, upper corner of the weatherstrip installed too high and well out of position. The feature line (shown circled) should be located down at the center-line of the metal notch.
