Service Bulletin

Bulletin No.: 17-NA-265

Subject: Flutter or Thump Noise from Rear of Vehicle

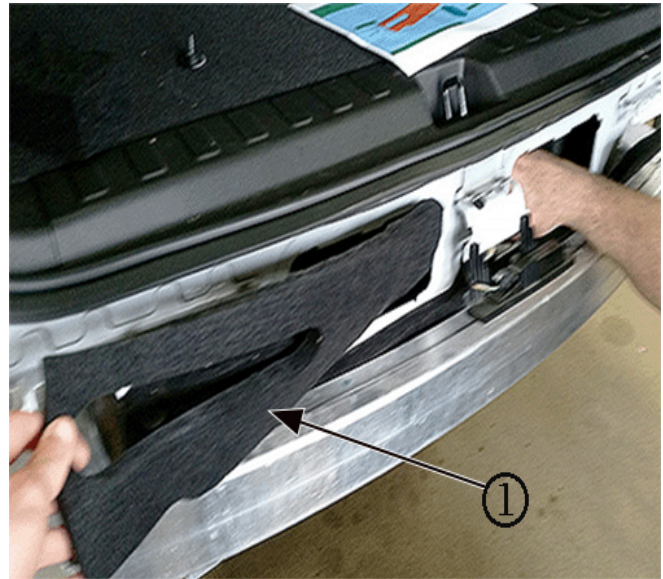
4849174

Note: The current design insulator panel has a different shape than the first design insulator shown in the graphic above. The shape is correctly shown in the illustration in the Correction section.

- 3.1. Slide the insulator panel (1) into one of the PRV openings.
