Service Bulletin

Bulletin No.: 18-NA-333

Subject: Malfunction Indicator Lamp (MIL) On, Whistle Type Noise at Startup, DTC P1101 Set

Brand:	Model:	Model Year:		VIN:		Engine:	Transmission:
		from	to	from	to		
Buick	Encore	2018	2019			1.4L (LE2)	All

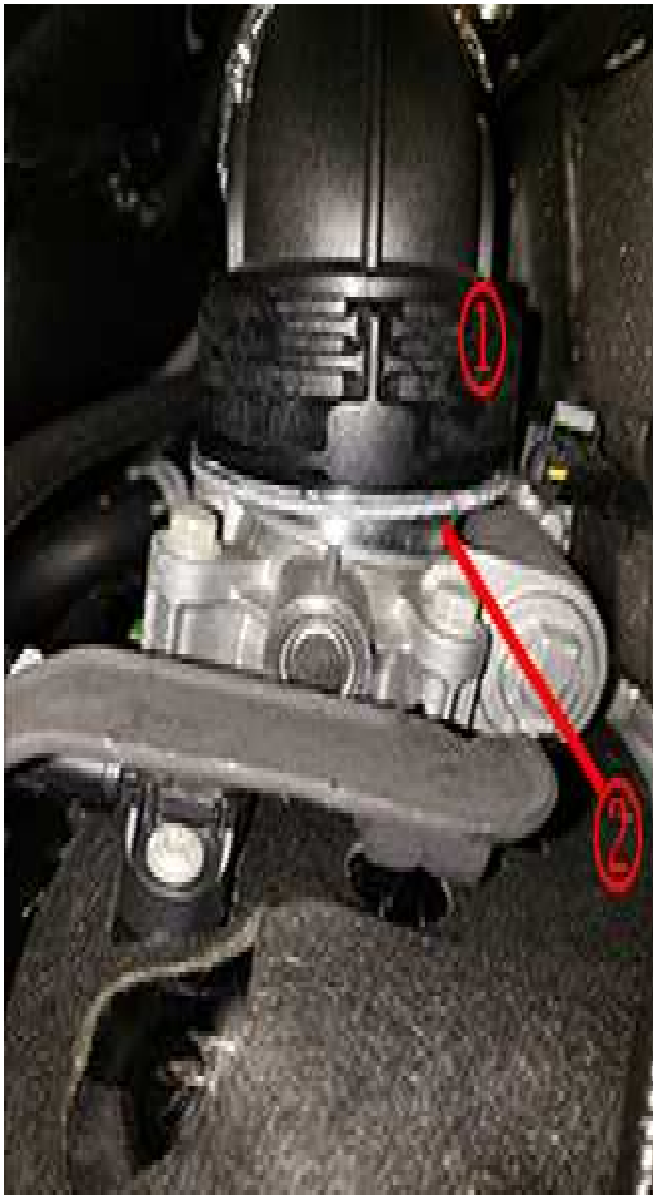
5164441

- 1. CAC outlet air hose
- 2. Throttle body connection point

Loosen the clamp, remove and reinstall the CAC outlet air hose to the throttle body to reseal the connection.
