Service Bulletin

Bulletin No.: 19-NA-153

Subject: Malfunction Indicator Lamp (MIL) Illuminated - DTC P0741 Set

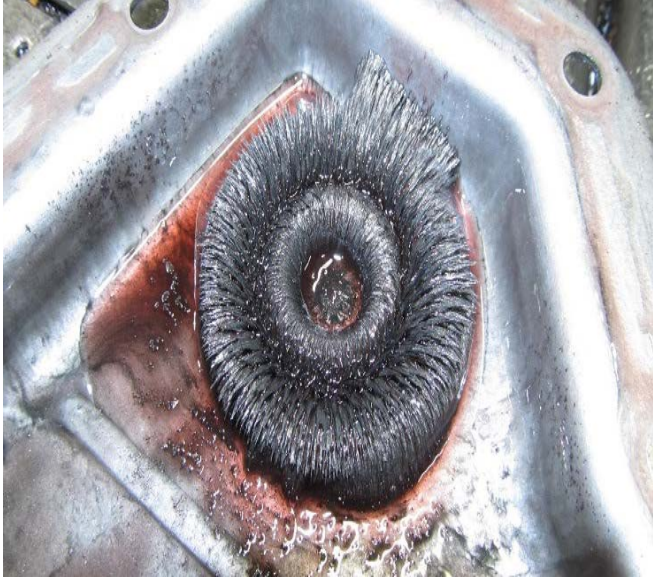
5360216

2. Remove the transmission oil pan.
3. Inspect the magnet in the pan for excessive metal accumulation.
 - If there was no signs of metal in the oil pan, install the pan and no further work is required.
 - If there was excessive metal shaving in the oil pan magnet, continue to step 4.
