TECHNICAL SERVICE BULLETIN

Popping Or Snapping Noise When Opening And/Or Closing The Liftgate - Built On Or Before 6-Mar-2019

19-222420 August
2019**Model:**

Ford 2019 Edge

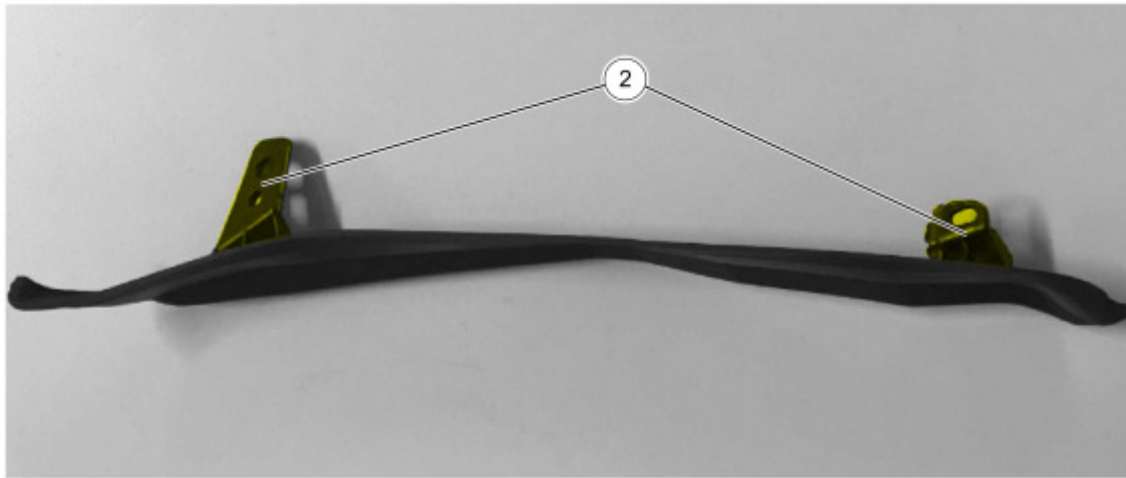
Figure 3

NOTE: The close out being removed will have 3 tabs and the new part will have 2 tabs. This is design intent of the new part.

3. Install the 2 tab reversing lamp close out and tighten to 1 Nm (8.85 in-lbs). (Figure 3)
