## SERVICE INFORMATION BULLETIN

**APPLICABILITY:** 2020MY Legacy and Outback  
2019-20 Impreza  
2019-20MY Crosstrek / Crosstrek Hybrid  
2019-20 Forester  
2019-20 Ascent  
All Models as Listed with Gen 2 Telematics

**NUMBER:** 15-251-19

**SUBJECT:** DTC B2A16

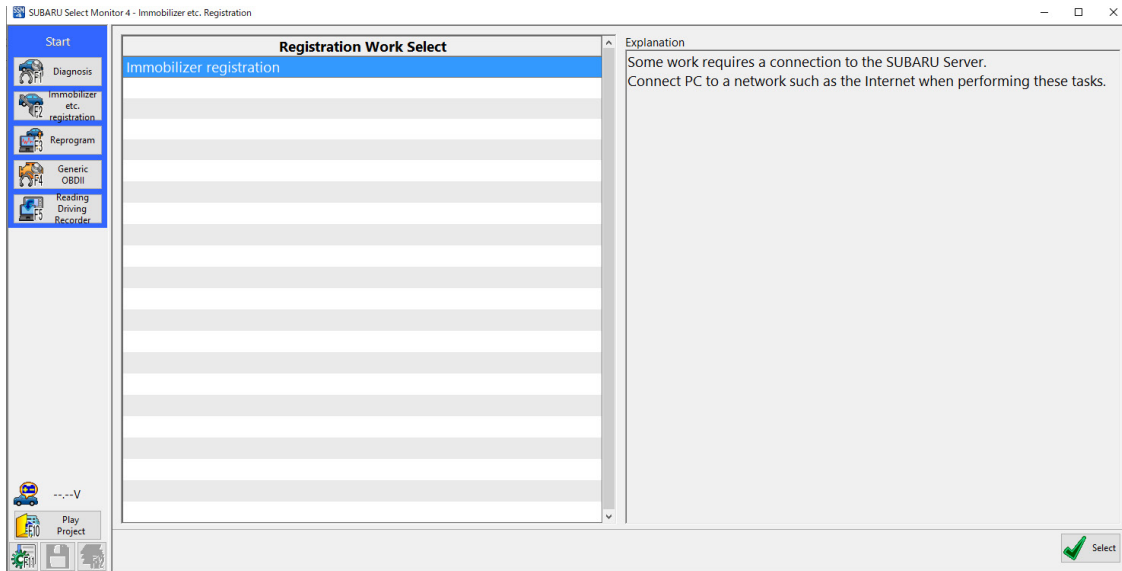
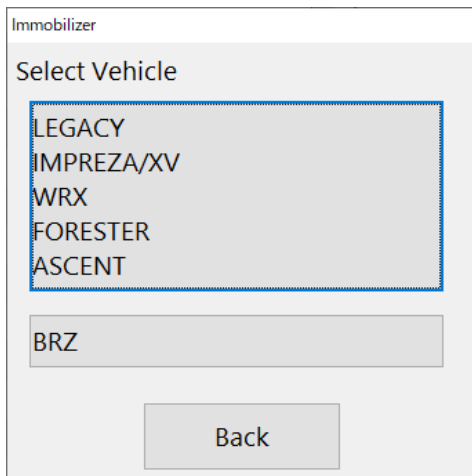
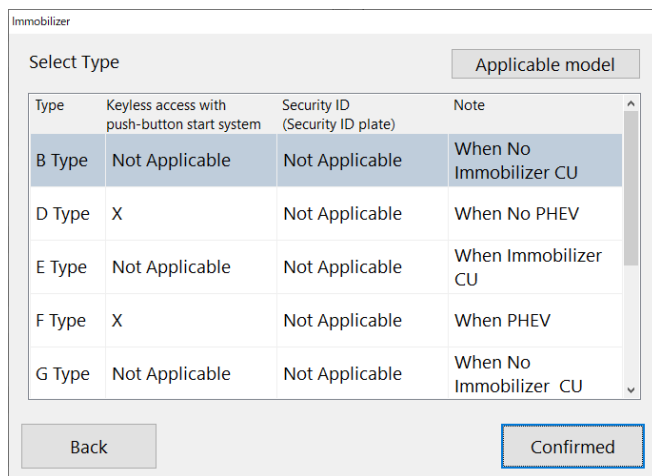
If DTC B2A16 is found in the DCM, start by registering the DCM with the vehicle immobilizer system to avoid a potentially unnecessary DCM replacement. Follow the instructions found in the applicable Immobilizer Registration Manual. See the basic SSM screenshots and additional information provided below for reference.

Once the DCM is registered, confirm the Telematics RES function operates. **NOTE:** The customer will need to help with this as it requires them to enter their PIN through either the MySubaru web page or the mobile MySubaru App.

If registering the DCM with the vehicle immobilizer system resolves the condition and STARLINK Telematics RES now operates normally, clear the DTC and release the vehicle.
