## TECHNICAL SERVICE BULLETIN

### 3.5L EcoBoost High Output - Lack Of Power And/Or Misfire With Or Without DTCs P0300 Through P0306 - Built On Or Before 1-Jun-2019

**19-2286**  
20 September  
2019

<b>Ford</b> 2019 F-150
---------------------------

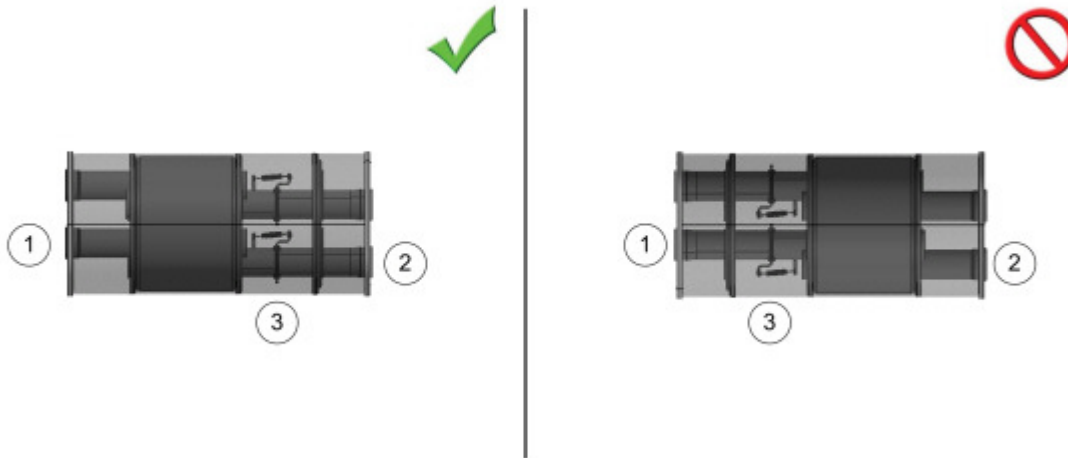
Figure 1

1. Disconnect the inlet side of the muffler. Refer to Workshop Manual (WSM), Section 309-00.
2. Insert a tape measure into the inlet side of the muffler assembly until it bottoms out. (Figures 1-2) Is the measurement at the end of the tube 584 mm (23 inches) or less?
  - (1). Yes - proceed to Step 3.
  - (2). No - this article does not apply. Refer to WSM Section 309-00 for normal diagnostics.

3. Replace the muffler assembly. Refer to WSM Section 309-00.
