SERVICE INFORMATION BULLETIN

APPLICABILITY: 2018MY Legacy and Outback

NUMBER: 15-225-18R

SUBJECT: DTC B2242 “UART COMMUNICATION”

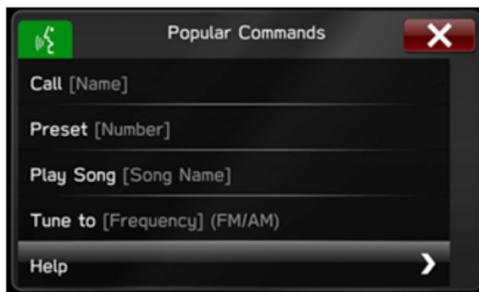
Step 3: Confirm the Popular Commands screen is displayed and that the list is shown in English.

- If the list is not shown in English, access “General Settings” after pressing “Settings” on the Home screen, scroll down the list to “System Language” and select the applicable “English” option.

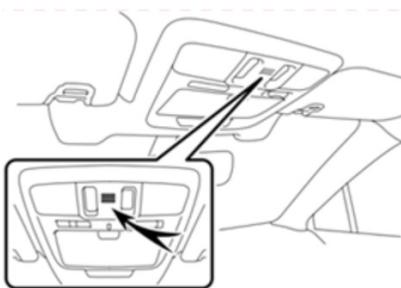
Step 4: In a normal voice, say “Auto AC on” into the microphone located in center of the overhead console.

- If the system responds with “OK Turning Auto AC on”, proceed to **Step 5**.
- If any other response is provided or a command is requested again, repeat **Step 4**.
- If the system still does not respond with “OK Turning Auto AC on” and the command list has disappeared from the screen, try again starting with **Step 2**.
