NUMBER: 09-70-19

SERVICE INFORMATION BULLETIN

APPLICABILITY: 2019-20MY Legacy and Outback

SUBJECT: CVT Fluid Cooler Hoses and Clamps- Design Change

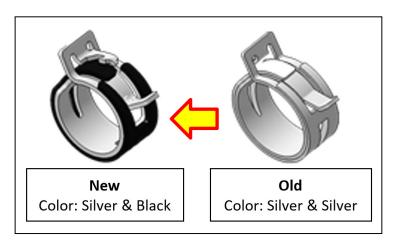
- The new coolant hoses appear the same as the originals except for the outer diameter which is 1mm smaller (the inner diameter remains unchanged).
- The new clamps are now black and silver (instead of all silver) as shown in the illustration. They also have a 2.1mm smaller inside diameter to work with the new hoses.

VERY IMPORTANT: There is NO interchangeability between the old and new -style parts. NEVER use an old -style clamp on a new -style hose and / or vice-versa.
