TECHNICAL SERVICE BULLETIN

6.7L - Illuminated MIL With DTCs P21DD, P204C, P21CD And/Or U02A2 - Built On Or Before 1-Aug-2018

19-2315

Ford 2017-2019 F-Super Duty

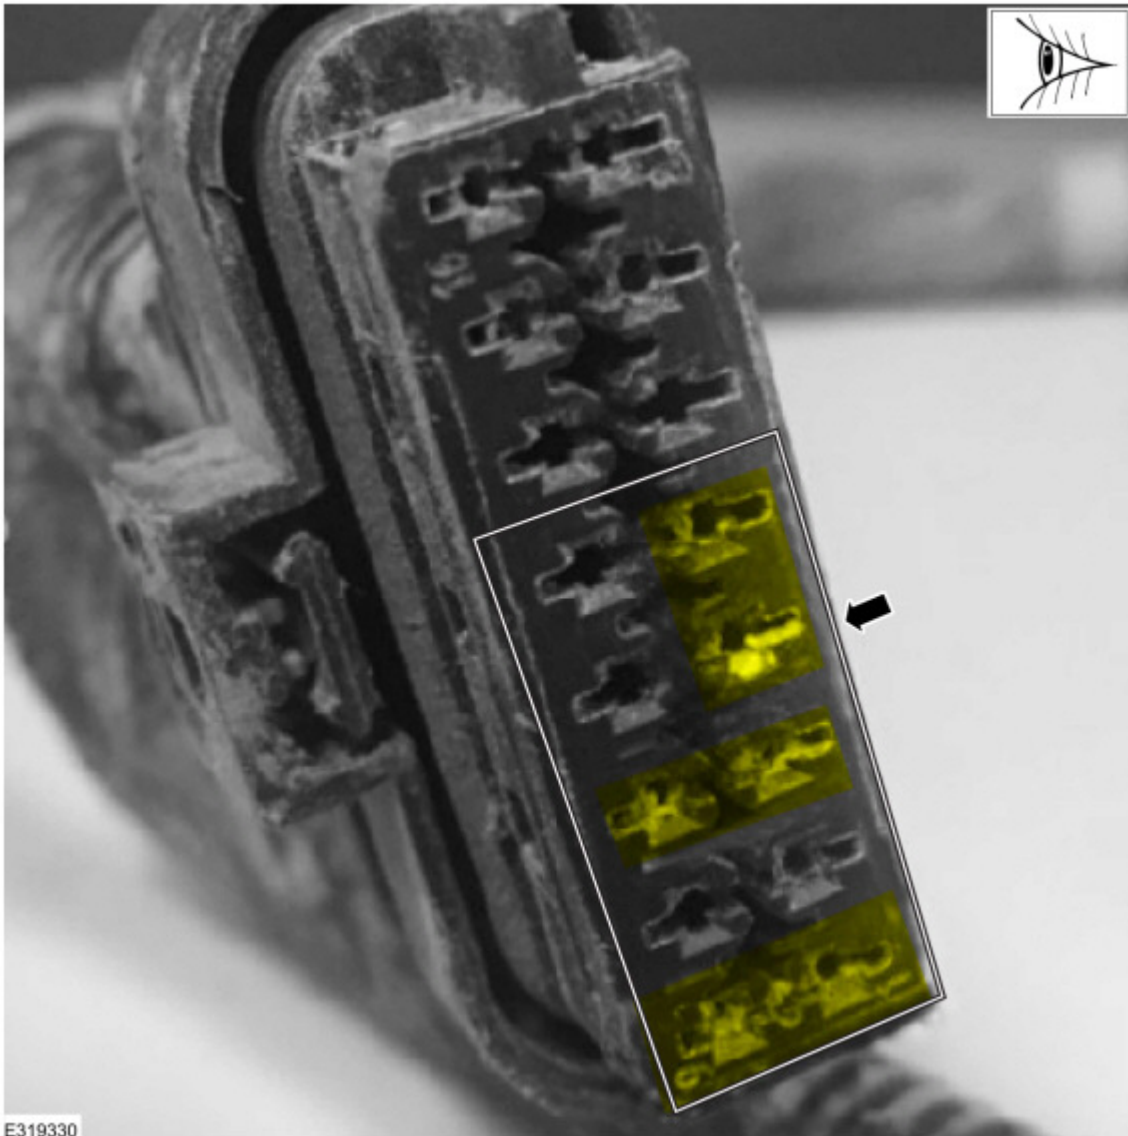
Figure 1

- Visible green corrosion on multiple terminals on the harness side of connector C3613. (Figure 1)
- Corroded pin 11 on the reductant pump/heater assembly at connector C3613. (Figure 2)
- Corroded pin 9 on the reductant pump/heater assembly at connector C3613 (Figure 3)
- Visible green corrosion on the reductant level sensor/quality module side of connector C4851. (Figure 4)
- Visible green corrosion on the harness side of connector C4851.(Figure 5)

(2). If there is corrosion present on the harness or component side of connector C3613, replace the reductant harness and the reductant pump/heater assembly.
