SERVICE BULLETIN

APPLICABILITY: 2017-**20MY** Impreza
 2018-**20MY** Crosstrek
 2018-19MY Legacy and Outback
 2019-**20MY** WRX and WRX STI
 2019-**20MY** Ascent
 2018-**20MY** BRZ
 2019-**20MY** Forester

NUMBER: 15-226-18R

SUBJECT: Harman Audio / Infotainment: Troubleshooting
 USB Functionality Concerns

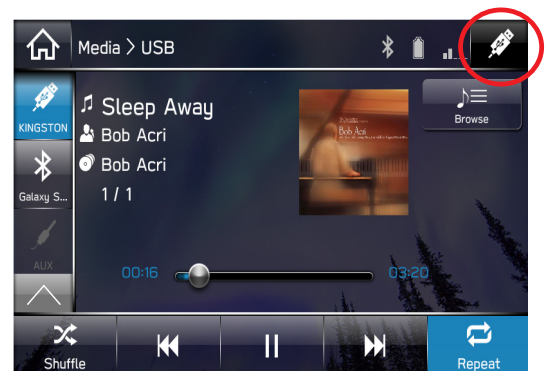
- 1) Always confirm the condition as reported by the customer.
- 2) This section addresses USB detection symptoms.
 - a. Confirm the USB is recognized (USB icon appears) on the Media screen as shown in the figure to the right.

- b. If the USB is not recognized, follow Service Diagnostic Mode from the Service Manual:
 - i. Turn the ignition switch to ACC.
 - ii. Press the “TUNE/SCROLL” button six times while pressing the “HOME” button.

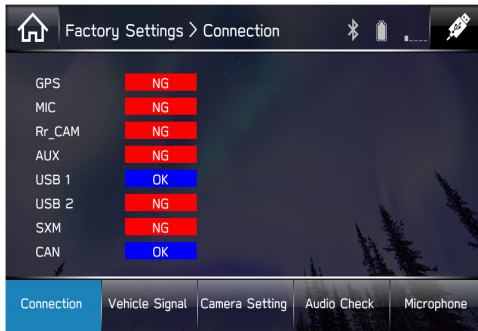
- i. On Service Menu, press “**Connection**” to display the list of items.
- ii. **OK**: Each device is connected properly.
- iii. **NG**: Connection is not established, or connection status (possibly including the related harness) is faulty.

- The USB connection showing “NG” when no USB device is connected to USB ports is normal.
- If the concern involves “CarPlay not working”, make sure a genuine Apple cable is used. In some cases, aftermarket cables may cause connection issues.
- If the concern involves “Android Auto not working”, try using another cable since Android phones do not require use of a genuine cable.

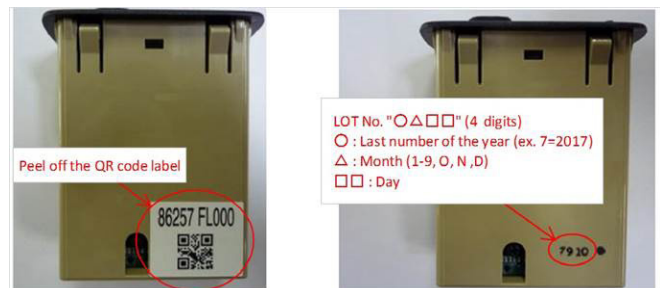
New firmware has been released to enhance connectivity for Auxiliary Terminal part numbers used with MID and HIGH level head units.

How to determine if the Auxiliary Terminal is pre- or post-countermeasure (CM):

- CAREFULLY peel off the QR code / part number label.
- Check the Lot# as shown below. If the number is after “7411” it is post-CM.
