## SERVICE BULLETIN

**APPLICABILITY:** 2017-**20MY** Impreza  
 2018-**20MY** Crosstrek  
 2018-19MY Legacy and Outback  
 2019-**20MY** WRX and WRX STI  
 2019-**20MY** Ascent  
 2018-**20MY** BRZ  
 2019-**20MY** Forester

**NUMBER:** 15-229-18R

**SUBJECT:** Harman Audio / Infotainment: Troubleshooting  
 Clock-Related Concerns

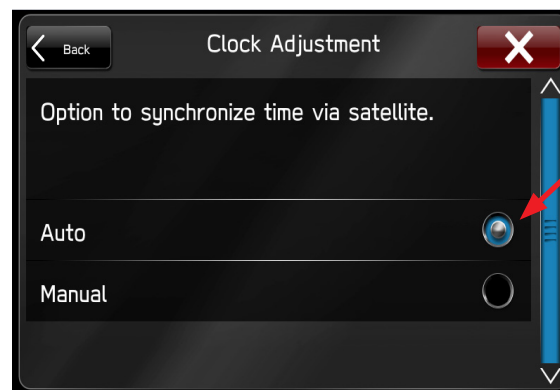
- a. What is the clock adjustment setting, Manual or Auto? (Clock setting information can be found under Settings > Vehicle > Clock Adjustment as shown below.)

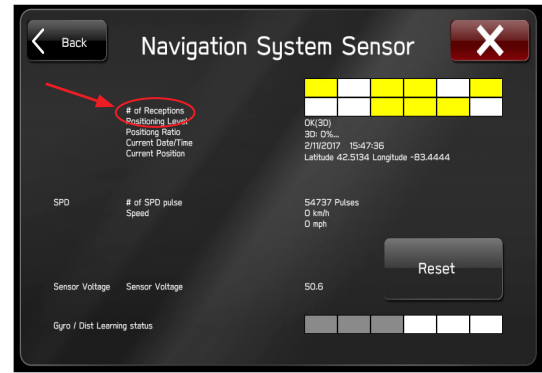
i. Open the Navigation System Sensor screen. Press and hold the Home hard key and press the Tune knob 6 times, then release the Home button. In the Dealer menu, select “Function check” > “Navi System Sensor” (See screenshot to the right.)

ii. Does the screen show the correct date and GMT time?

iii. Note the number of satellites acquired. If none, move vehicle to an area with open sky.

iv. If system does not show the correct time while in open sky, investigate the GPS antenna:

1. Ensure the GPS antenna is connected and fully seated into the grey fakra connector on the head unit.
2. Confirm there is no damage to cable/antenna.

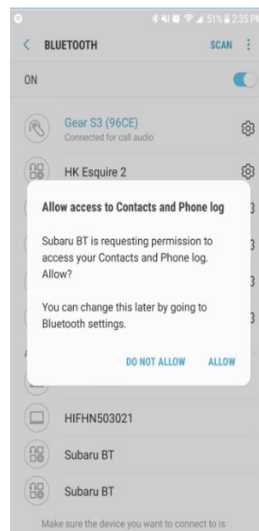
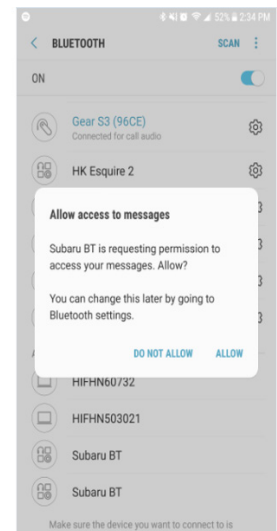
1. Android Phone:

Once the phone is paired to the head unit, the phone will display a pop-up prompting the user to accept access to Phonebook / Contacts. Select “ALLOW”. You may also receive follow up messages for access to phone history (log) and messages. Make sure to allow access to all of them. (See screenshots to the right.)

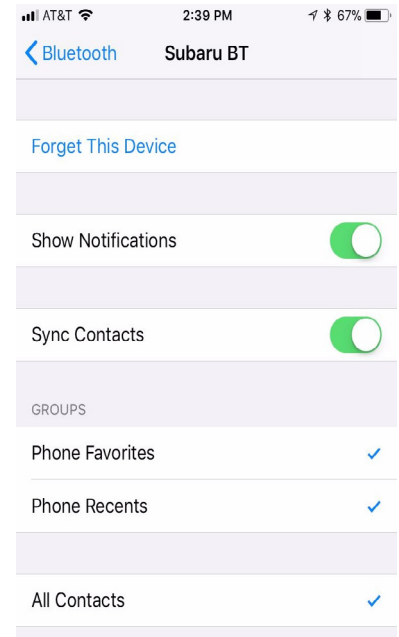
2. iPhone:

After pairing, access must be enabled on the phone. To do this, go to Settings > Bluetooth > Select the paired head unit labeled “Subaru BT” and make sure both Sync Contacts and Show Notifications are enabled. (See screenshot to the right.)

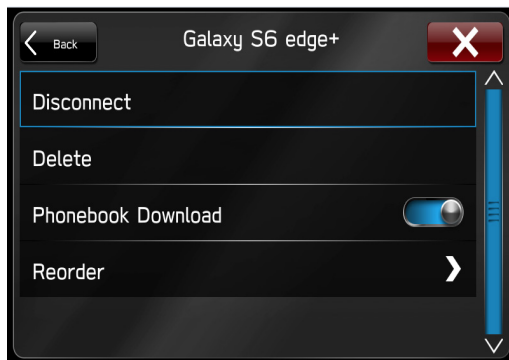
iii. After these items are enabled, disconnect the device from the head unit then reconnect. (See example screenshot of head unit display below.)

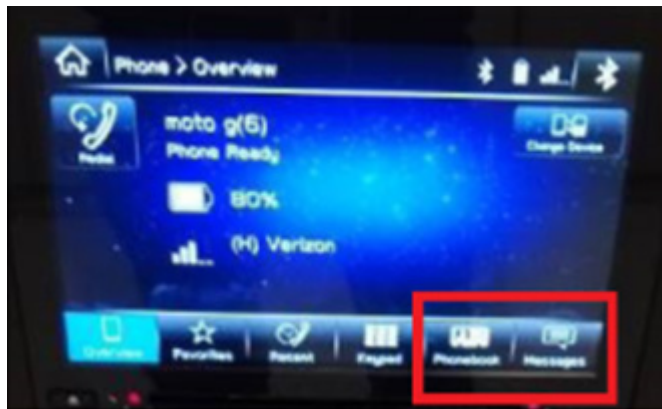
iv. Confirm both the Phonebook and Messages buttons on the display are highlighted (activated) as shown below.

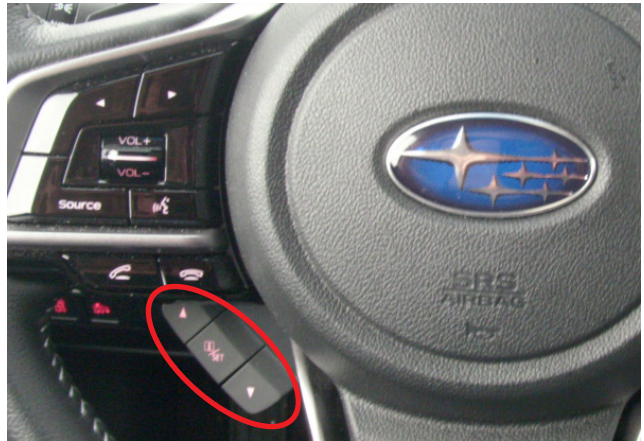
i. If vehicle is equipped with a color MFD, press the i/Set button until the MFD displays the “Hold SET button” screen. Hold the i/Set steering wheel button to enter the settings menu. The date and time settings are accessible from this menu.
