TECHNICAL SERVICE BULLETIN

5.0L - Metallic Grinding/Rattling Sound From The Transmission Bellhousing Area - Built On Or Before 12-Feb-2019

19-2358
03 December
2019

Ford 2018-2019 F-150	Engine: 5.0L
--------------------------------	--------------

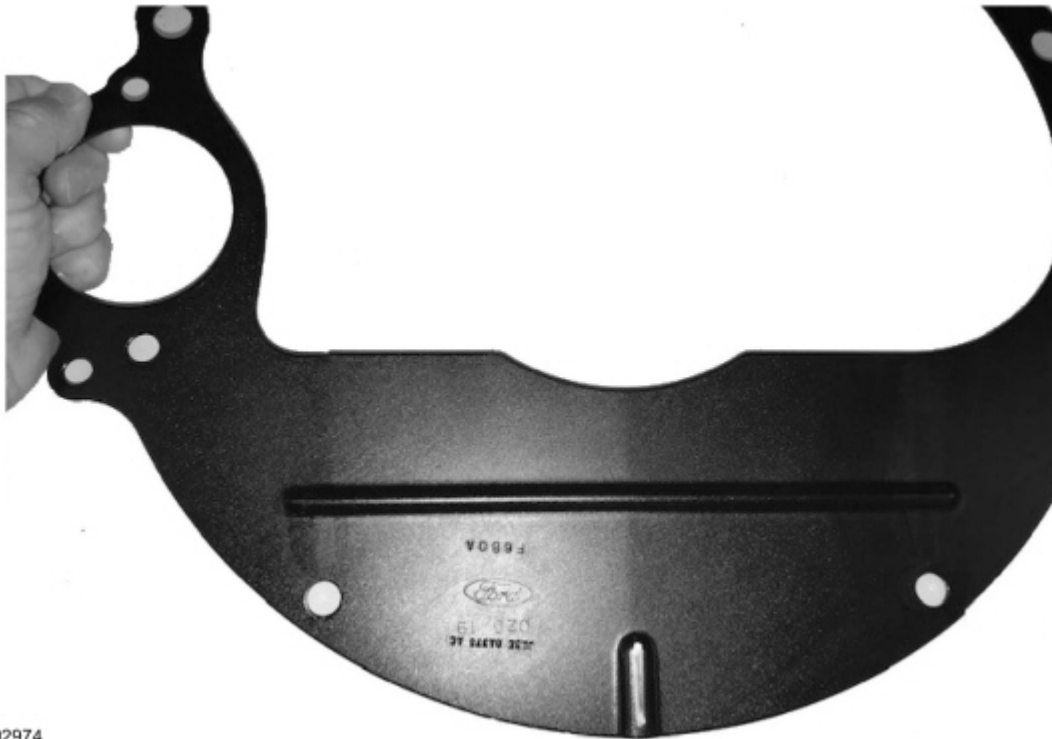
Figure 1

Issue: Some 2018-2019 F-150 vehicles equipped with a 5.0L engine built on or before 12-Feb-2019 may exhibit a metallic grinding/rattling sound coming from the transmission bellhousing area under various operating conditions. This may be due to the torque converter studs contacting the engine to transmission spacer plate. To correct the condition, follow the Service Procedure steps to replace the engine to transmission spacer plate with a new engine to transmission spacer plate that includes a bend for additional clearance.

1. Remove the flexplate. Refer to Workshop Manual (WSM), Section 303-01D.
2. Replace the engine to transmission spacer plate. (Figure 1)

3. To install, reverse the removal procedure.

- (1). Reuse the transmission fluid cooler tube bracket bolt. Clean the threads and install a small patch of Motorcraft® Threadlock and Sealer or equivalent.
