TECHNICAL SERVICE BULLETIN 2.7L/3.0L EcoBoost - Oil Pan Leaking - Built On Or Before 15-Aug-2019

19-2387

19 December 2019

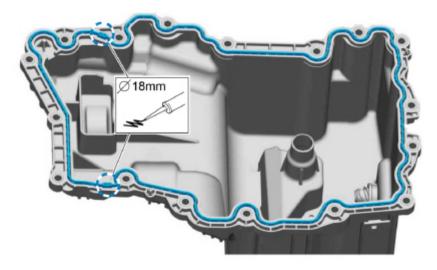
E309539

Issue: Some 2018-2019 Edge/Continental, 2018 MKX and 2019 Nautilus vehicles built on or before 1-Aug-2019 and 2018-2019 Fusion/MKZ vehicles built on or before 15-Aug-2019 equipped with a 2.7L EcoBoost or 3.0L EcoBoost engine may exhibit an oil leak from the engine oil pan RTV seal. To correct the condition, follow the Service Procedure steps to replace the oil pan with a new oil pan equipped with a press in place gasket.

- 1. Remove and discard the oil pan and oil pump seal. Refer to Workshop Manual (WSM), Section 303-01.
- 2. Clean and prepare the engine sealing surface. Refer to WSM, Section 303-00.
- 3. Install the new oil pump seal.
- 4. Apply a 18 mm (0.708 in.) bead of Motorcraft® High Performance Engine RTV Silicone to engine the front cover-to-cylinder block joint areas on the oil pan. (Figure 1)

NOTE: The new oil pan does not require the use of Motorcraft® High Performance Engine RTV Silicone in any other location.
