SERVICE BULLETIN

APPLICABILITY: 2019MY Forester
SUBJECT: Combination Meter Visor- Light Leaking

NUMBER: 12-278-20
DATE: 01/15/20

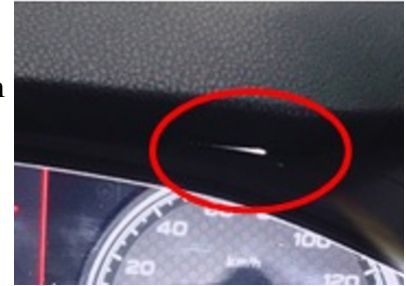
This bulletin provides a procedure to address a limited number of customer concerns regarding light seen “leaking” past the combination meter visor. A small gap can develop between the instrument panel (IP) and the combination meter visor as a result of slight dimensional differences in these parts. When the gap occurs, light may be seen leaking through the gap as shown here.
