SERVICE INFORMATION BULLETIN

APPLICABILITY: 2008-11MY Impreza (5-Door Model)
 2008-14MY Impreza WRX
 2015-19MY WRX
 2017-18MY Forester
 2013-19MY BRZ

NUMBER: 07-167-20

SUBJECT: Stop Lamp Switch -
 Rasing Sound when Applying Brake

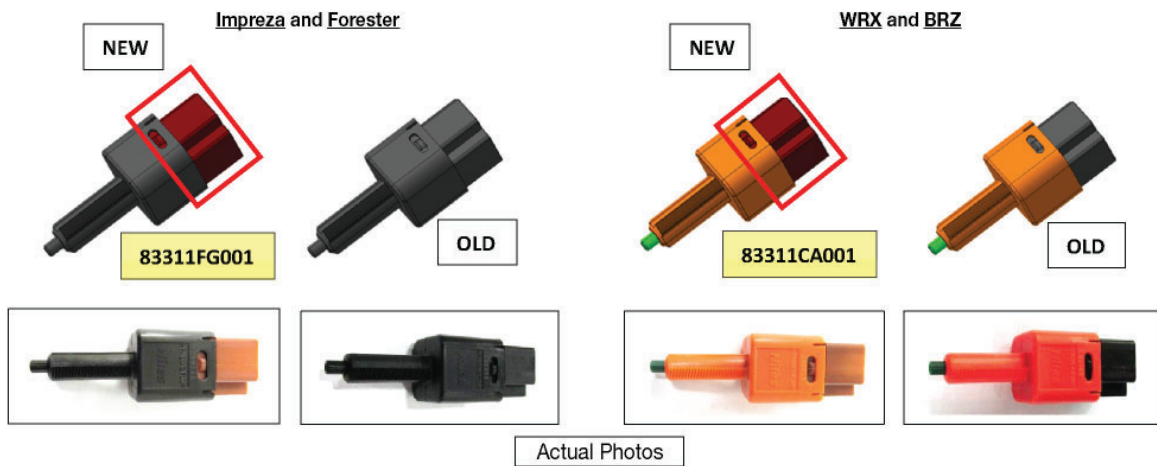
The new switches can be identified by a brownish -colored harness connection socket as opposed to black.
