Bulletin No.: PIP5527E

Preliminary Information

PIP5527E Drivability Concerns Caused By Intake Rocker Arm Oil Control Valve or External Oil leak - Chuggle Surge Misfire P0101 P0106 P0171 P0300 P219A P16D0 P16D1 P2646 P2647

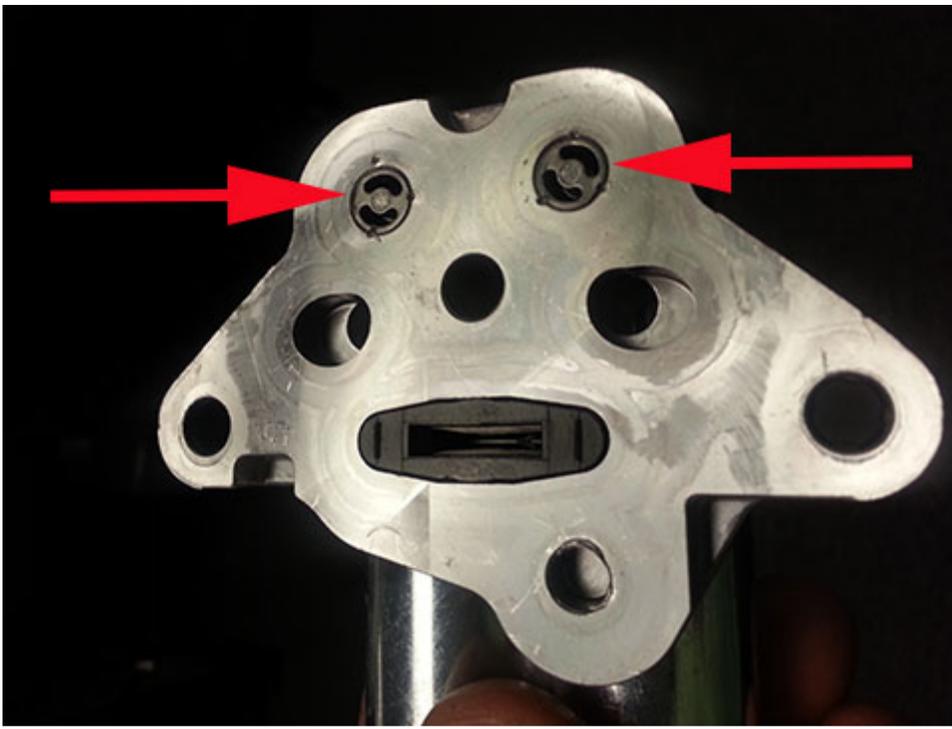
This is a good valve with components still in place.

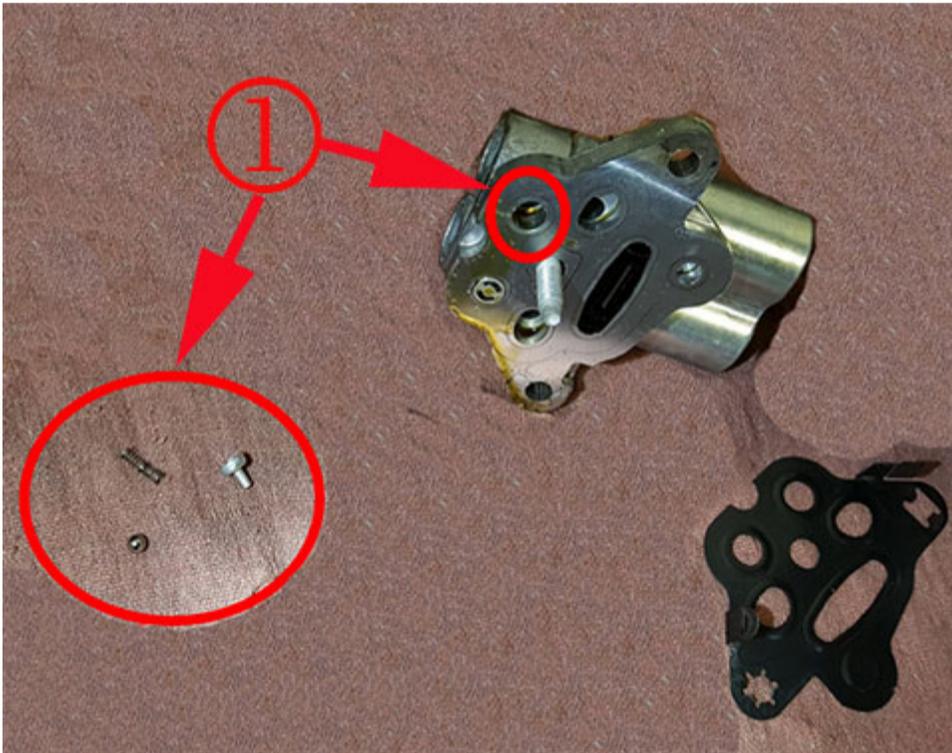
See illustrations below for items #1 being missing.

The camshaft cover must be replaced because the components become lodged in the camshaft cover oil passages and can not be removed.

This is a bad valve with components missing.

If any of the components are missing, replace the intake rocker arm oil control valve and camshaft cover.
