## TECHNICAL SERVICE BULLETIN

### Long Wheelbase - 60/40 Second Row Seat(s) Stuck Or Difficult To Fold/Unfold - Built On Or After 1-Jan-2013

**20-2047**20 February  
2020

<b>Ford</b> 2013-2020 Transit Connect
--

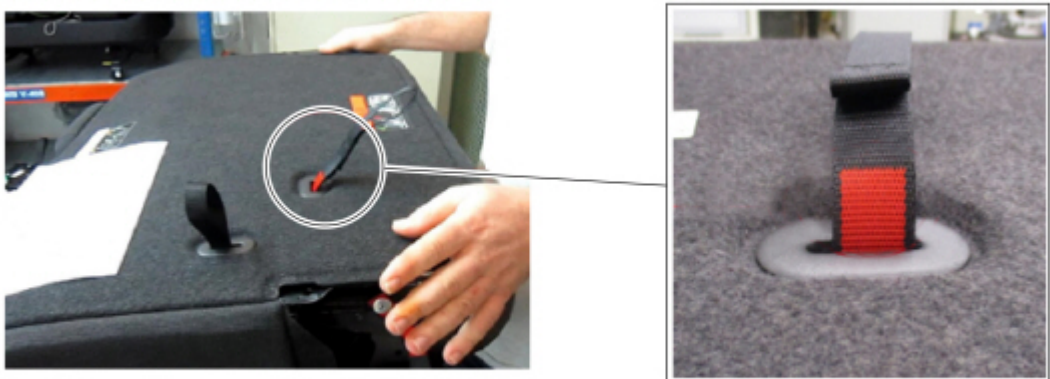
Figure 1

1. Is either section of the second row seat bottom stuck in the folded position and/or is the strap stuck and displaying the red indicator on the strap on the seat back? (Figure 1)
