Service Bulletin

Bulletin No.: 18-NA-279

Date: January, 2020

Subject: Passive Door Unlocking Inoperative and/or Enabling and Disabling of Passive Unlocking

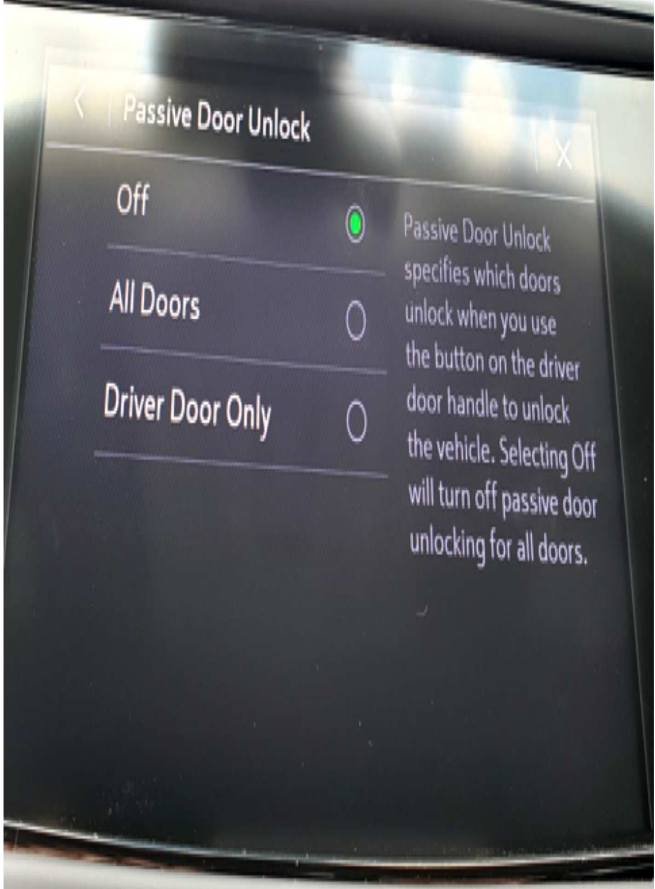
<p>Involved Region or Country</p>	<p>North America and N.A. Export Regions</p>
<p>Condition</p>	<p>Some customers may comment that the passive door unlocking feature is inoperative when pressing the button on any door handle or tailgate release handle. They may also comment that all turn signals flash 4 times quickly when the button is pressed.</p>
<p>Correction</p>	<p>When using the following procedures, the owner can cycle between Passive Unlocking Enabled to Passive Unlocking Disabled, and back.</p> <p>Once any individual FOB is used to disable Passive Unlocking, Passive Unlocking will be disabled for ALL FOBs.</p> <p>Additionally, as shown below, some listed vehicles have "Passive Door Unlock" as a Vehicle personalization feature via the center stack. When selected, this option applies to ALL FOBs.</p>

Starting State	Do:	Results in:
Passive Unlocking is Enabled	Press and Hold both Lock and Unlock FOB buttons for 3 seconds.	Turn Signals flash 4 times and Passive Unlocking is Disabled. When the button on the door handle is pressed, the Turn Signals flash 4 times and the doors remain locked.
Passive Unlocking is Disabled	Press and Hold both Lock and Unlock FOB buttons for 3 seconds.	Turn Signals flash 2 times and Passive Unlocking is Enabled. When the button on the door handle is pressed, the door(s) will unlock.
