SERVICE BULLETIN

APPLICABILITY: 2019-20MY Ascent
SUBJECT: Hood Panel Vibration

NUMBER: 12-281-20
DATE: 02/19/20

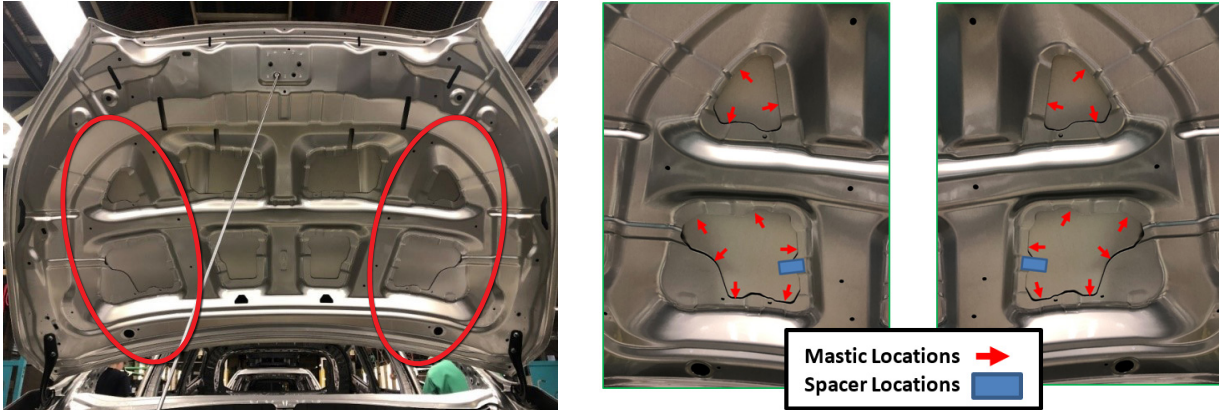
This bulletin provides a repair procedure to address a small number of customer concerns of the hood panel surface vibrating while driving. This condition can result if the mastic (adhesive) used to bond the inner hood reinforcing panel to the outer panel (skin) begins to separate.

- Use the photos below to identify the inspection areas and determine the potential repair points.

- Before applying adhesive, CAREFULLY insert the spacer between the inner and outer hood panels at the location (s) indicated in the above photo on the side intended for the repair. Use two spacers if both the left and right side need to be repaired. Keep the edge of the spacer outside the gap as shown to make removal after the adhesive is cured easier.

- Using the fine point tip of the applicator nozzle, CAREFULLY apply the adhesive between the outer and inner hood panels as indicated in the photo above. Apply enough material to adhere both panels, keeping the width of the adhesive approximately 18mm (3/4in.).

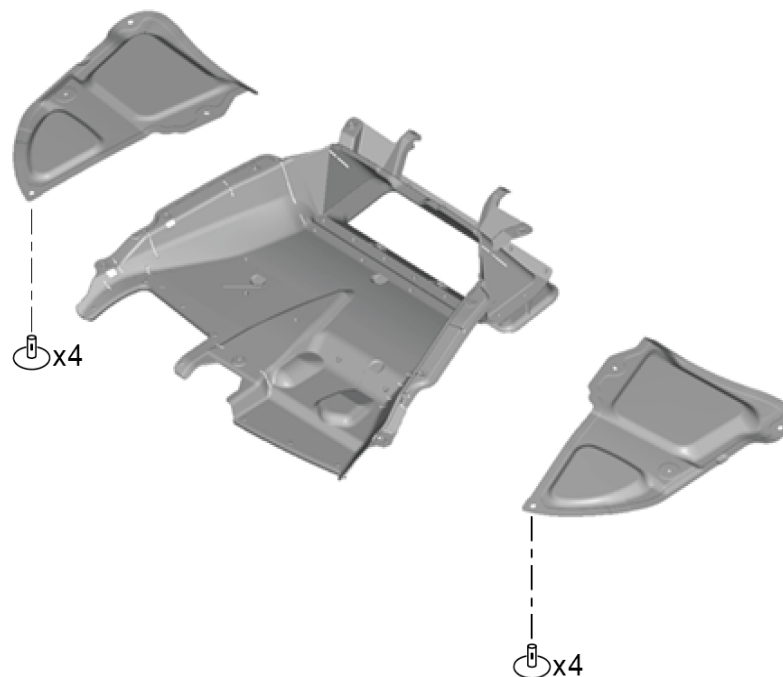
CAREFULLY remove the under hood insulation materials following the procedure in the applicable Service Manual. **NOTE:** The four (4) retaining clips (qty. 8 total) for both outer sections shown below p.n. **90814FC001** are 1-time use and **MUST** be replaced at reassembly.

- Thoroughly clean all areas indicated in the photos above where the repair adhesive will be applied with alcohol wipes (or isopropyl alcohol on a **clean** shop cloth). All application areas must be completely free of any foreign material (grease, dirt) which could prevent proper adhesion to either panel. Always allow the alcohol to dry completely before proceeding with application of the adhesive.
