SERVICE BULLETIN

APPLICABILITY: 2020MY Legacy and Outback
SUBJECT: Denso Gen 4 Cockpit One (CP1) Infotainment System Operating TIPS

NUMBER: 15-259-20
DATE: 02/19/20

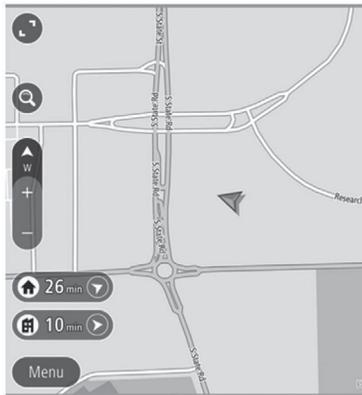
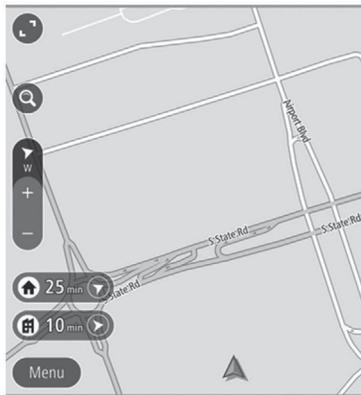
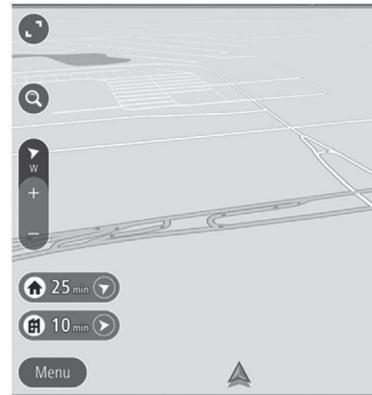
CONDITION #1: During Navigation operation, the map orientation can be changed between 2D north-up, 2D heading-up and 3D.

The map orientation defaults to 2D north-up, 2 mile scale whenever the ignition is cycled off-on.

This is a normal operating characteristic.

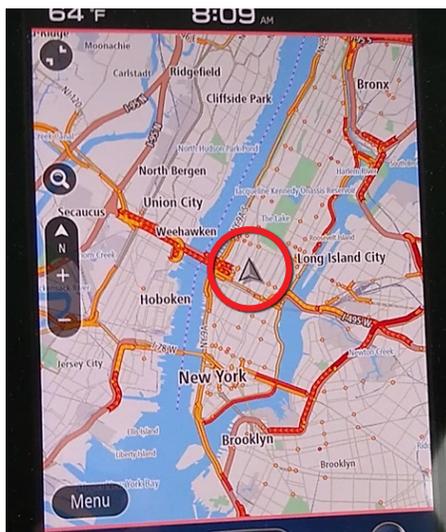
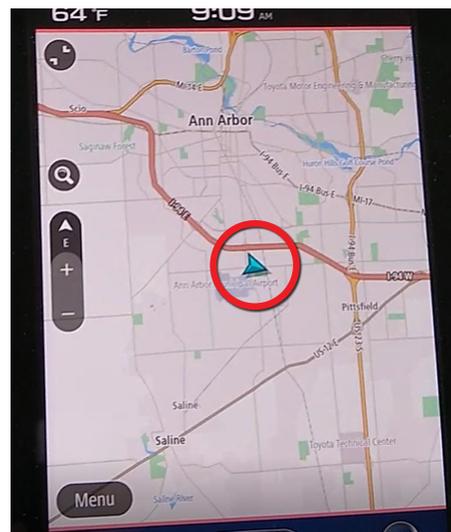
CONDITION #2: NAVI screen does not show the correct location.

It is possible during Delivery Mode for the NAVI GPS display to show Manhattan, NY location all the time. This is a default setting for GPS in this mode. Other indicators of Delivery Mode are:

- The arrow is gray in color
- The clock time displayed is inaccurate.

Following Delivery Mode or Memory Initialization
(map arrow is gray).

Normal Operation (map icon is blue/green).

If a vehicle presents with this concern, inform the customer that the map icon will change to cyan (blue/green) and the clock will reset to the correct time as soon as the GPS module receives the current vehicle location. In a case where the vehicle location shown on the Navigation screen does not update to show the correct location and the clock remains inaccurate, perform the applicable diagnostics to confirm the GPS antenna integrity and secure harness connection.

NOTE: The synching process time varies depending on the available GPS signal strength. Driving the vehicle (while avoiding frequent direction changes) for a few miles will help to expedite the process.

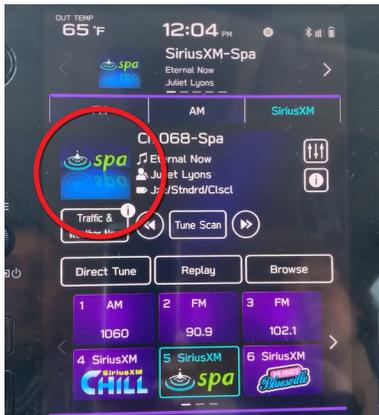
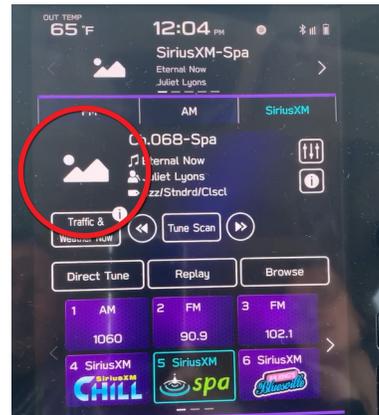
CONDITION #3: Artwork appearance on the Center Information Display disappears.

It is a normal operating characteristic for the SXM station artwork to disappear from the CP1 / Gen 4 Infotainment system display whenever the vehicle is in motion. Artwork is restored when the vehicle stops.

Artwork is displayed when stopped or parked.

Artwork is NOT displayed when moving.

Explain to customers questioning this condition that it is a normal operating characteristic intended to reduce distraction. Replacing the head unit will not change this characteristic.

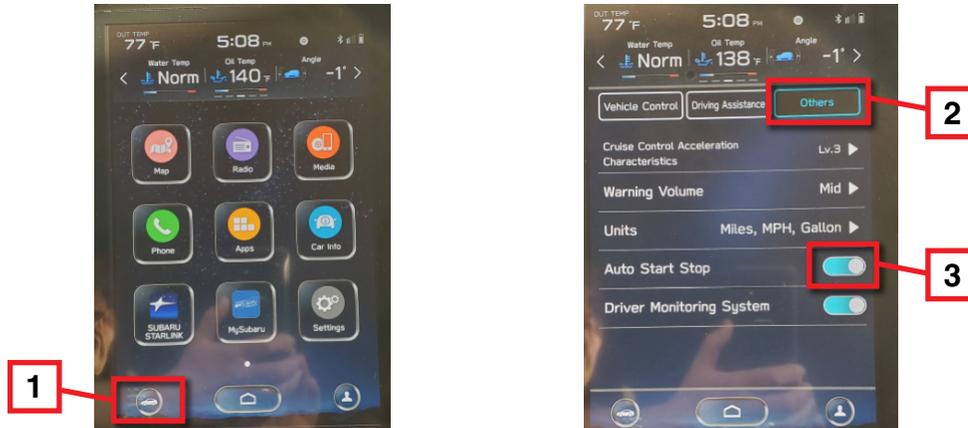
CONDITION #4: Engine Auto Start-Stop operation defaults to “ON” following the ignition cycle off-on.

The Auto Start-Stop feature operates automatically to save gasoline and reduce emissions when the vehicle is stopped. By design, the Auto Start-Stop feature always defaults to ON whenever the ignition is cycled off-on.

There may be times when this feature needs to be deactivated. Follow the sequence provided below to deactivate Auto Start-Stop:

1. Touch the Vehicle Icon on the Home screen
2. Touch the Others tab on top
3. Move the Auto Start-Stop slider to OFF.

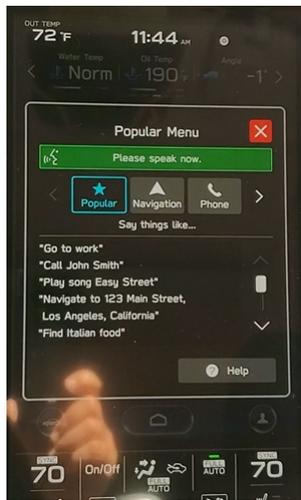
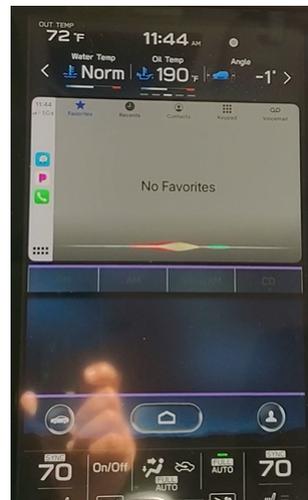
CONDITION #6: Voice Recognition (VR) operation is inconsistent when using Apple CarPlay or Android Auto applications.

When using the CarPlay or Android Auto application, it is important to note using a *short* press (quick press/ release) of the Talk switch on the steering wheel to start the VR system invokes the native (vehicle) on-board VR application and *not* Siri or Google. This is a different behavior from the previous generation Harman Gen 3 head unit. This change allows the use of VR for HVAC or media control while using CarPlay or Android Auto.

This detail is important to keep in mind when using the VR feature for functions like voice to call or voice to text. For example, due to CarPlay protocols, placing a call using the native on-board VR by speaking a contact name isn't possible. When CarPlay is active, a **long** press of the Talk button will activate Siri and allow calls to be made using the phone's contact list. Alternatively, calls can be made using the native on-board VR when prompted by speaking the desired phone number. To recap, when CarPlay or Android Auto are in use, placing handsfree phone calls by speaking contact names is not possible using the native VR system. In addition, when CarPlay or Android Auto are active, a **short** press of the Talk button activates only the native VR system which can be used for HVAC and other settings. When using CarPlay or Android Auto, a **long** press of the Talk button will activate Siri / Google Assistant to allow their use in making handsfree calls using the phone's contact list. The native VR can only be used to call contacts when CarPlay or Android Auto are NOT in use unless the customer chooses to dial by phone number rather than by contact.

REMINDER: To start Siri / Google Assistant, while using CarPlay / Android Auto press and HOLD (**long** press) the Talk switch on the steering wheel.

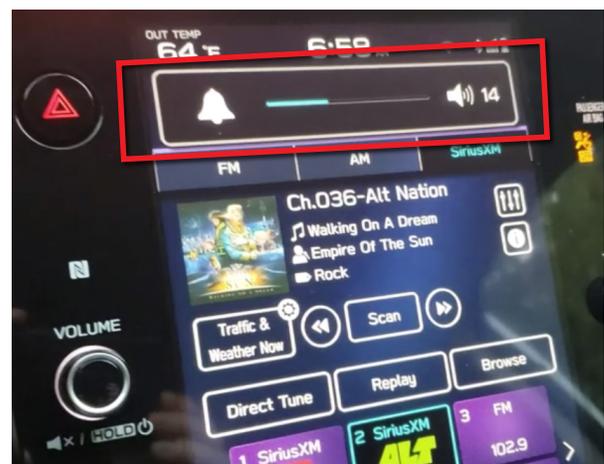
CONDITION #7: Intermittent volume adjustment concerns when using Android Auto application.

There are instances when using Android Auto, the audio volume cannot be adjusted intermittently even though notification of the adjustment by turning the volume control knob occurs as shown below on the display as shown here.

This condition occurs because Android Auto operation is being prioritized over the CP1 / Gen 4 Infotainment system.

This condition is temporary and will clear eventually. To expedite clearing and regain faster volume control for the audio source, there are some work arounds. One option is to relaunch Android Auto by disconnecting and reconnecting the phone to the CP1 / Gen 4 Infotainment system or, a short press of the Talk button on the steering wheel to start the native VR followed by saying “cancel” after the beep is heard. The procedure shown below copied from the Owner’s Manual regarding sound output can also be used.

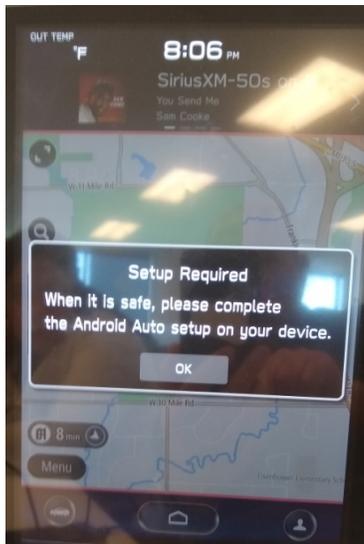
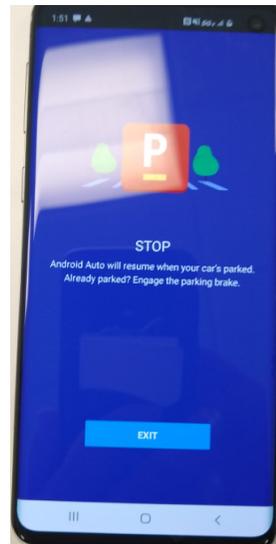
CONDITION #8: Android Auto does not launch.

CAUSE / NOTE: The vehicle must be stopped and the electric parking brake (EPB) must be ON to complete the initial pairing process between the CP1 / Gen 4 Infotainment system and the phone using the Android Auto application. When connecting a phone to the USB port, follow the messages on both the CP1 display and the phone screen. See below an example.

This is a normal operating characteristic. It is a good practice to confirm an undamaged, genuine cable is used to connect the phone as well as the making sure the phone is set to accept connection with a new vehicle.

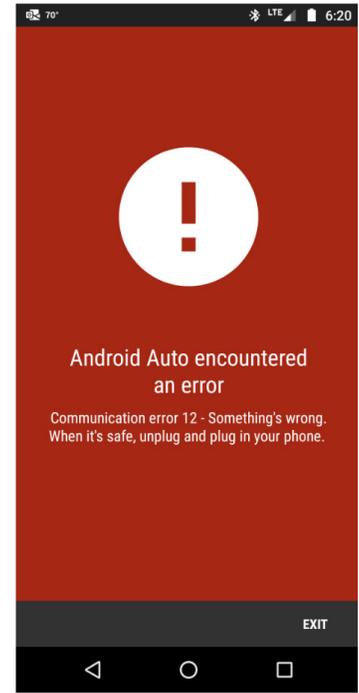
CONDITION #9: Android Auto connection failure is displayed.

Reports have been received regarding a communication error message displayed on the phone screen as shown here.

When this message is displayed on the phone after connection to the CP1 / Gen 4 Infotainment system, the Android Auto application fails to launch. Investigation has shown the source of this error is on the phone side and can be resolved by re-synching communication by disconnecting and reconnecting the phone. The communication error number (12 shown in the example) is irrelevant.

When reviewing a similar issue, explain to the customer that replacing the head unit will not resolve this condition as it is not the root cause of the error. It is a good practice to confirm an undamaged, genuine cable is used to connect the phone as well as making sure the phone is set to accept connection with a new vehicle.

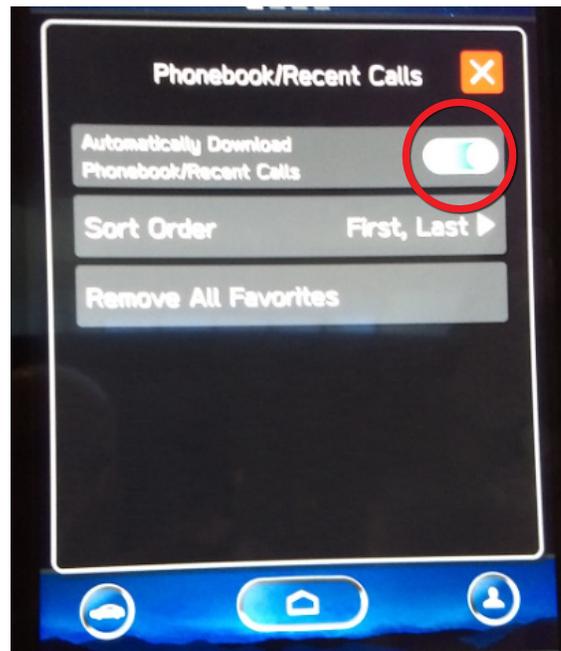
Home > Settings > Phone > Phonebook/Recent Calls

CONDITION #10: User is unable to download Phonebook Contacts.

Confusion regarding the phone contact transfer process.

When assisting with questions about the phonebook download process, start by verifying the option is enabled in the CP1 / Gen 4 Infotainment system using the following screen shot as a guide.

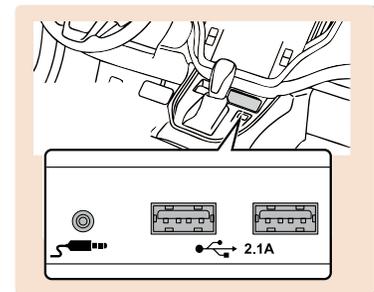
**CONNECTING A USB MEMORY DEVICE/
PORTABLE DEVICE**

CONDITION #12: Playback of audio files using a USB memory device does not work.

There are no restrictions for the brand or size of the USB Memory device. All will work with the CP1 / Gen 4 Infotainment system as long as they meet following requirements:

- USB communication formats: USB 2.0 LS (1.5 Mbps) / FS (12 Mbps) / HS (480 Mbps)
- File format: FAT 32
- Supported file extensions: m4a / aac, mp3, wma, wav, flac, m4a **NOTE:** It is recommended to remove all files in formats not supported by the CP1 system from the USB memory device.

Always confirm the customer is using a correct port as well as following the guide lines for the media requirements. If the customer still can't play back their audio files using a USB memory device, confirm the device has not been damaged. Once the USB device is confirmed to be OK, follow the applicable Service Manual procedure to perform further diagnostics.

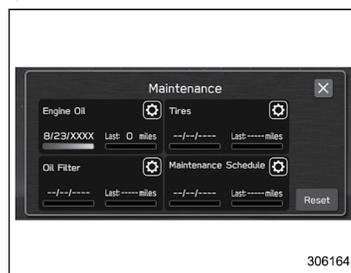
Maintenance

CONDITION #13: Even if a user follows the proper procedure, a "Notification Date" cannot be set and shows " - - / - - / - - - - / " as shown below after inputting a notification date and pressing "Set."

Date and Time have not been set. The user must set a date and time prior to setting a "Notification Date."

Two methods to set the date and time for the BASE model are listed below:

- 1) Synchronize with Phone: Pair a Bluetooth phone to synchronize the date and time from the phone.
- 2) Manual: Manually set the date and time using the Time Setting menu.
