# Preliminary Information

## PIP5527G Drivability Concerns Caused By Intake Rocker Arm Oil Control Valve - Chuggle Surge Misfire P0101 P0106 P0171 P0300 P219A P16D0 P16D1 P2646 P2647

Models

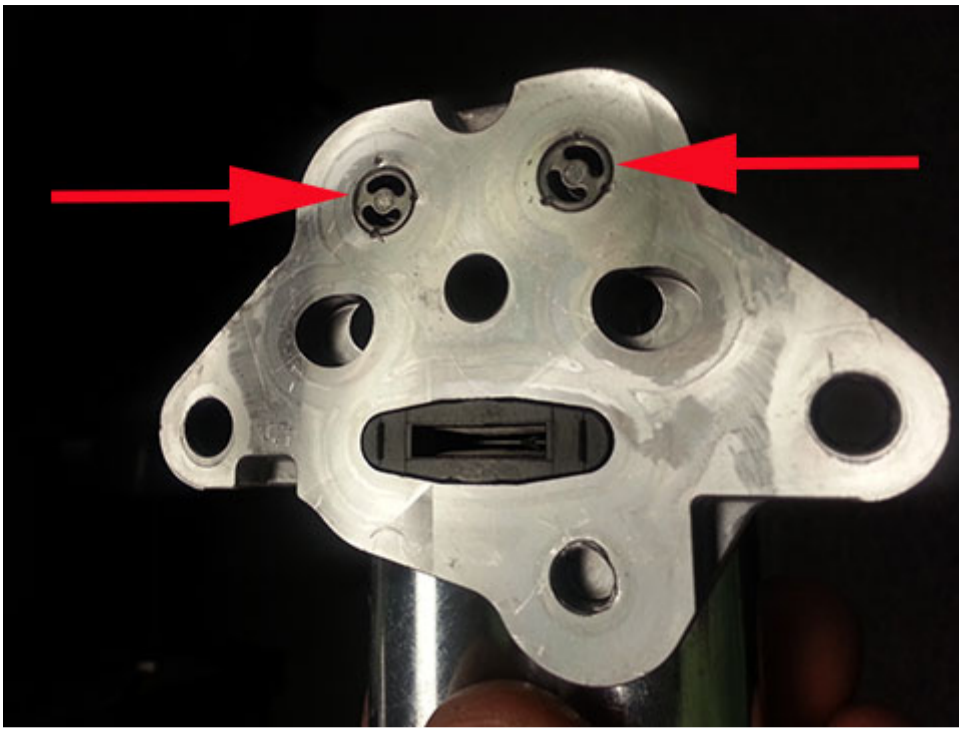
This is a good valve with components still in place.

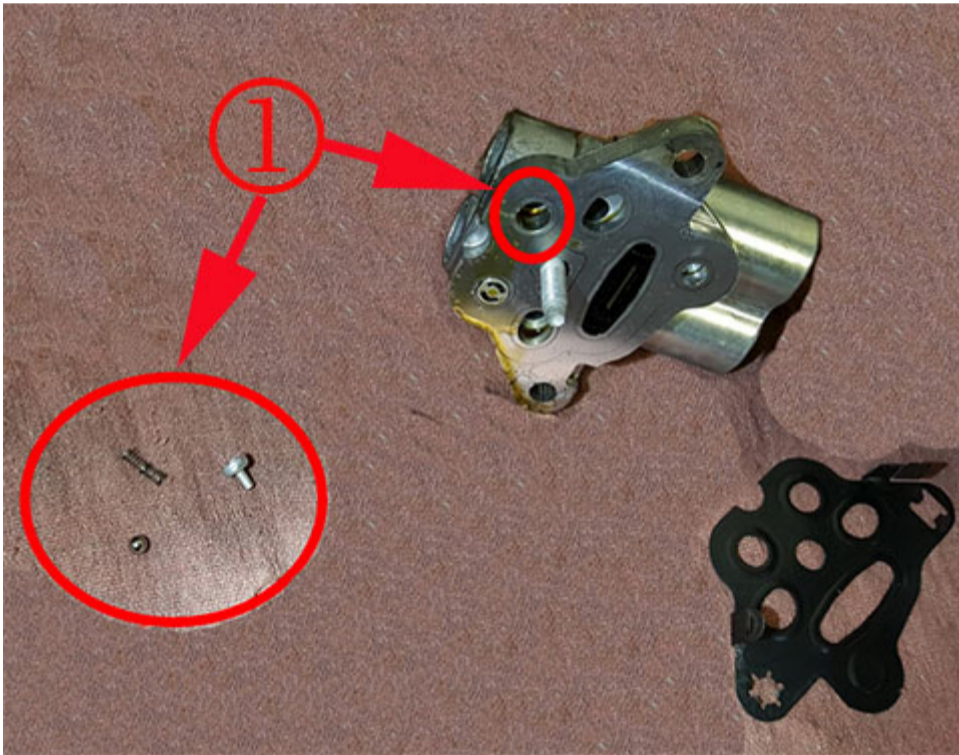
See illustrations below for items #1 being missing.

The camshaft cover must be replaced because the components become lodged in the camshaft cover oil passages and can not be removed.

This is a bad valve with components missing.

If any of the components are missing, replace the intake rocker arm oil control valve and camshaft cover.
