**SERVICE INFORMATION BULLETIN**

**APPLICABILITY:** 2015-19MY Legacy and Outback  
 2017-18MY Forester  
 2017-20MY Impreza  
 2018-20MY Crosstrek  
 2015-20MY WRX  
 2017-20MY BRZ

**NUMBER:** 07-171-20  
**DATE:** 03/06/20

**SUBJECT:** Battery Sensor Removal and Installation Precautions

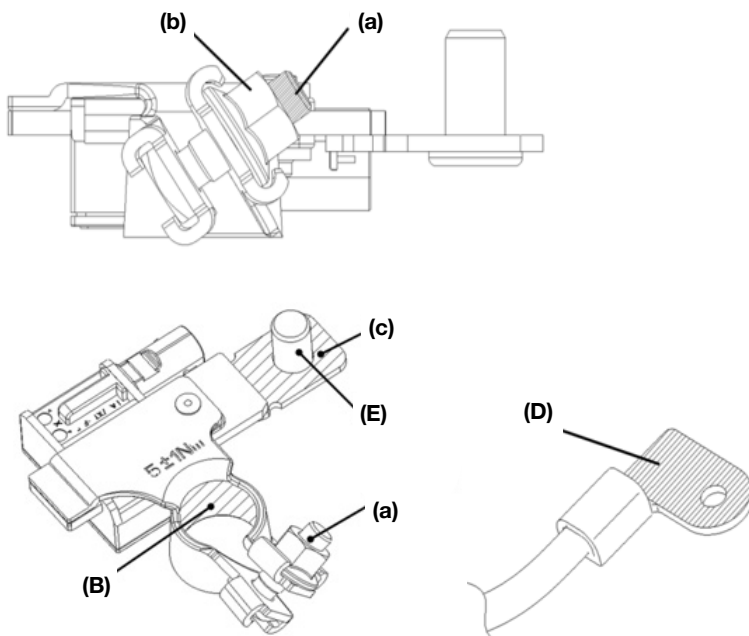
### LEGACY/OUTBACK/FORESTER/WRX/ BRZ

This Service Information Bulletin is in response to several battery sensor replacements resulting from improper removal and / or installation practices. Some common mistakes related to battery sensor removal and / or installation are:

- Removing the sensor from the battery post instead of removing the ground cable from the sensor
- Not fully cleaning and de-greasing the battery post and the sensor’s ground cable connection point before reinstalling the sensor
- Not properly supporting and holding the sensor in place with one hand while removing or installing it or the battery ground cable
- Twisting the sensor when installing onto the battery post instead of pushing it straight down
- Over-torqueing the 10 mm hex nut on the battery post clamp portion of the sensor. This happens when the sensor is not fully installed onto the battery post. Over-torqueing the nut can distort and damage the sensor.
- The threaded end of the clamp bolt is crimped. If the 10 mm nut is loosened too far, the threads of both the nut and bolt can become damaged and the clamp portion distorted.

- Disconnect the sensor harness connector.
- While supporting and holding the sensor in place with one hand, remove the 12 mm hex nut from (c) and disconnect the ground cable (D) from the sensor stud (E). Loosen but **DO NOT REMOVE** the 10 mm hex nut from the clamping bolt. **REMINDER:** The threaded end of the clamp bolt (a) is crimped. If the 10 mm nut (b) is loosened too far, the threads of both the nut and bolt can become damaged and the clamp portion distorted.
- **CAREFULLY** clean any grease from the battery post, inside the clamping portion (B) and the ground cable connection (C) using a mild solvent on a clean shop cloth.
