**SERVICE BULLETIN**

**APPLICABILITY:** 2020MY Legacy and Outback Models **NUMBER:** 15-261-20  
**SUBJECT:** Reprogramming File Availability for Optimization of Gen 4 Denso CP1 Infotainment Systems **DATE:** 03/10/20

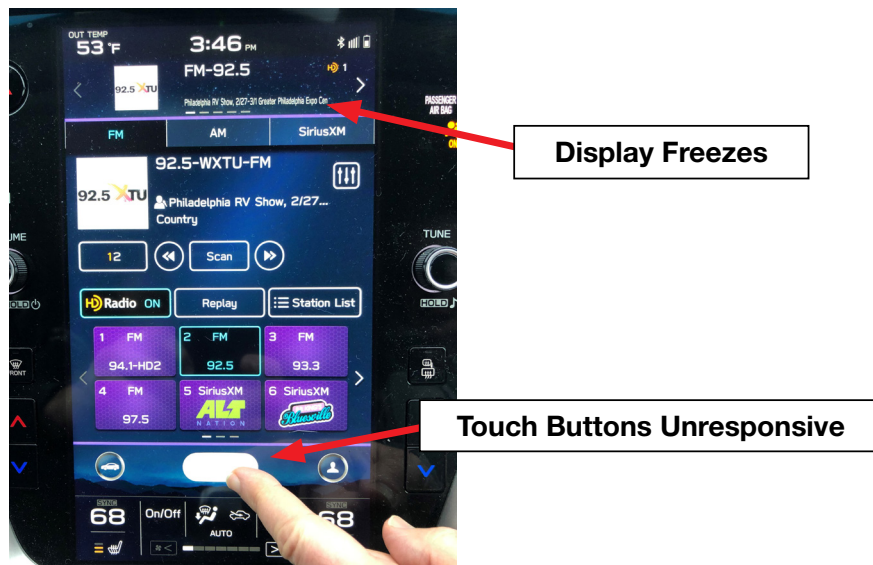
**Symptom #1**

The CP1 display and/or center Combination Meter display freezes. No response from touch screen or voice guidance. After switching the ignition off and opening the driver’s door, the system does not recover\*\*.

**NOTE\*\*** After switching the ignition off and leaving the driver’s door open more than 70 seconds, the system *may* recover after switching the ignition back on.

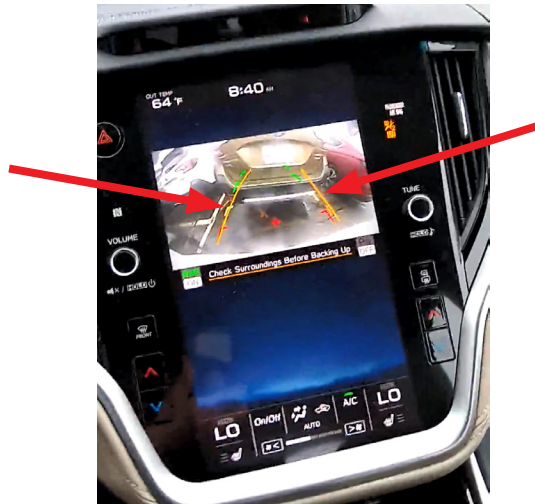
## Symptom #2

Delayed response of rear view camera guide lines.

When the rear view camera is activated and the steering wheel is turned, there is a delay before the steering-responsive guide lines respond to the steering wheel input.

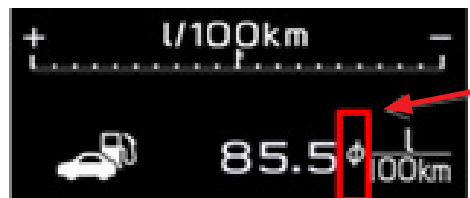
## Symptom #3

Fuel consumption display has unnecessary 'Φ' mark when changing mileage unit to Km.

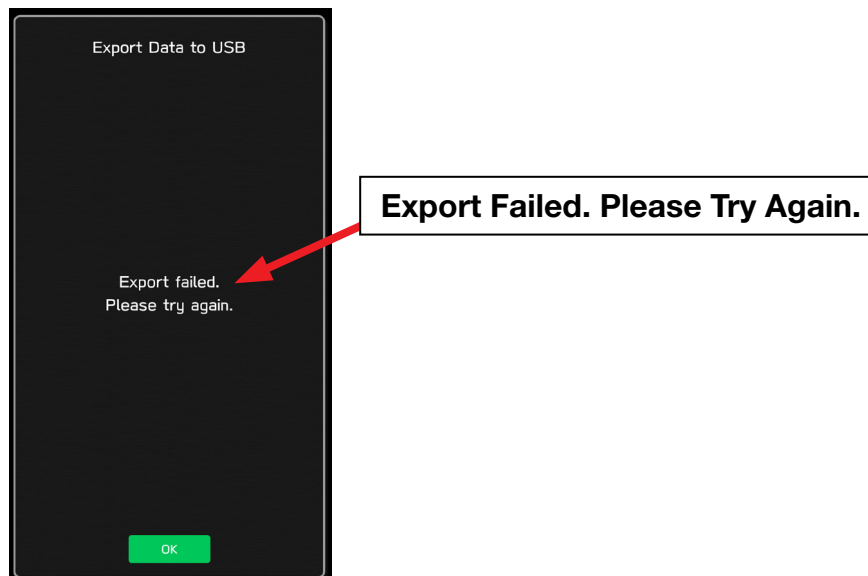
## Symptom #4

Diagnostics Recorder Data cannot be exported to the USB memory device. When the diagnostic log data is being downloaded (by selecting: Dealership Menu > Diagnostics Recorder > Export Data to USB), it fails after the progress bar reaches almost 90% with an error message of Export failed. Please try again.

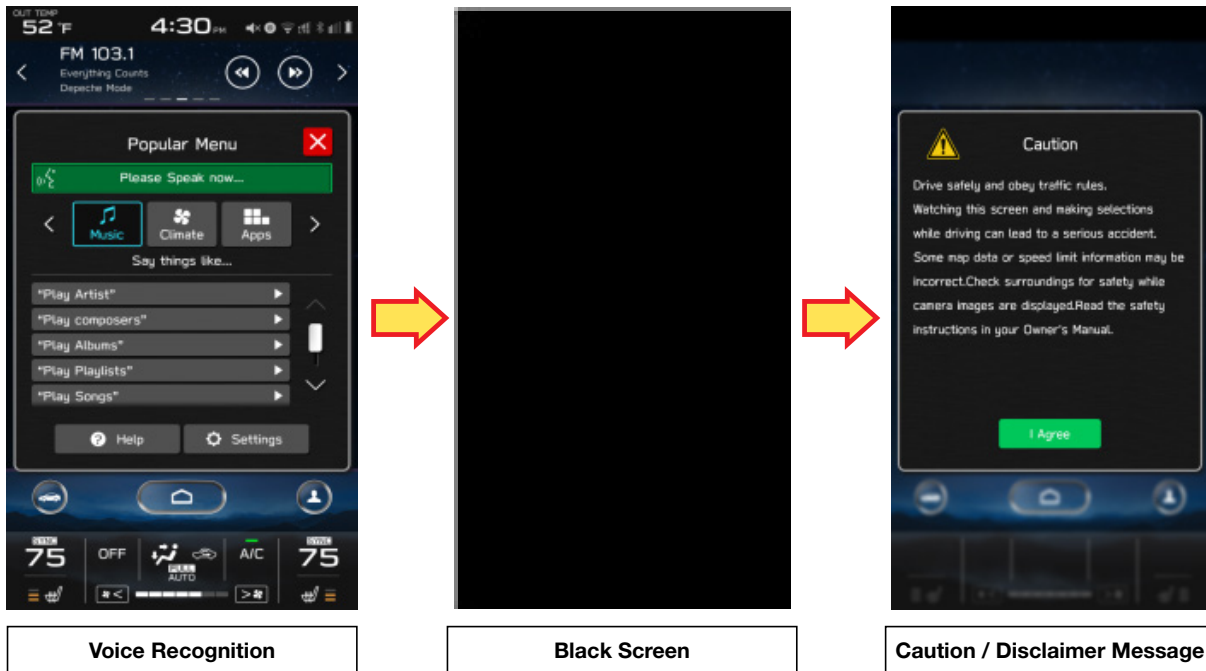
## Symptom #5

When using Voice Recognition to search for a 'Nearby POI' (Point of Interest) in Canada with FRENCH language selected, the CP1 display turns black and displays a Caution / disclaimer message.
