SERVICE BULLETIN

APPLICABILITY: 2017-18MY BRZ

NUMBER: 07-172-20

SUBJECT: Headlight Anti-Fog Enhancements for High Heat and Humidity

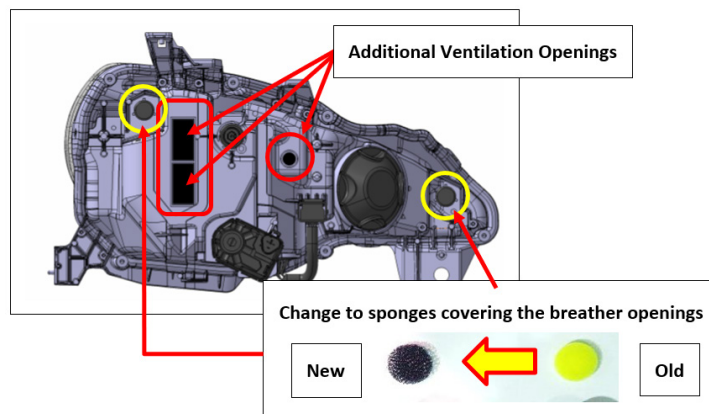
- Additional ventilation added for optimized temperature control inside the headlamp housing.
- The added temperature control enhances performance of the anti-fogging coating on the inside of the headlamp lens, improving its resistance to prolonged high temperature / humidity conditions.

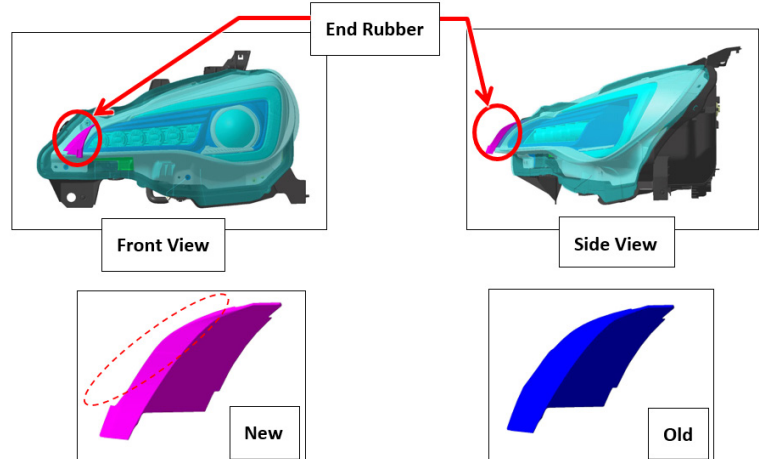
- The material used for the ventilation opening caps (sponges) has been changed.
- The end rubber portions have been changed to enhance their appearance and fit between the headlamp and bumper cover.
- The end rubbers have also been made available to order as separate components.
