SERVICE BULLETIN

APPLICABILITY: 2017-20MY Impreza
 2018-20MY Crosstrek

NUMBER: 12-283-20

SUBJECT: Hood Stay Support / Prop Rod- Design Change

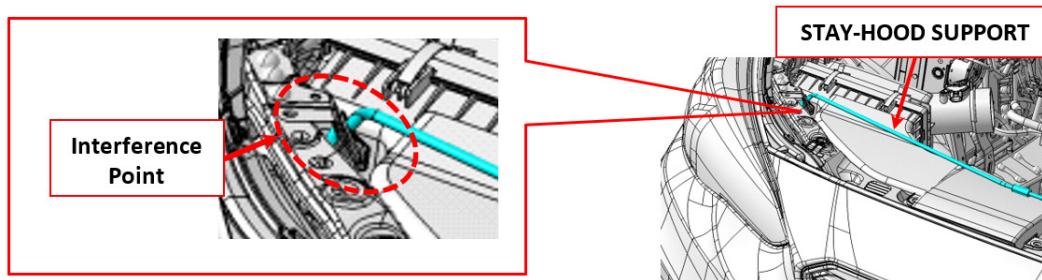
This bulletin announces a design change made to the hood stay support (a.k.a. prop rod). The change prevents a vibration sound resulting from contact with adjacent under-hood components.

A section of cushion was added as shown below to eliminate the source of the vibration sound.

The part number for the new stay support is: **57251FL001**.
