SERVICE BULLETIN

APPLICABILITY: 2019-20MY Crosstrek Hybrid (PHEV) **NUMBER:** 16-127-20
SUBJECT: AT Select Lever Guide Plate- Design Change **DATE:** 03/24/20

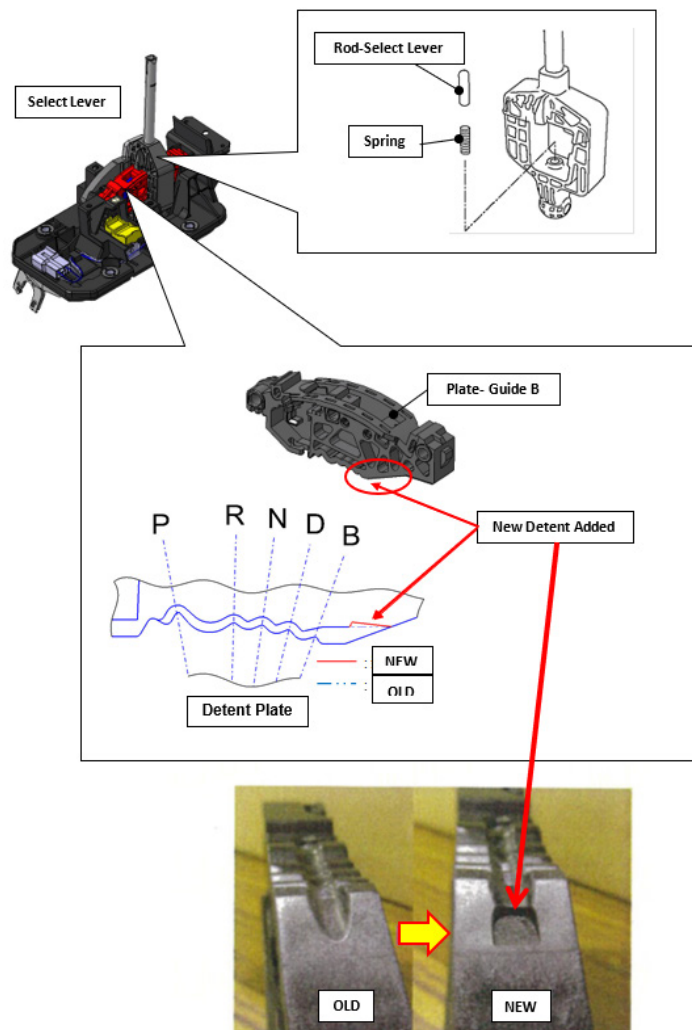
This bulletin announces a design change made to the AT select lever guide plate (shift detent plate) shown below. A revised detent was added to the plate to prevent improper reassembly of the select lever components in the event repairs requiring disassembly are necessary.

The new guide plate was incorporated into production starting with VIN **LH200438**.

The part number for the new guide plate is: **35122FL201**.
