Preliminary Information

PIP5527H Drivability Concerns Caused By Intake Rocker Arm Oil Control Valve - Chuggle Surge Misfire P0101 P0106 P0171 P0300 P219A P16D0 P16D1 P2646 P2647

Models

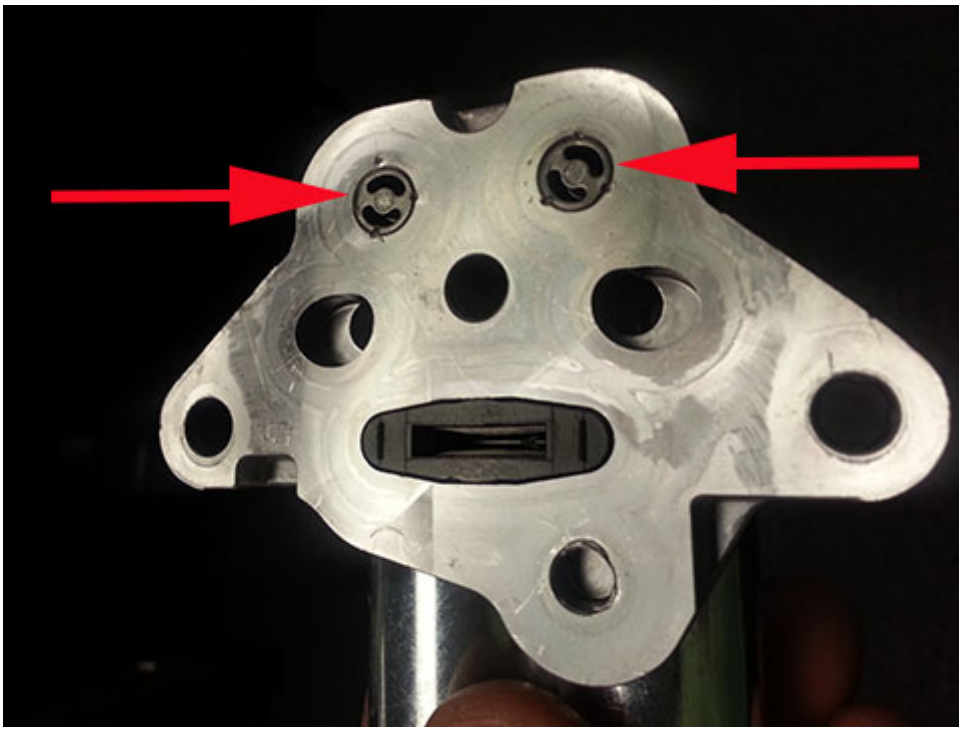
This is a good valve with components still in place.

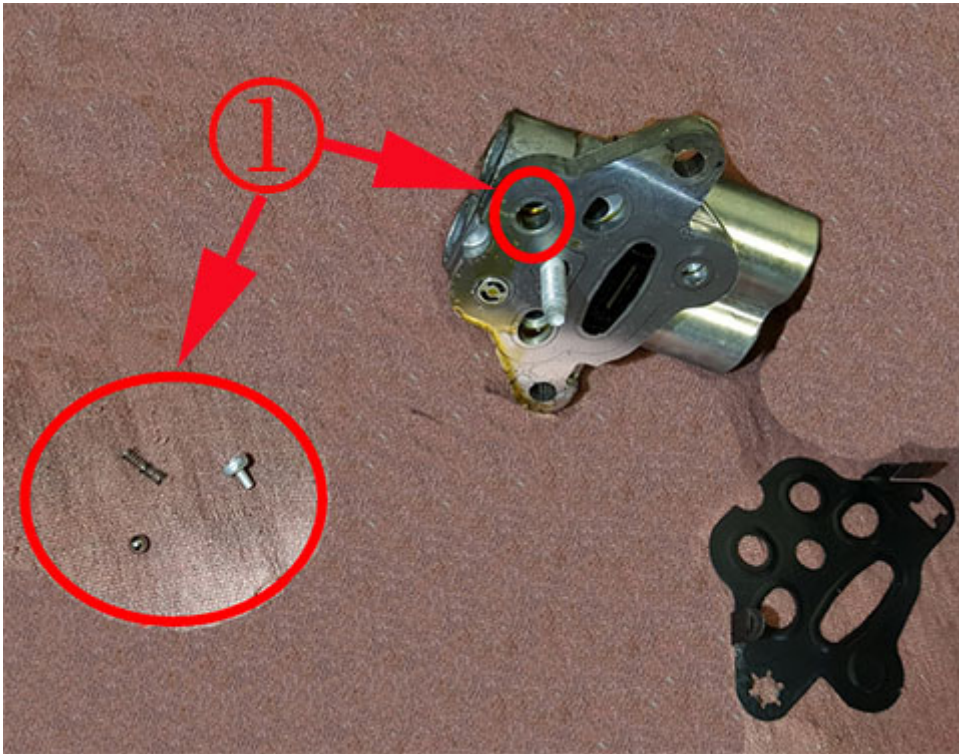
See illustrations below for items #1 being missing.

The camshaft cover must be replaced because the components become lodged in the camshaft cover oil passages and can not be removed.

This is a bad valve with components missing.

If any of the components are missing, replace the intake rocker arm oil control valve and camshaft cover.
