Bulletin No.: PIC6293D **Published date:** 03/3/2020

PIC6293D Installation Of the GM Accessory Interior Spectrum Lighting Kit

Brand:	Model:	Model Years:	VIN:		Engine	Transmissions:
			from	to	Engine:	Transmissions.
Chevrolet	Camaro	2016 - 2020	All	All	All	All

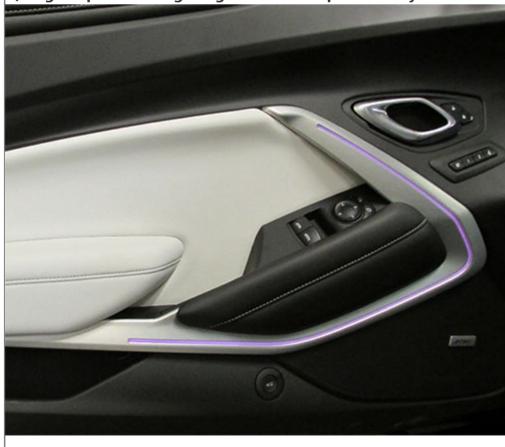
1) Light up Accent Lighting on the door panels only

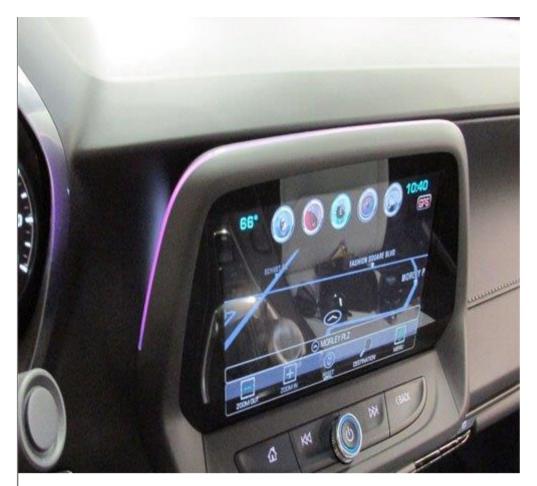
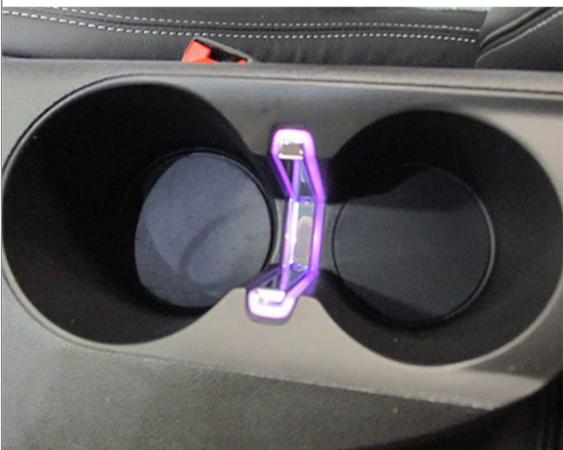
3) Light up Accent Lighting on the door panels AND Footwell Lighting

IMPORTANT: When installing a GM Accessory Lighting Kit, the light strips around the radio display and the center cupholders will NOT illuminate. The only way to get these two lights to operate is to purchase the vehicle with the factory C70 RPO. The radio display and the center cupholder will NOT illuminate with installation of the GM Accessory Lighting Kit.

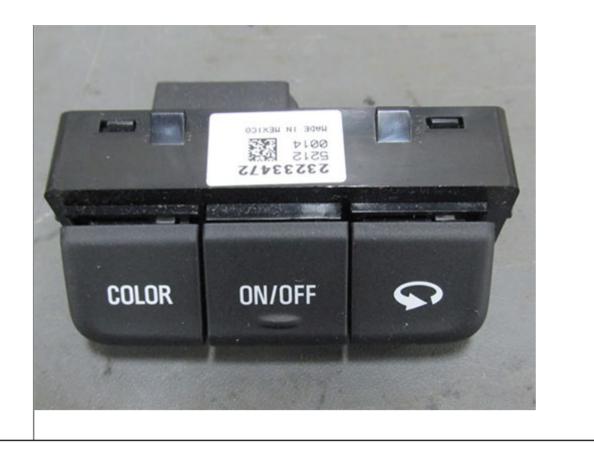
Vehicles equipped with the base radio (RPO IOB or IOR) do not require any programming. That is why the color selections are not available on the radio screen. This system uses a dashmounted switch to change the system's lighting colors. It is installed on the left hand side of the steering column. This switch can be seen in the photo below.
