## TECHNICAL SERVICE BULLETIN

### 2016-2019 Explorer - Roof Rail Covers Loose

**20-2154**

Ford  
2016-2019 Explorer

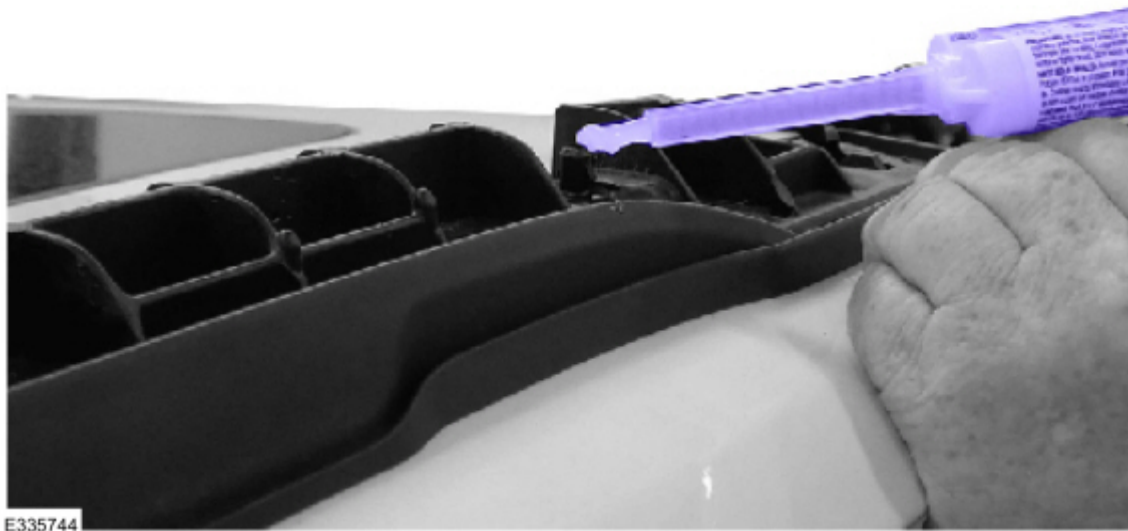
Figure 1

**Issue:** Some 2016-2019 Explorer vehicles may exhibit roof rail covers that become loose or partially detached. This may be caused by a lack of retention of the clips securing the roof rail covers. To correct the condition, follow the Service Procedure to replace the retaining clips and apply adhesive to the roof rail covers.

1. Remove the roof rail cover. Refer to Workshop Manual (WSM), Section 501-08.
2. Replace the roof rail retaining clips.
3. With retaining clips installed in the roof rail cover, apply a 5 mm (0.20 in.) bead of 3M™ Super-Fast Repair Adhesive 04747 or equivalent on each contact patch of the roof rail cover and roof rail base assembly. (Figure 1)
