TECHNICAL SERVICE BULLETIN

Water Leaking On Right Front Floor During Or After A/C Use - Built On 31-Aug-2018 And Through 02-Feb-2020

20-2170
14 May 2020

Ford 2018-2020 Expedition
2018-2020 F-150
2018-2020 F-Super Duty
Lincoln 2018-2020 Navigator

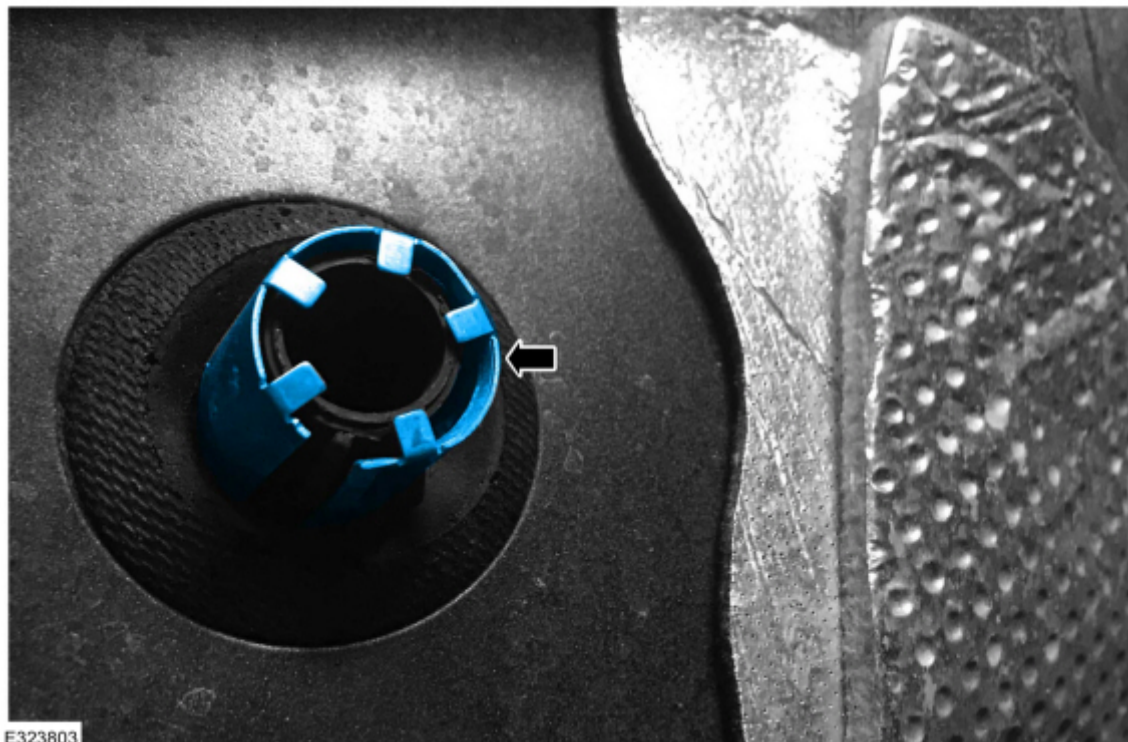
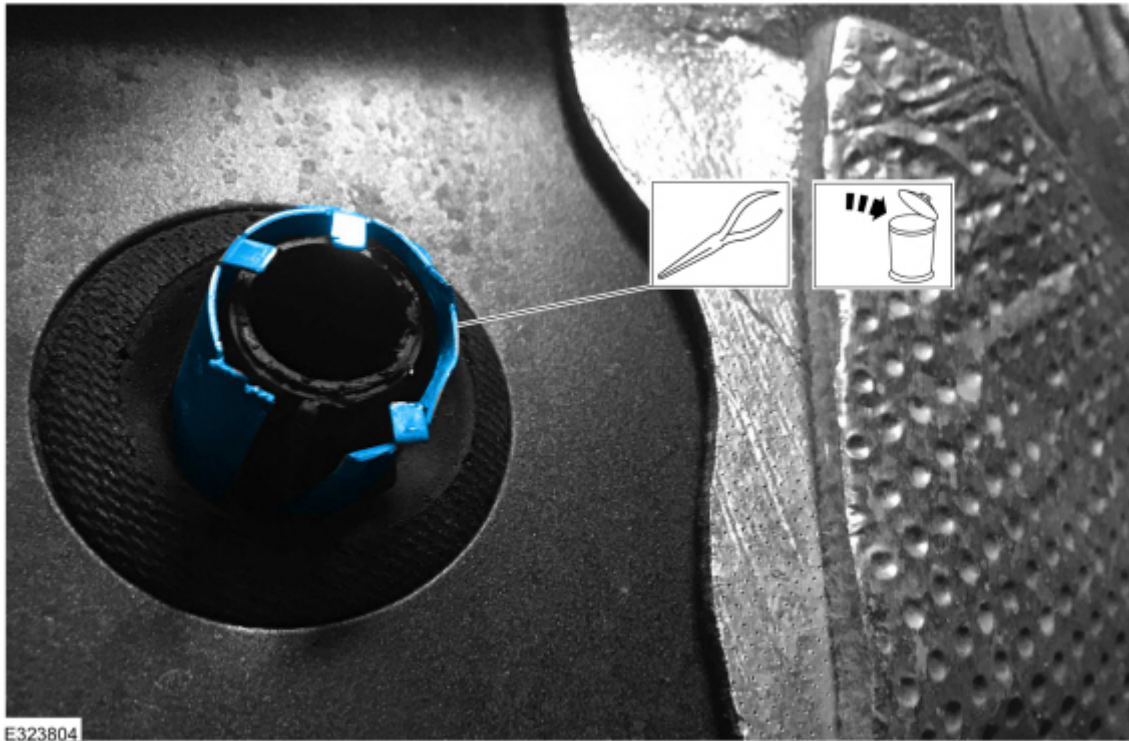
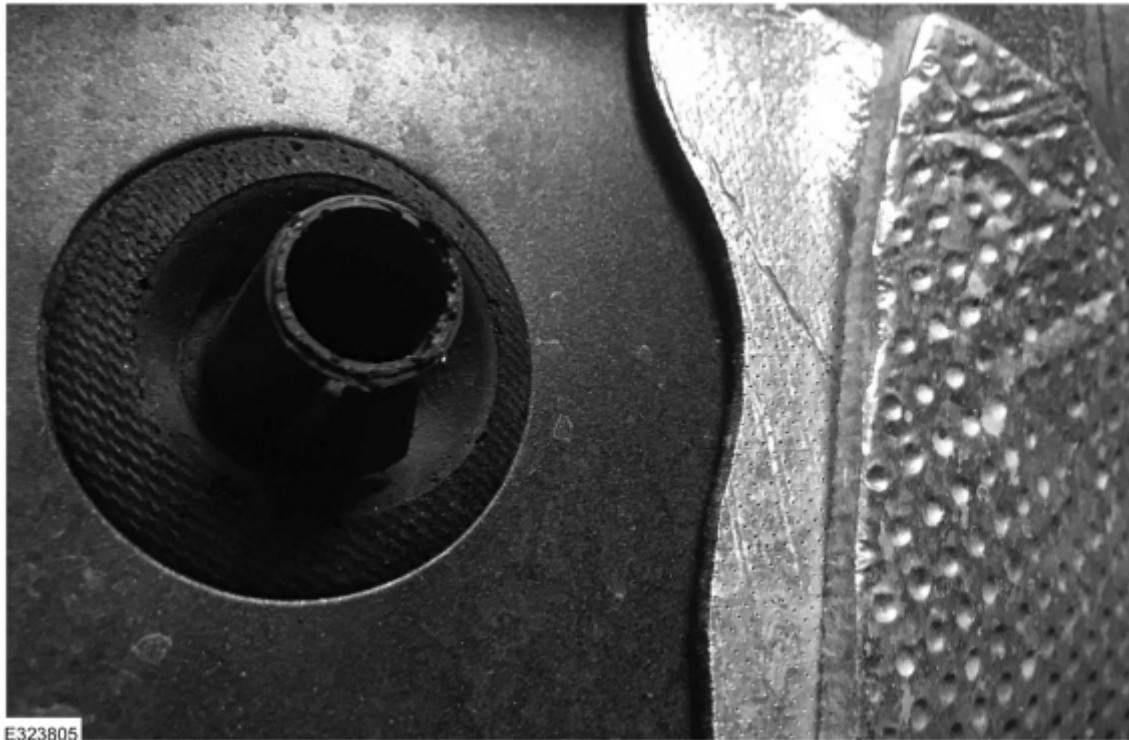
Issue: Some 2018-2020 F-150/Expedition/Navigator/F-Super Duty vehicles built on 31-Aug-2018 and through 02-Feb-2020 may exhibit a water leak on the right front floor during and/or after the air conditioning (A/C) is used. This may be due to condensation from the evaporator drain tube entering the vehicle through the drain tube seal. To correct the condition, follow the Service Procedure steps to install an elbow on the evaporator drain tube to direct the condensation away from the seal.

1. Raise the vehicle and remove the right front tire.
2. Remove the right front fender splash shield. Refer to the Workshop Manual (WSM), Section 501-02.
3. Using needle nose pliers or equivalent, remove and discard the metal shield from the evaporator drain tube by bending the tabs away from the tube. (Figures 1-3)
