## SERVICE BULLETIN

**APPLICABILITY:** 2015-16MY Legacy and Outback  
2012-16MY Impreza  
2013-19MY Crosstrek  
2013-19MY Forester  
2015-16MY WRX and STI

**NUMBER:** 12-203-16R

**SUBJECT:** Squeaking Sound from Front Seat Buckle

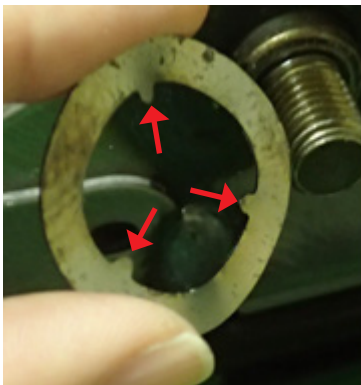
**OLD** Wave Washer

The 3 “tang” seen on the inside of the **OLD** wave washer have been deleted. The inside diameter of the **NEW Spring** wave washer has been decreased and a small felt added to allow the washer to turn smoother with the buckle and have a better fit on the shoulder portion of the retaining bolt.
