SERVICE BULLETIN

APPLICABILITY: 2019-20MY Ascent

NUMBER: 07-177-20

SUBJECT: 120V (Volt) Power Inverter Assembly-
Design Change

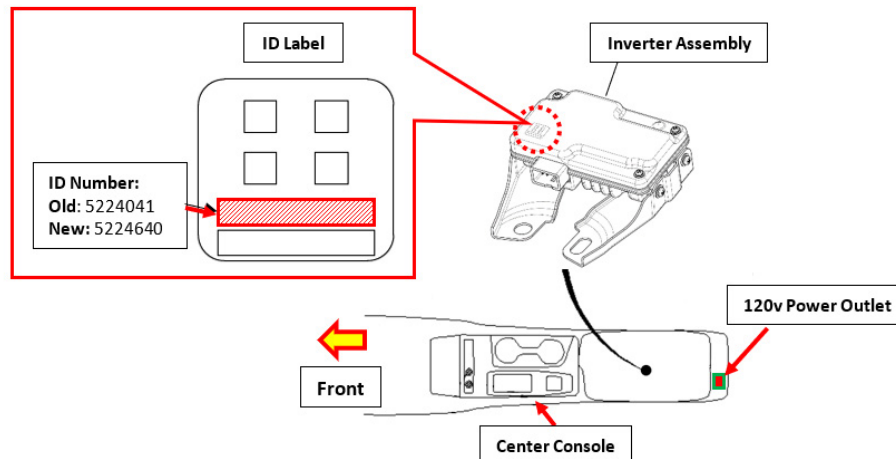
Location of Inverter and Part ID Number Label

As mentioned earlier, the inverter is located inside the center console, under the storage box area. The new part can be identified by the number **522460** located on the label as shown in the illustration below.

Using the illustration above as reference, locate the label on the inverter case and confirm the ID number.

- If the ID number is **5224041**, replace the inverter following the procedure in the applicable Service Manual.
- If the new ID number 5224640 inverter is already installed, the appliance(s) being used when the condition occurs should be inspected for possible excessive current draw.
