SERVICE INFORMATION BULLETIN

APPLICABILITY: 2018-20MY Crosstrek
2019-20MY Forester

NUMBER: 12-296-20

SUBJECT: Rear Frame and Stabilizer Bar Bracket
Mounting Bolt- Design Changes

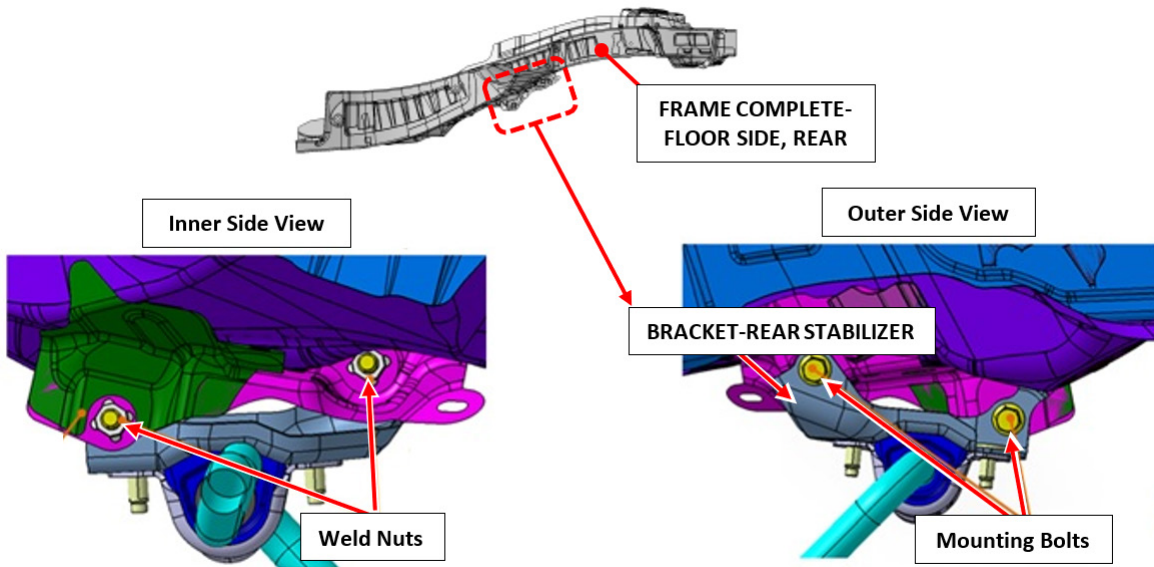
- The new Flange Bolts listed here are NOT compatible with weld nuts used in the original frames. Therefore, using the new-style Flange Bolts on the original frame will damage the weld nuts.
- The original Flange Bolts (p.n. 010108200) are reusable and readily available if needed.
- The new Flange Bolts have a special lubricant applied to their threads and are One-Time use.
- There have been no changes to the part numbers of the stabilizer bar brackets.
