## TECHNICAL SERVICE BULLETIN

### 2020 Explorer/Aviator - Exhaust Rattle Noise

**20-2220**  
29 June 2020

<b>Ford</b> 2020 Explorer
<b>Lincoln</b> 2020 Aviator

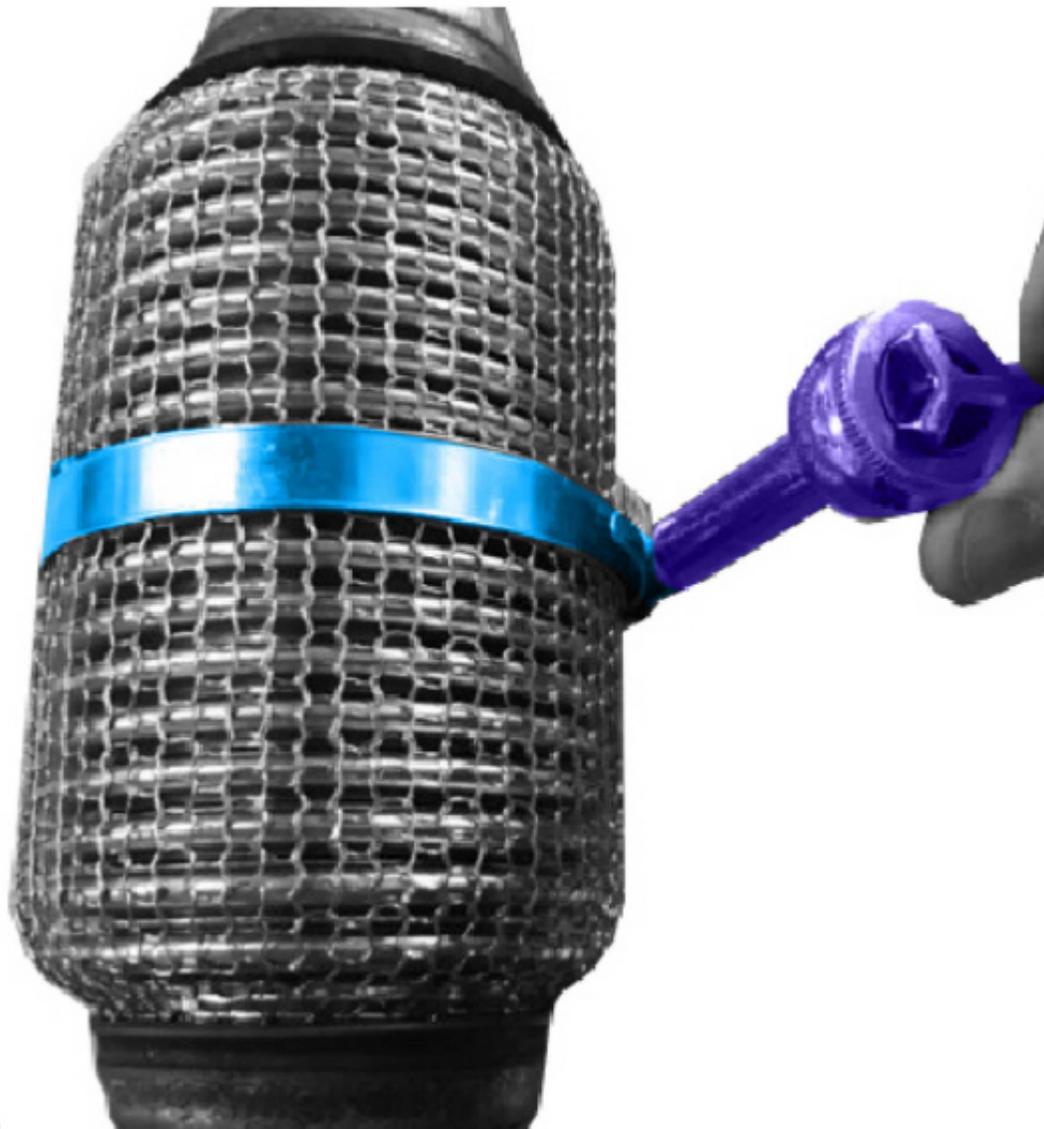
Figure 1

**Issue:** Some 2020 Explorer/Aviator vehicles may exhibit a rattle type noise originating from the exhaust flexible pipe. This may be due to the natural harmonic frequency of the pipe. To correct the condition, follow the Service Procedure to install a worm gear clamp over the exhaust flexible pipe.

1. Open and install the worm gear clamp over the flexible portion of the exhaust flexible pipe. Tighten to 2.7 Nm (24 lb-in) (Figure 1).
