Service Bulletin

Bulletin No.: 20-NA-012

Subject: Radio Software Version V135116 Over-the-Air Update

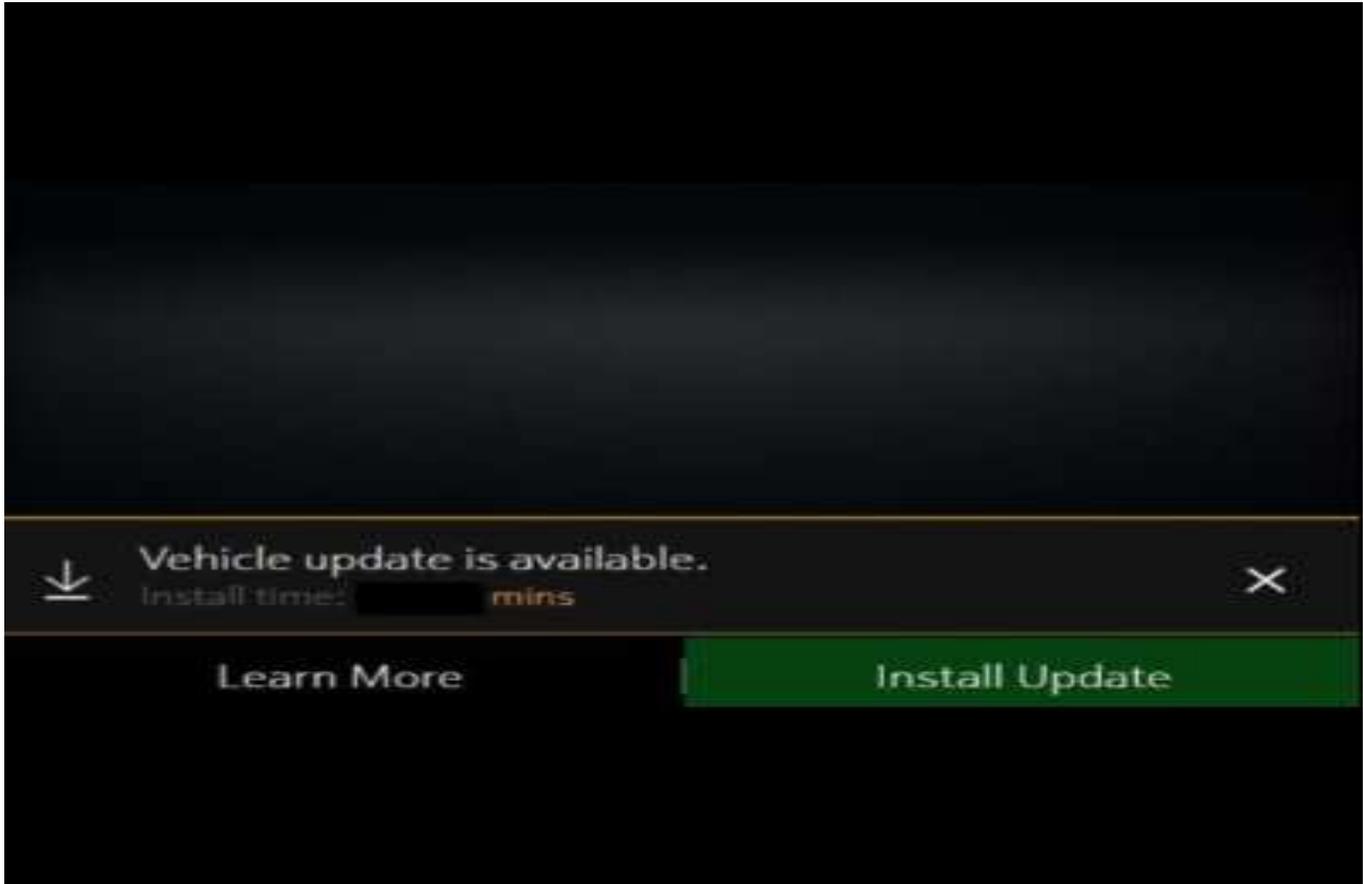
5494687

1. If a remote package is on the system, you may see the below pop up upon shifting the vehicle to Park.

2. Select "Install Update."
 - If no update available pop up is displayed, navigate to "Settings" -> "Updates." If there is a remote package downloaded on the system, it will display "Install Now", proceed with install. If there are no options available, proceed with the software update following the **Update Procedure Using TIS2WEB (USB Download)** section of this document.

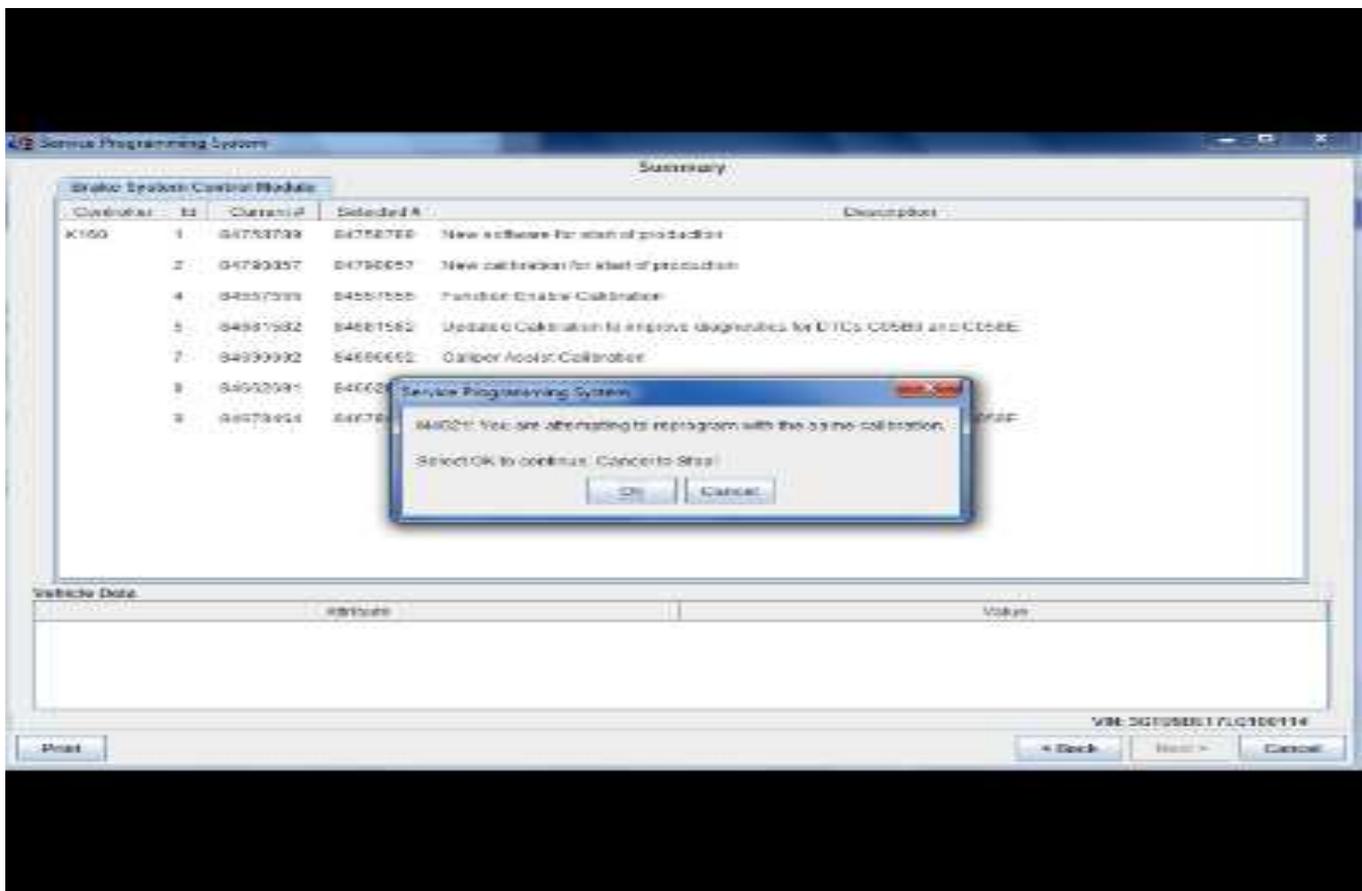
5431207

Important: TIS2WEB screen shown. Techline Connect screen is similar and will be included soon.

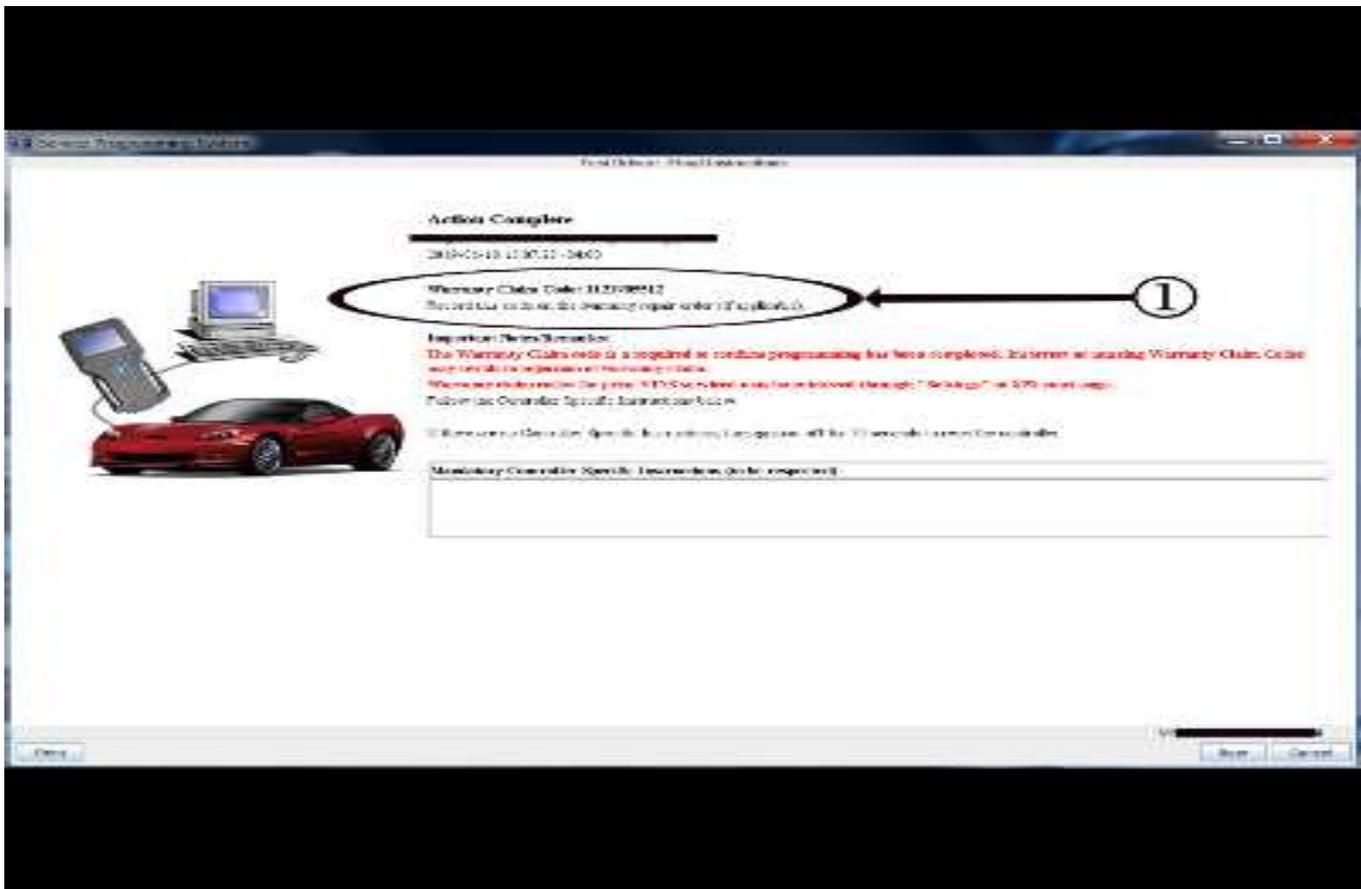
5431209

Important: TIS2WEB screen shown. Techline Connect screen is similar and will be included soon.

1. Start SPS, select Radio – USB File Transfer and follow the on-screen instructions.

Important: To avoid warranty transaction rejections, you MUST record the warranty claim code provided on the SPS Warranty Claim Code (WCC) screen on the job card. Refer to callout 1 above for the location of the WCC on the SPS screen.

2. Record SPS Warranty Claim Code on the job card for warranty transaction submission.
3. Insert the USB drive into the vehicle while in Park. If the software does not automatically begin to update within one minute, reference the **Troubleshooting** section below.
4. Follow the on-screen prompts to complete the USB software update.

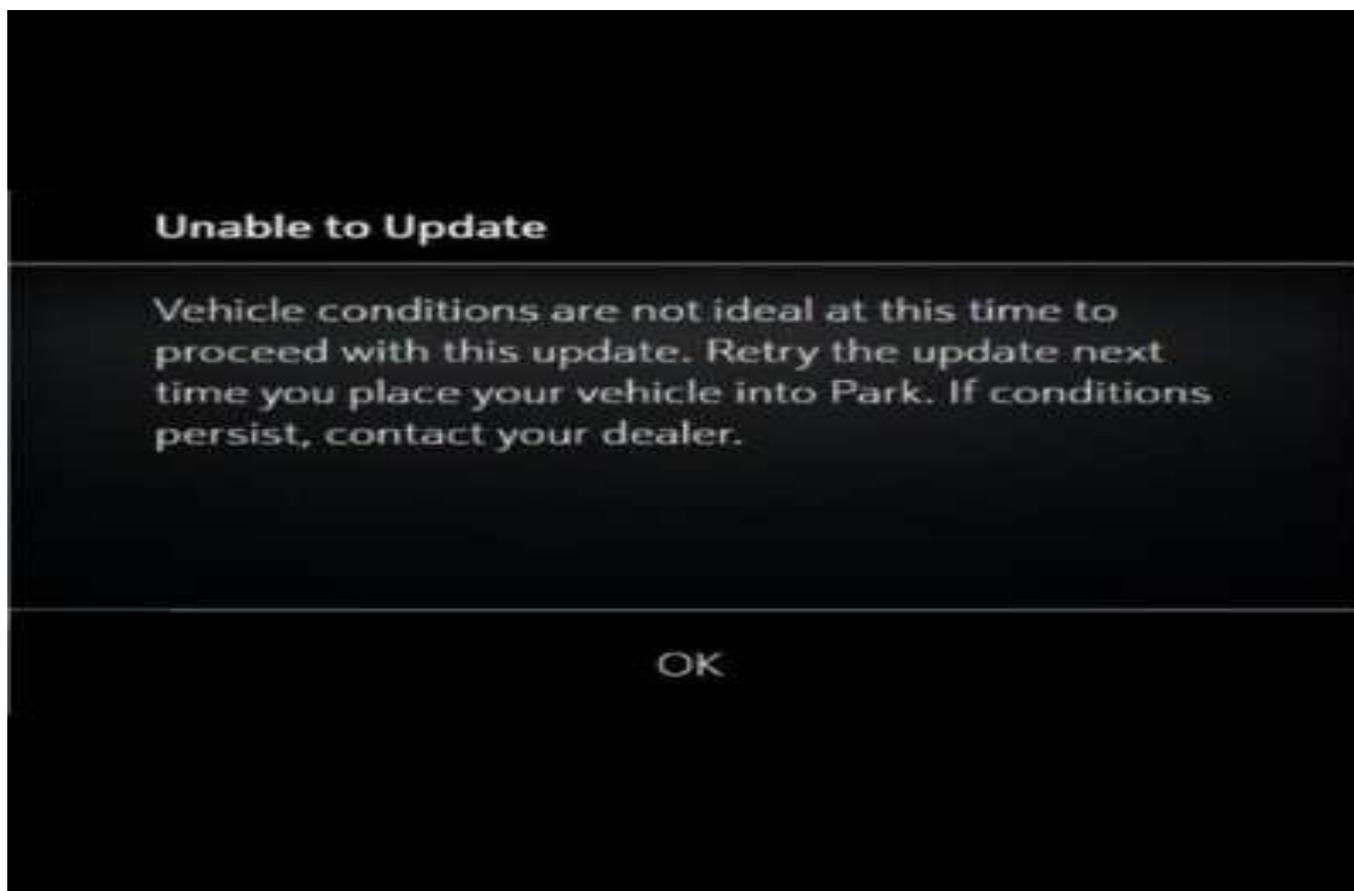
5495032

Scenario 1: Vehicle conditions are not ideal.

If the above screen is shown, download the update through TIS2Web and perform USB update. Ensure the vehicle battery is being maintained (using EL-49642 or battery maintainer) while performing this update.

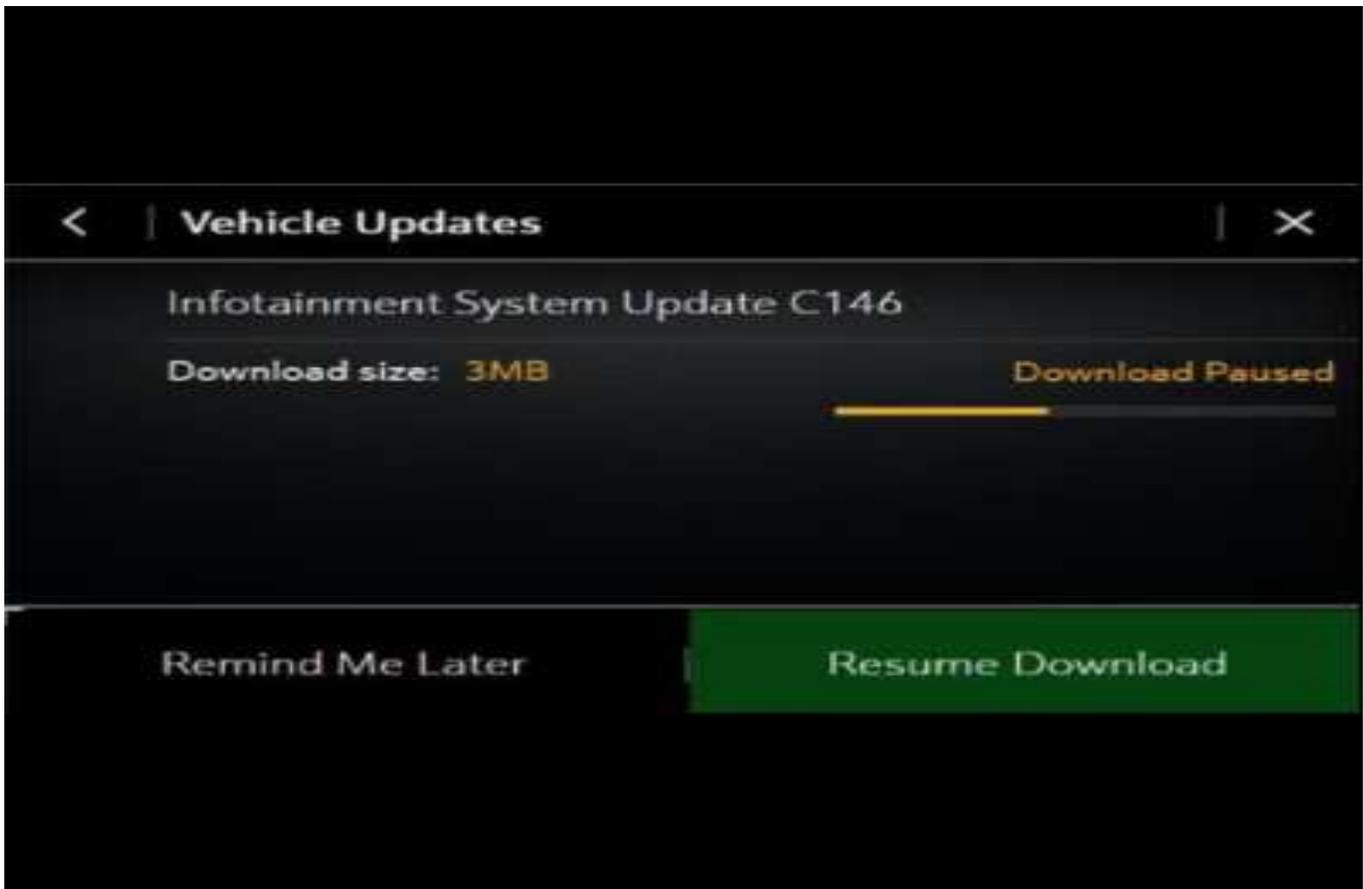
5494724

Scenario 2: Consistently Paused Download

If the above screen is shown and resuming the download repeatedly fails, a USB update will need to be performed. Turn the vehicle on, return to the home screen, and insert USB stick (see previous section). Verify the part number is correct and follow on screen prompts.

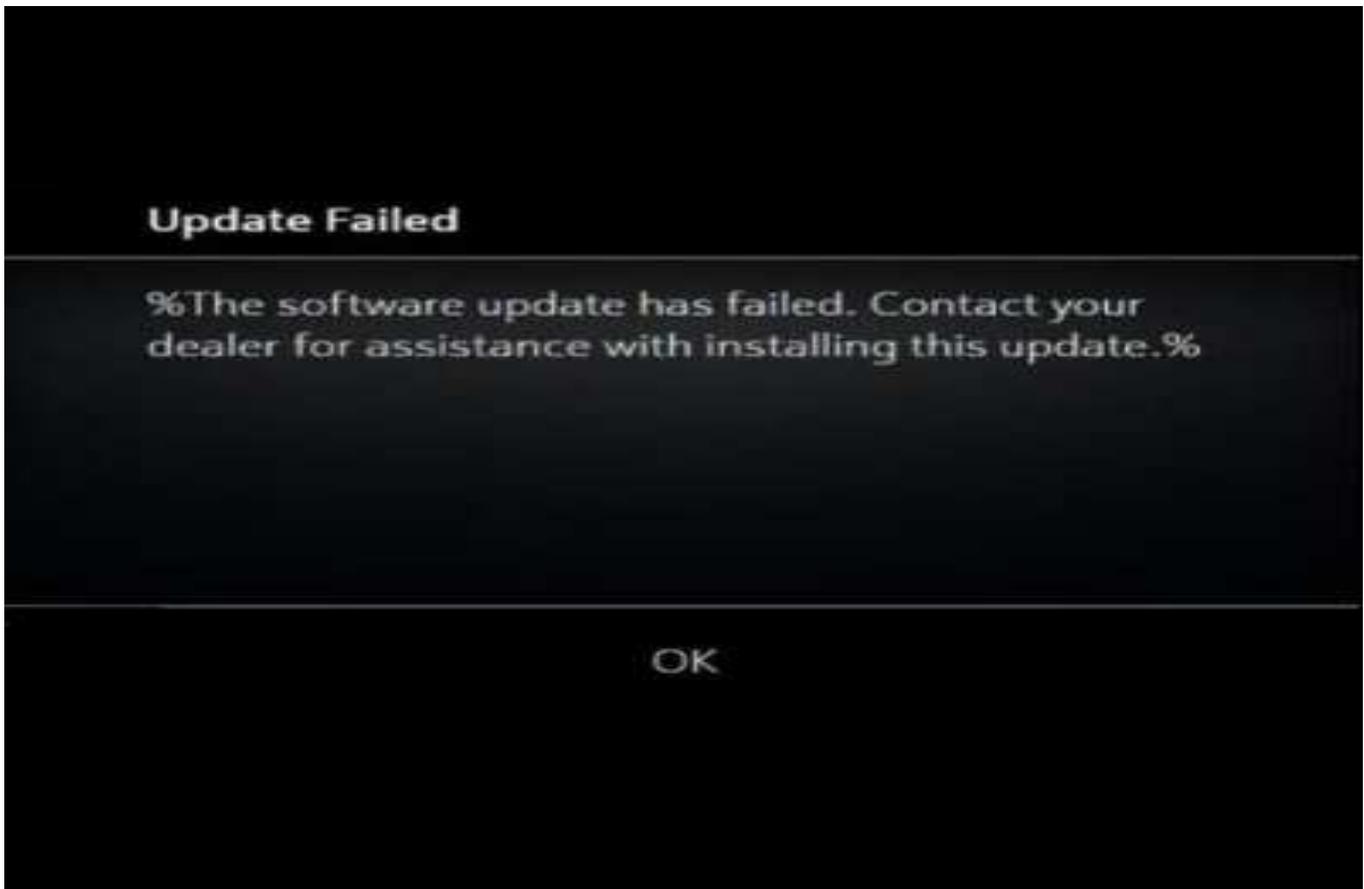
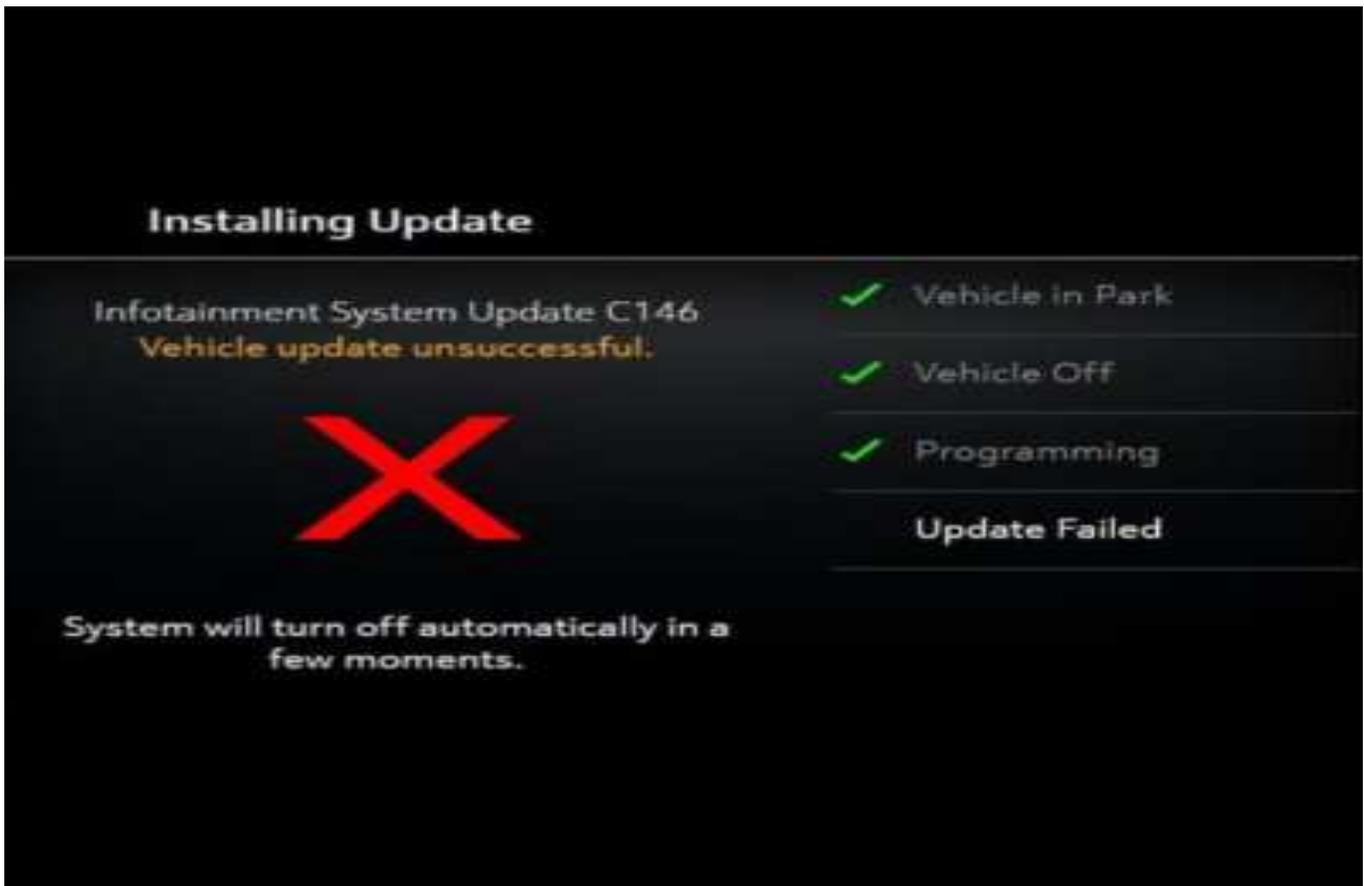
Scenario 3: Update Failed. Return to dealer screen.

If one of the above screens is shown, download the update through TIS2Web and insert a USB stick into the radio. A yellow progress bar should come on the screen and the update will proceed. If this screen above is shown when trying to update the radio through USB, reformat the USB drive to FAT32 on your PC, perform Return to Factory Defaults, and then try to download the update through TIS2WEB again.
