# Service Bulletin

Bulletin No.: 20-NA-055

Date: June, 2020

**Subject:** IPC Gauges Inoperative, Numerous DIC Error Messages, No Brake or Electric Power Steering Assist, Transmission in Default Gear, No Reverse and/or Back Up Lights, No DRL, No Cruise or Adaptive Cruise and/or No Trailer Brake Lights

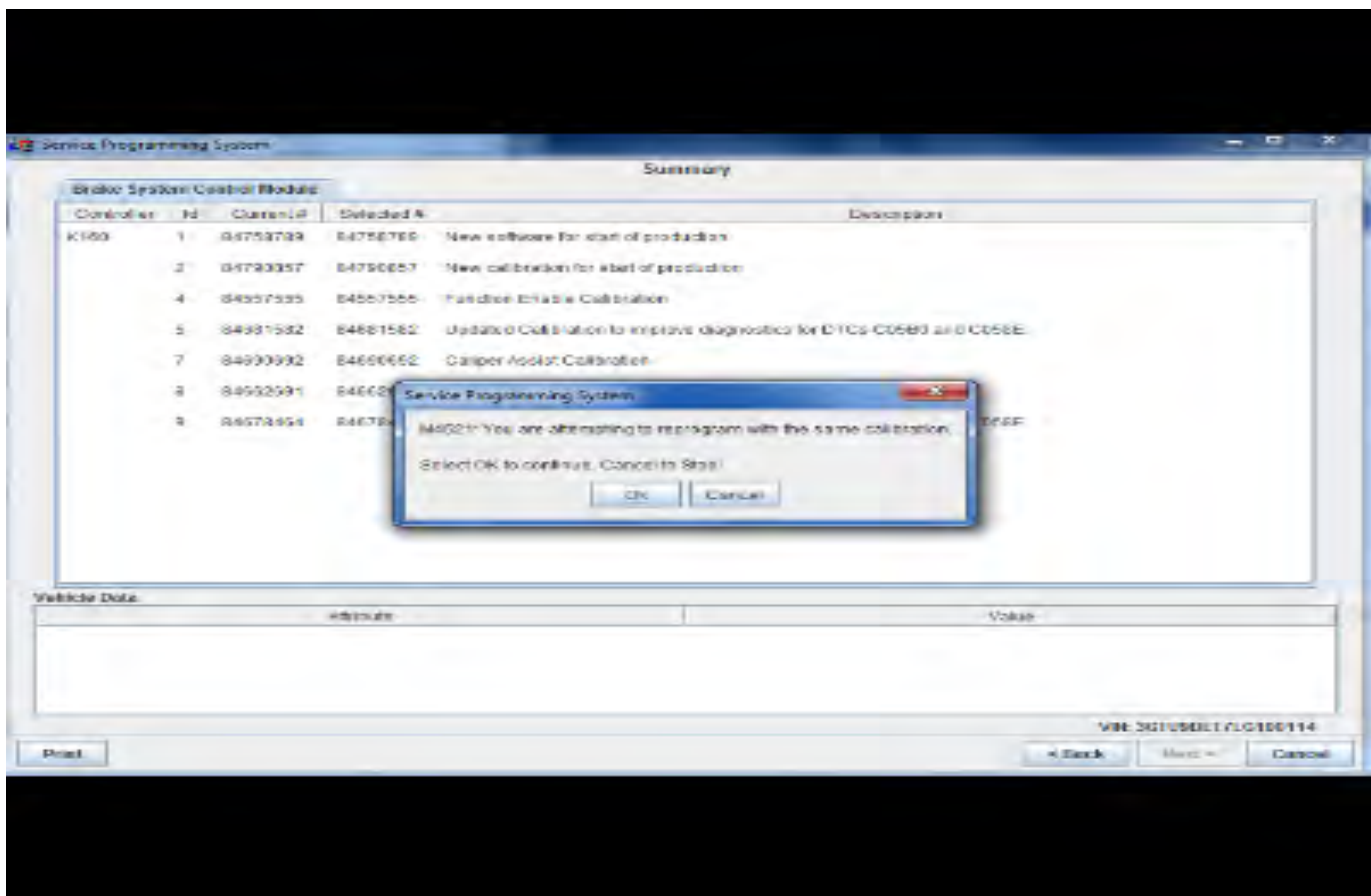
5431207

**Important:** TIS2WEB screen shown. Techline Connect screen is similar and will be included soon.

**Important:** If the Same Calibration/Software Warning is noted on the SPS screen, select OK and follow screen instructions. After a successful programming event, the WCC is located in the Service Programming

System dialogue box of the SPS Summary screen. No further action is required. Refer to the Warranty section of the bulletin.

1. Reprogram the ECM module. Refer to *K20 Engine Control Module: Programming and Setup* in SI. Modify as required (e.g., select x module from the controller screen. Then provide step-by-step instructions or refer to SI procedure.
