Service Bulletin

Bulletin No.: 20-NA-071

Subject: Service Engine Soon Lamp Illuminated and/or Service Power Brake Assist Message Displayed, with DTCs P0557 or P0558 Stored

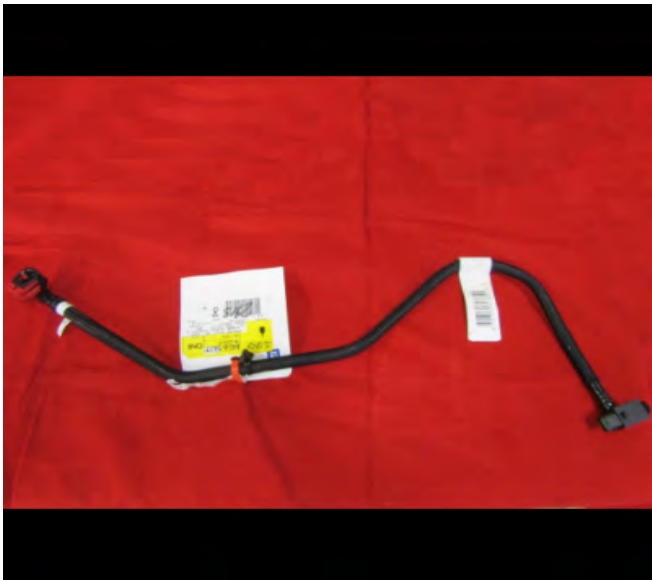
5549611

LGX Hose

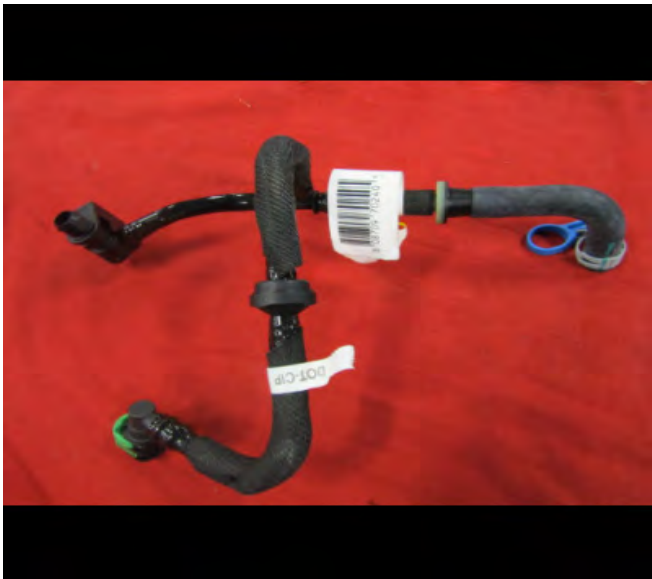
5549612

LFY Hose

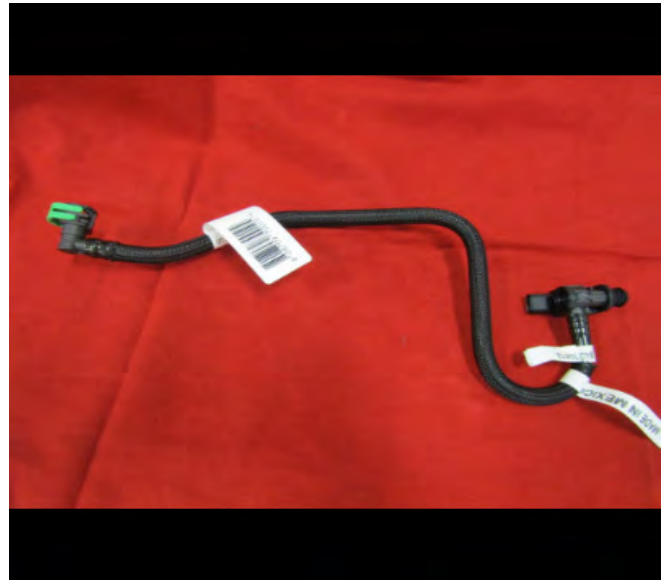
5549615

LCV Hose

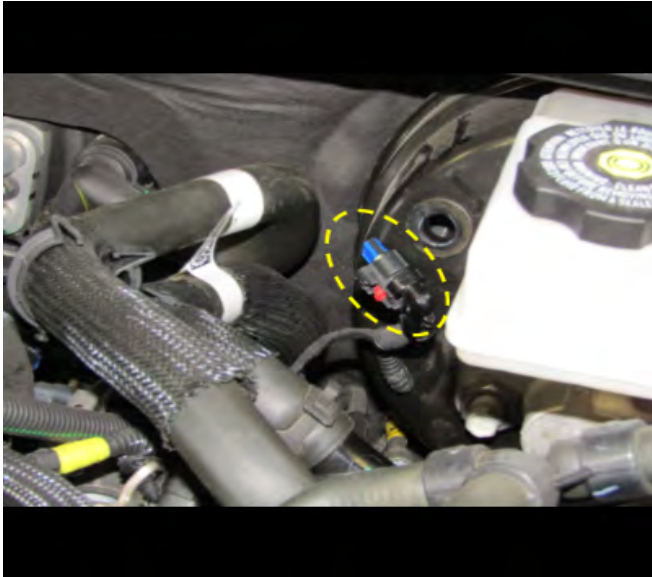
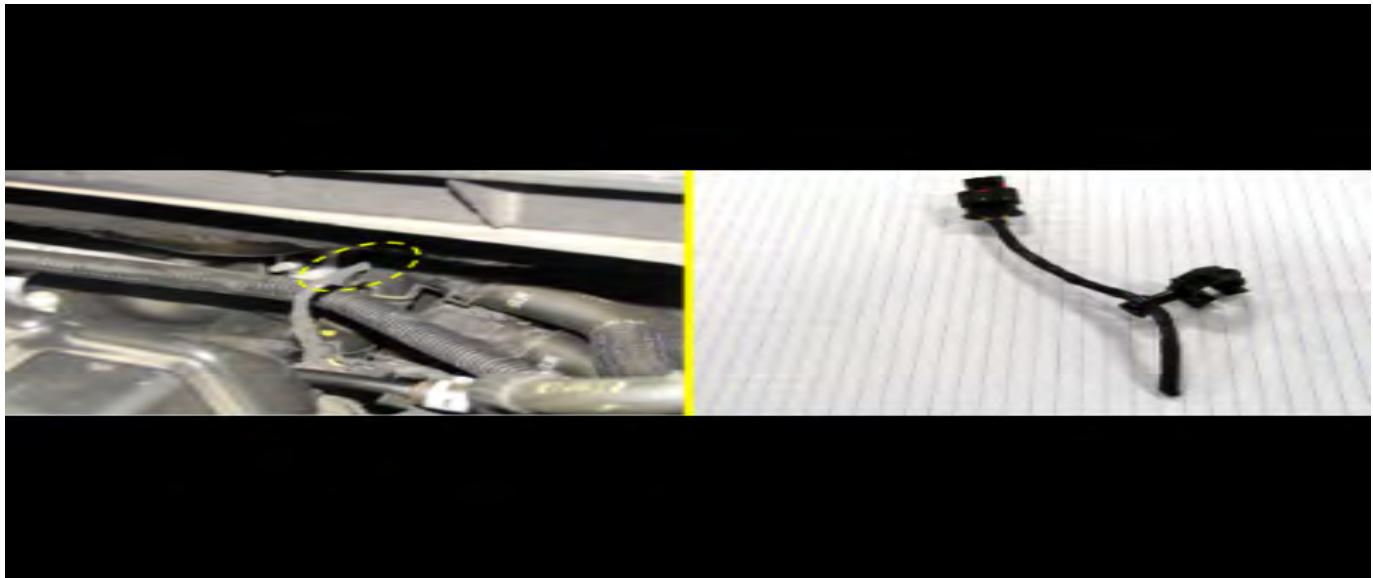
Note: The top graphic shows the LGX connector intact; the bottom one shows the LFY wiring already cut.

2. Locate the power brake booster vacuum sensor electrical connector. Fold conduit back and cut off connector, leaving approximately 5.0 cm (2.0 in) of wiring on the engine harness side.
3. Tape the cut wiring end to the engine harness. These wires will no longer be used.

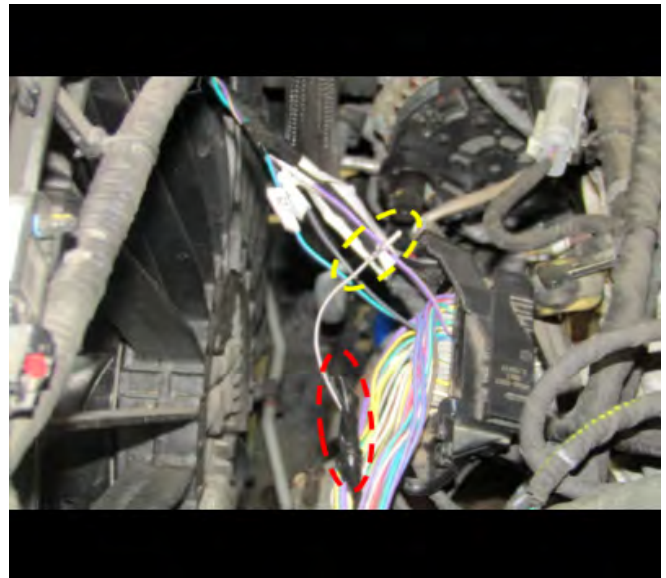
5549629

Note: In this step, do NOT cut the terminal off of circuit #2151 (circled in yellow in the graphic above).

15. Cut off the terminated leads that were in circuits #6030 and #6031 and fold and tape off the ends (circled in red in the graphic above). These circuits will no longer be used.

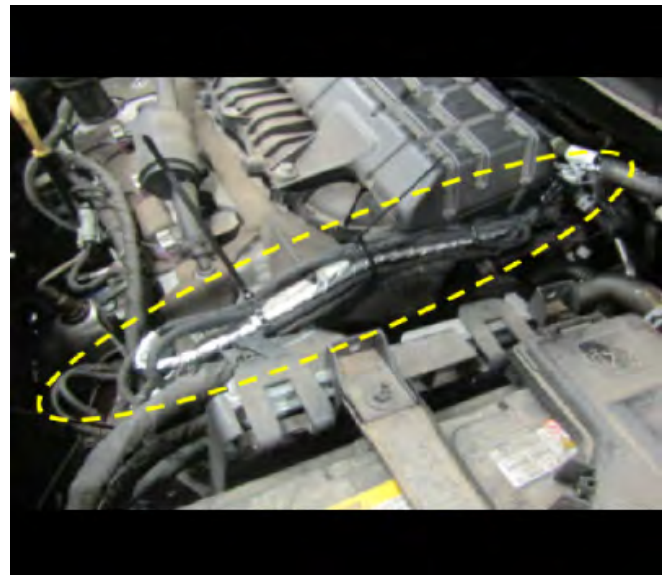
5549633

Note: Graphic shown above is LFY harness routing.

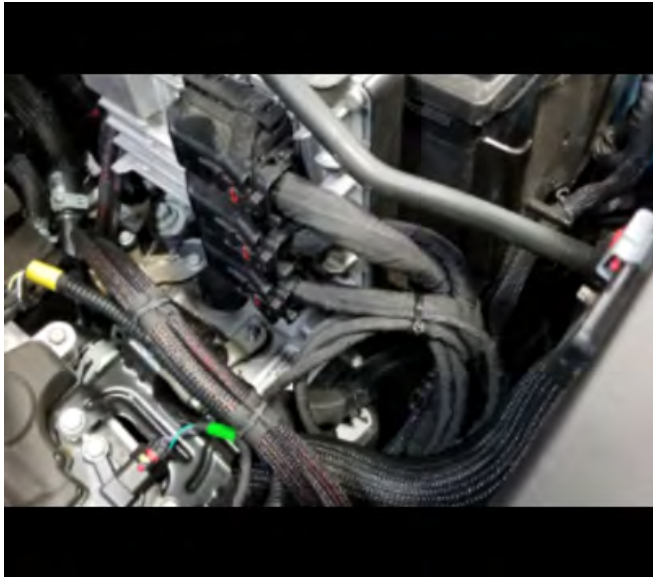
5549634

Note: Graphic shown above is LGX harness routing, with LCV being similar.

Important: It will be necessary to coil the extra wire length. Ensure the wire is tied back away from any sharp edges or moving parts that could cause damage to the harness.
