Service Bulletin

Bulletin No.: 20-NA-120

Subject: Information on Malfunction Indicator Lamp (MIL) Illuminated - Multiple DTCs Set

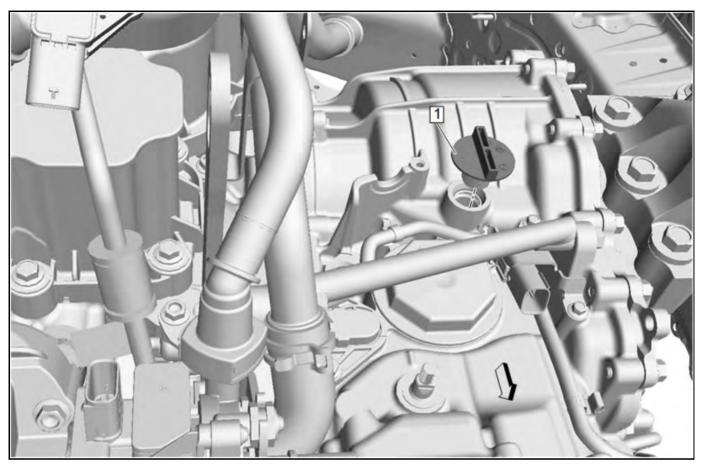
5171810

The pulley and chain can be accessed through the transmission fluid filler cap (1) at the top of the transmission.

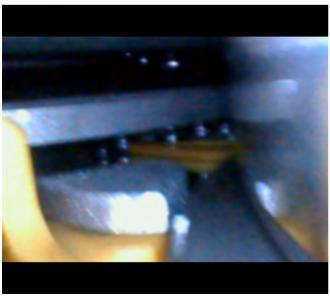
1. Insert the borescope between the chain guard pivot and the inside edge of the primary pulley.

Borescope image should look like the example above. 2. Inspect the chain pin ends.

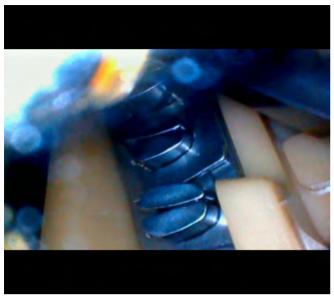
5608011

If the pin ends have no signs of slip marks, the transmission is OK to be repaired for the cause of the DTC/low fluid level.

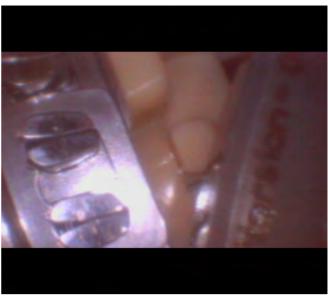
5608015

• If the pin ends have signs of slip marks, the transmission should be replaced, not repaired.

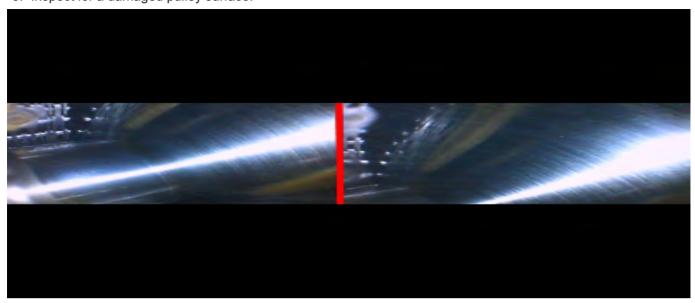
5608026

If the pulley surfaces do not show signs of damage, the transmission is OK to be repaired for the cause of the DTC/low fluid level.

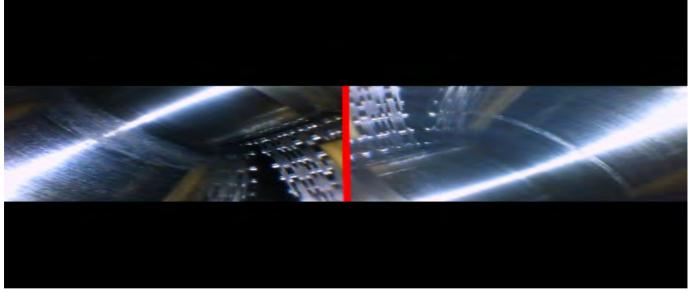
5608042

If the pulley surfaces show signs of surface grooving and scuffing, the transmission should be replaced, not repaired.
