# Service Bulletin

Bulletin No.: 20-NA-125

**Subject:** Rattle or Creak Noise from Quarter Panel Area While Traveling at Highway Speeds

Brand:	Model:	Model Year:		VIN:		Engine:	Transmission:
		from	to	from	to		
Chevrolet	Corvette	2020	2020	—	—	All	All

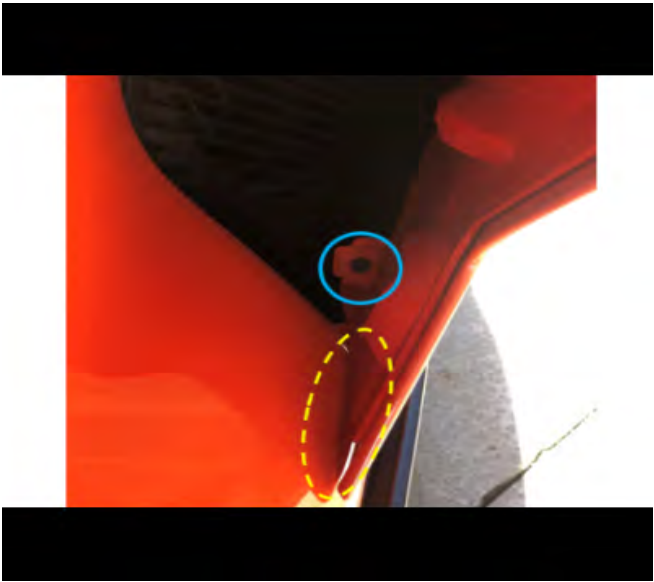
</div> <p>5614871</p> <p><b>Note:</b> The contact area is shown circled in yellow in the graphic above.</p> <p>The cause of the condition may be that the lower quarter extension may have interference contact with the rocker panel, creating the noise.</p>
Correction	Verify which side has the condition and adjust the quarter panel extension to obtain clearance between the extension and rocker panel. Follow the steps in the Service Procedure below.
