PIT5751A SES MIL / Reduced Engine Power / Misfire / IPC Gauges Sweep / IPC Warning Message / Loss Communication / Various DTCs / Blown Fuse (Inspect Engine Harness 3.0L Diesel)

Brand:	Model:	Model Years:	VIN:		Engine:	Transmissions:
			from	to		
Chevrolet	Silverado 1500	2020	All	All	3.0L LM2	All
GMC	Sierra 1500	2020	All	A	3.0L LM2	All

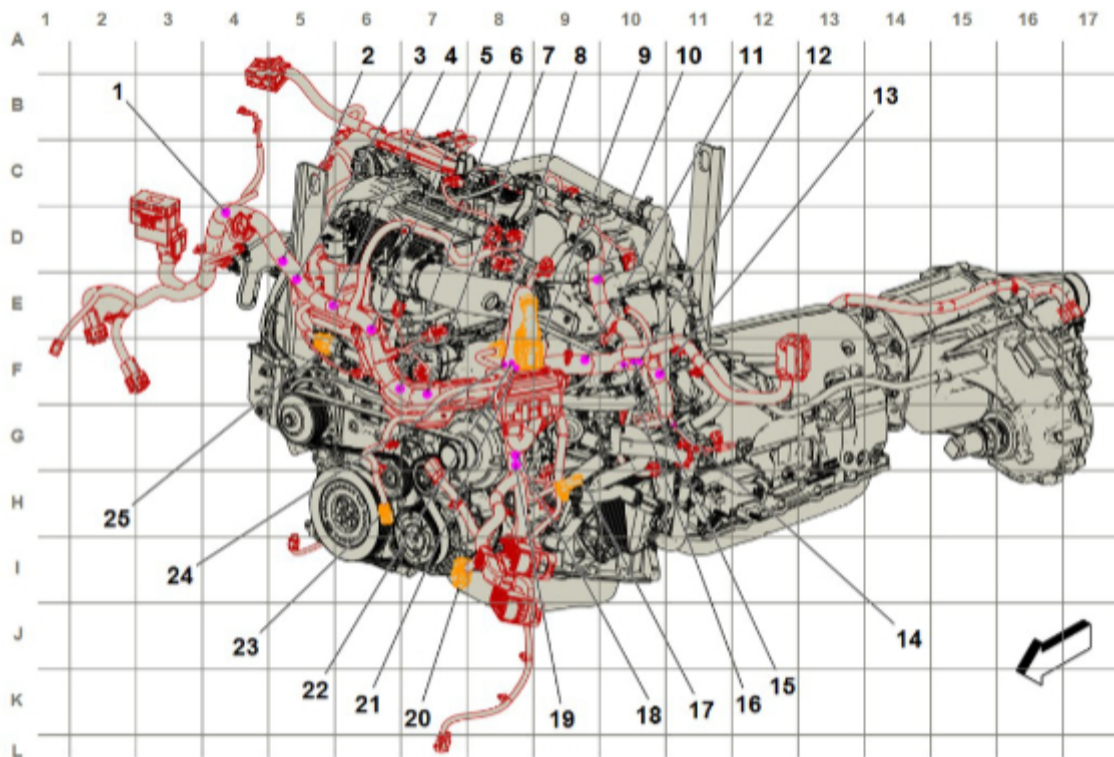
These concerns could be caused by the engine harness getting pinched/shorted/chaffed in grid coordinates G-8, shown below. This location is approximately 18 inches from the ECM connectors, shown below (1). Due to the number of circuits in the harness, there is a wide variety of different symptoms that could occur, depending on which circuit(s) are damaged.

In many cases, the ECM has been unnecessarily replaced for these concerns. Please thoroughly inspect the areas shown above and follow published SI diagnostics before any parts are replaced. If any concerns are found, then follow SI Wiring and Connector repair instructions to correct the concern.
