Bulletin No.: PIT5757

### PIT5757 Front License Plate Bracket Does Not Fit Correctly To The Fascia

Brand:	Model:	Model Years:	VIN:		Engine:	Transmissions:
			from	to		
GMC	Yukon Models	2021	All	All	All	All

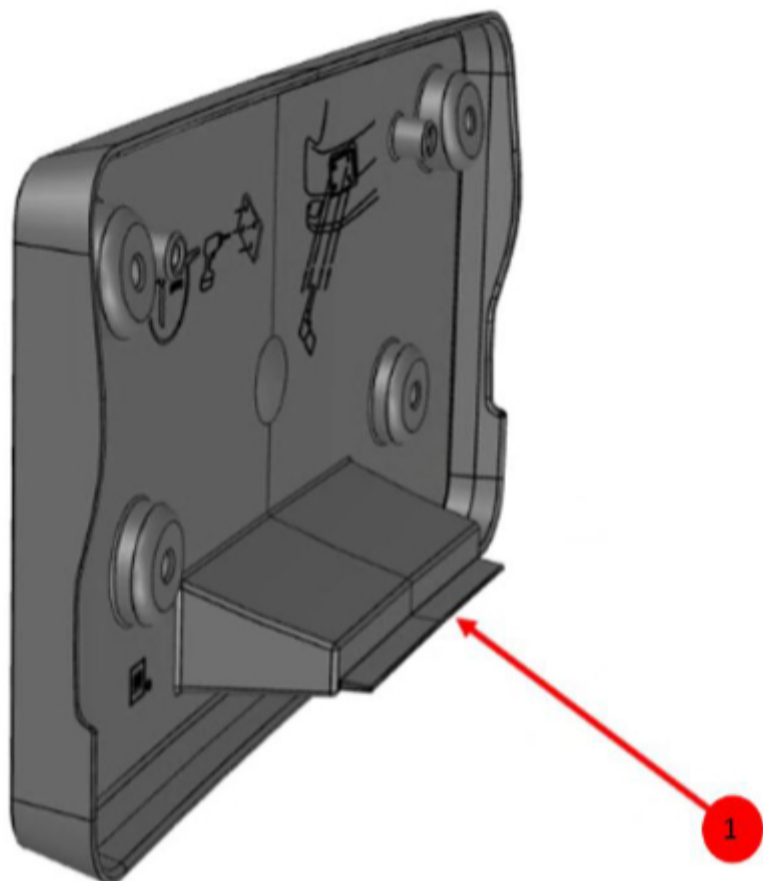
Involved Region or Country	North America
Condition	Some dealerships may notice the front license plate/tag bracket does not fit or mount properly to the front fascia.
Cause	This concern could be caused by the license plate bracket flange (1) incorrectly molded and is too long.
